Special Coverage Adjustment

15682 Primary Tank Module Flange Fuel and Vapor Leaks

Reference Number: N150682
GWM Number: 2015682

Release Date: July 2016
Revision: 00

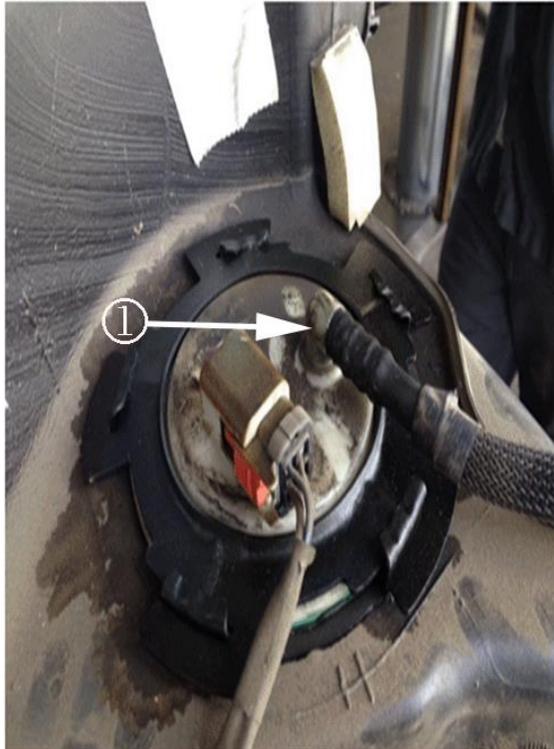
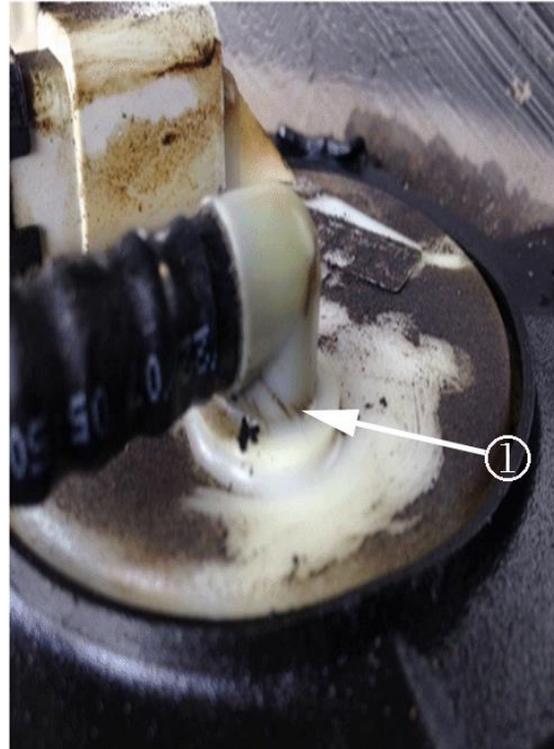
4563373

1. Inspect for an evaporative emission leak at the top of the left side fuel tank by performing an evaporative emission system test using the J 41413-200 Evaporative Emissions System Tester. Refer to *Evaporative Emission System Diagnosis* in SI.
 - If an evaporative emission leak is NOT detected at the top of the left side fuel tank, no further action is required. Inform the customer that any additional diagnosis and repairs are not covered under this special coverage.
- Note:** Do NOT remove the fuel tank until the replacement parts are available to complete the repair. Parts are in limited supply. A vehicle identification number (VIN) is required to order parts. Refer to the parts section of the bulletin.
- If an evaporative emission leak is detected at the top of the left side fuel tank, remove the fuel tank – left side. Refer to *Fuel Tank Replacement - Left Side* in SI.

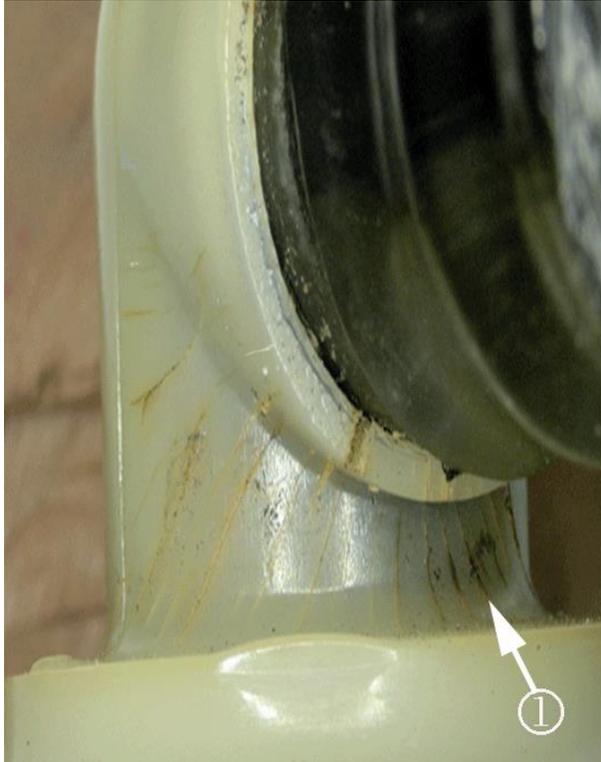
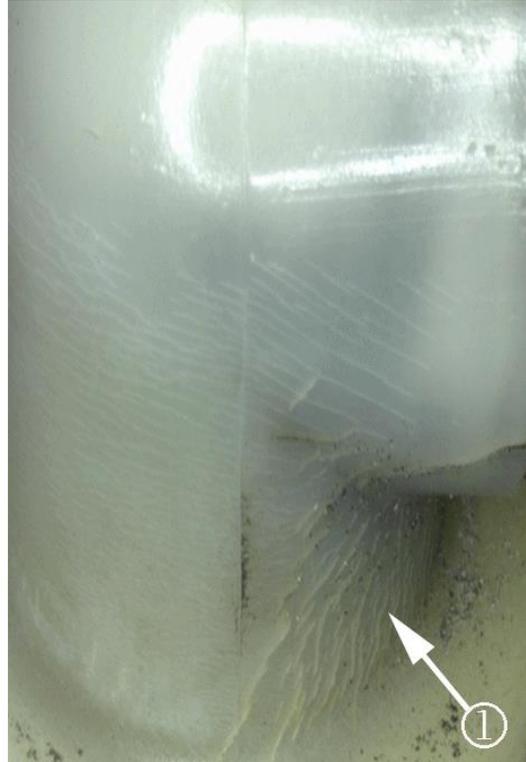
4563374

2. Inspect the fuel feed port (1), the electrical connector, and the flange seal on the fuel tank fuel pump module for cracking and/or evidence of fuel leakage.
 - If the fuel feed port, the electrical connector, or the flange seal on the fuel tank fuel pump module are cracked or show evidence of fuel leakage, replace the fuel tank fuel pump module. Refer to *Fuel Tank Fuel Pump Module Replacement - Left Side (LS3, LS7)* or *Fuel Tank Fuel Pump Module Replacement - Left Side* in SI.
 - If the fuel feed port, the electrical connector, or the flange seal on the fuel tank fuel pump module are NOT cracked or do not show evidence of fuel leakage, no further action is required. Inform the customer that any additional diagnosis and repairs are not covered under this special coverage.

Correction	Dealers are to replace the left hand fuel tank fuel pump module. The repairs will be made at no charge to the customer.
