# Service Bulletin

Bulletin No.: 06-02-35-002

**Subject:** Diagnostic Trouble Code (DTC) C0710 Steering Wheel Position Sensor (SWPS) Signal, Service Stability System Message on Driver Information Center (DIC) (Inspect and Secure Wires in SWPS Connector)

**Models:** 2004-2006 Cadillac XLR  
2005-2006 Chevrolet Corvette  
with Steering Wheel – Tilt, Telescoping (RPO N37)

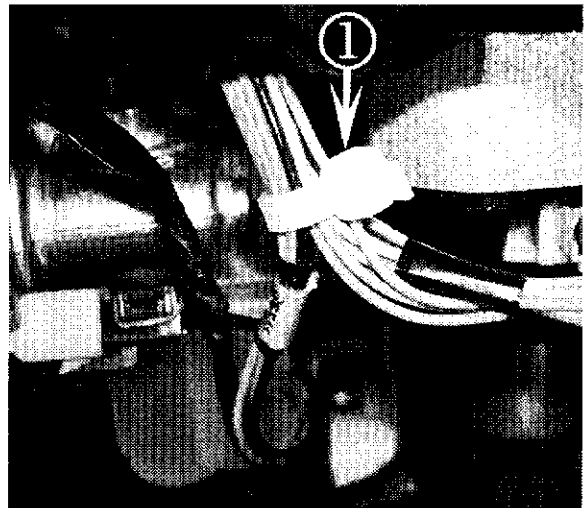
1714896

The most likely cause of a DTC C0710 on a vehicle equipped with telescoping/tilt steering wheel is high resistance in SWPS connector C202. Fretting terminal corrosion maybe present in the SWPS connector due to the telescoping motion of the steering column. When the steering column is telescoped in and out, the female terminals within the SWPS connector may move on the male terminals of the SWPS. This movement between the terminals may cause a high resistance condition in the SWPS connector.

1. Remove the driver's side close out panel.
  - Cadillac XLR — Refer to Closeout/Insulator Panel Replacement - Left (SI Document ID 1207847)
  - Chevrolet Corvette — Refer to Closeout/Insulator Panel Replacement - Instrument Panel (I/P) Lower (SI Document ID 1495116)
2. On XLR models only, locate and remove the plastic strap (1) on the steering column harness that retains the three wiring harnesses. Discard this strap.
3. Disconnect the SWPS connector C202 located on the lower center of the steering column.

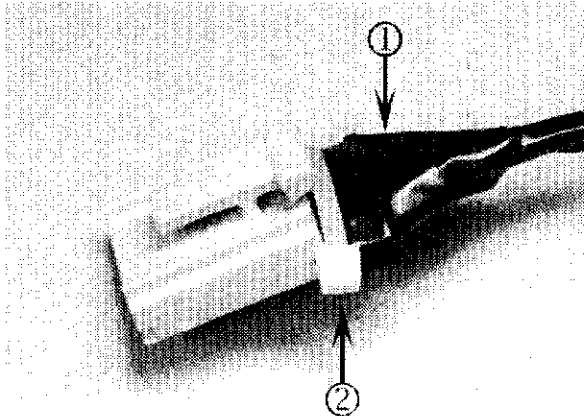
1743934

- Failure to properly tape the wires in the connector may result in additional concerns.
- Failure to use a small plastic strap 2.5-3.5 mm (0.10-0.14 in) in width may prevent the SWPS connector from properly seating, resulting in additional SWPS DTCs.
- Failure to position the plastic strap in the connector notch shown below may result in the strap becoming loose and allowing the terminal to move within the connector.

4. Using electrical tape (1), tape from the plastic strap up the wires a minimum of 2.5 cm (1 in).
5. Install a small plastic strap (2) 2.5-3.5 mm (0.10-0.14 in) wide around the SWPS sensor connector so that it retains the wires to the connector as shown.

**Important:** Install and remove the SWPS connector a minimum of three times to remove any possible terminal corrosion.
