Special Coverage Adjustment

15682 Primary Tank Module Flange Fuel and Vapor Leaks

Reference Number: N150682 **Release Date:** August 2016
GWM Number: 2015682 **Revision:** 01
Revision Description: This bulletin is being revised to accurately depict the origin on the flange in which fuel and vapor leaks have been confirmed. Please discard all previous copies of bulletin 15682.

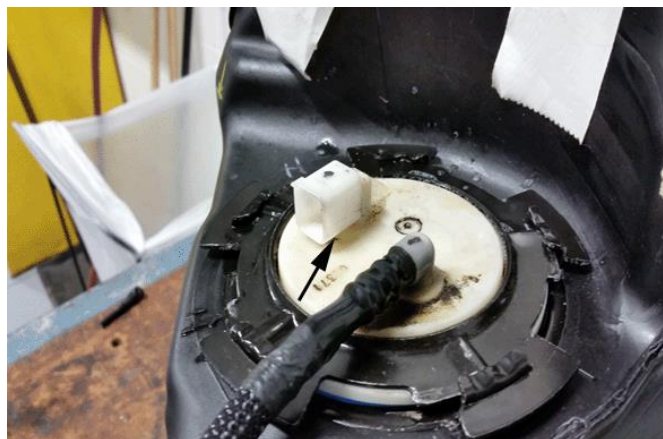
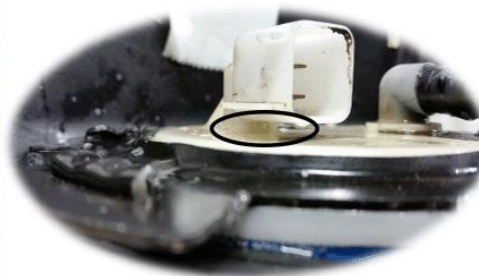
4567575

3. Inspect the area below the electrical connector (as shown above) for evidence of fuel leakage.
 - If there is evidence of fuel leakage, replace the fuel tank fuel pump module. Refer to Fuel Tank Fuel Pump Module Replacement - Left Side (LS3, LS7) or Fuel Tank Fuel Pump Module Replacement - Left Side in SI.
 - If there is NO evidence of fuel leakage, no further action is required. Inform the customer that any additional diagnosis and repairs are not covered under this special coverage.
4. If fuel was removed to perform the evaporative emissions system test in step 1, refuel the fuel tank to the previous level.
