# 2006 - 2009 Cadillac XLR XLR-V: Service Bulletin: #16-NA-130: No Reverse, No Second After Upper Valve Body Replacement

## #16-NA-130: No Reverse, No Second After Upper Valve Body Replacement - (Apr 27, 2016)

**Subject:** No Reverse, No Second After Upper Valve Body Replacement

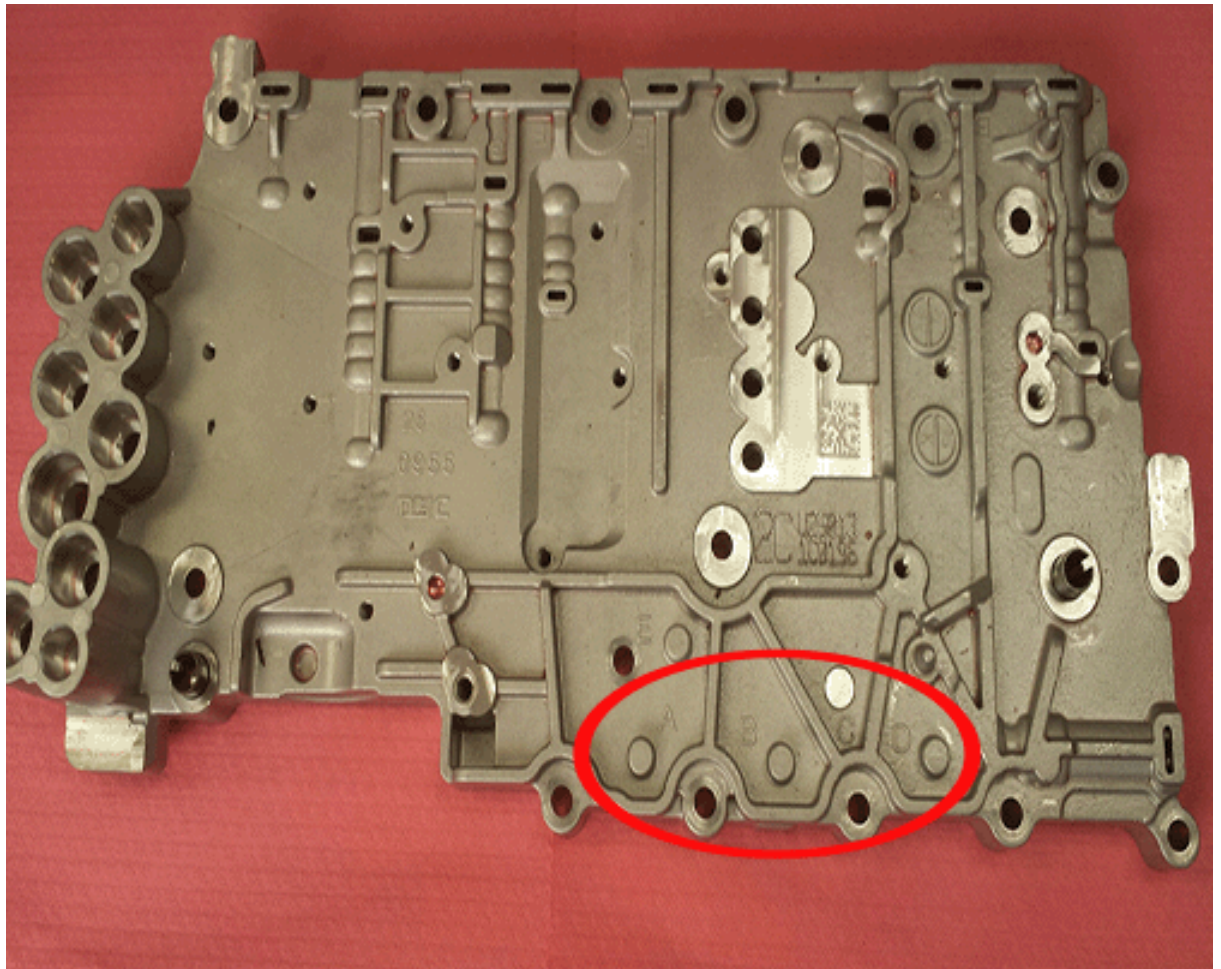
Location of the four post shown above.

Upper valve bodies are unique by transmission RPO. Each upper valve body has four posts labeled A, B, C and D on the top side of the upper valve body. Inspect the upper valve body as shown below to determine the correct RPO usage.

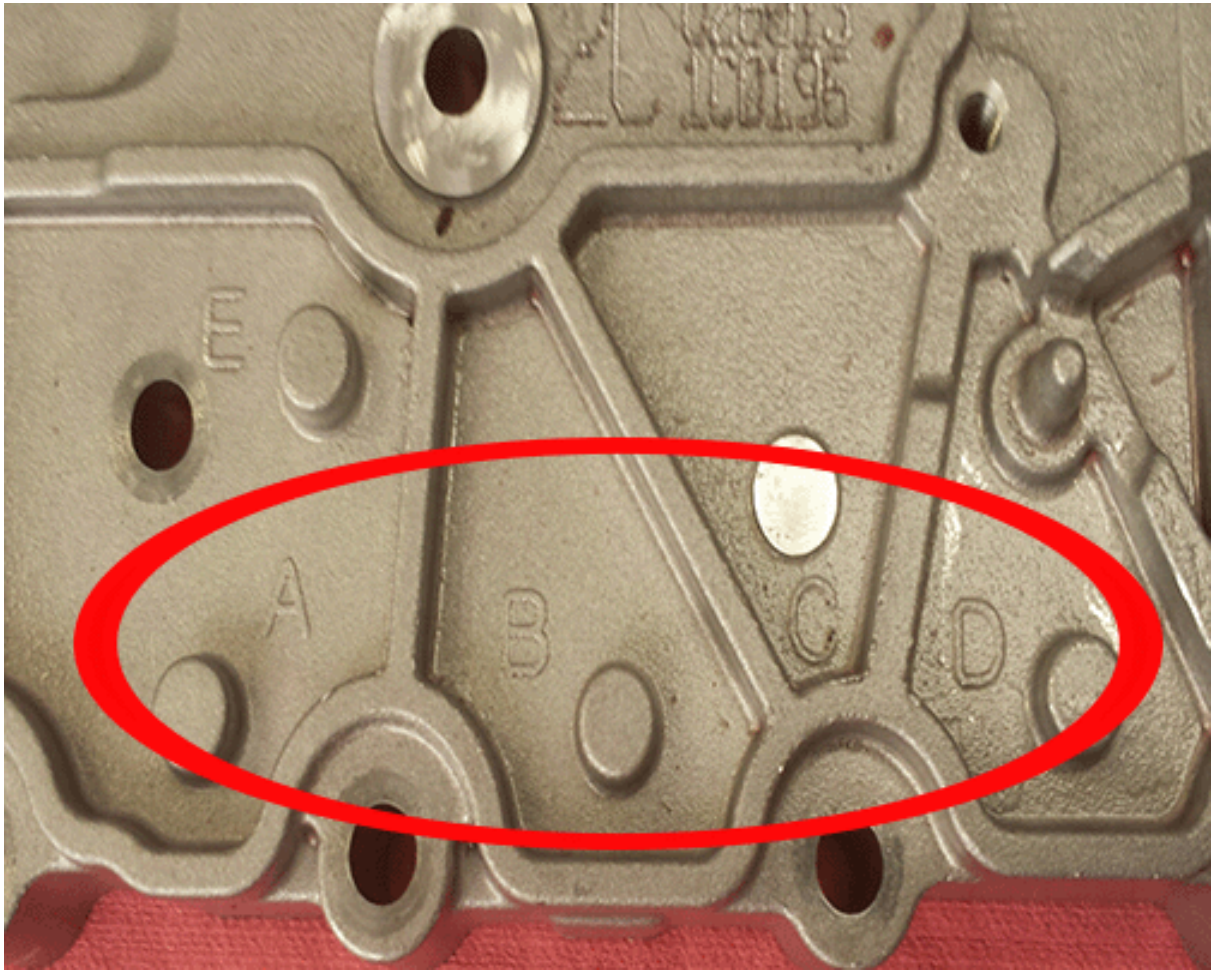
The post corresponding to the correct RPO will be milled off. In this case the “C” post is milled indicating that this is an MYC upper valve body. A milled “A” post indicates MYA, a milled “B” indicates MYB, a milled “C” indicates MYC and a milled “D” indicates MYD.
