# 2006 - 2009 Cadillac XLR XLR-V: Service Bulletin: #16-NA-130: No Reverse, No Second After Upper Valve Body Replacement

## #16-NA-130: No Reverse, No Second After Upper Valve Body Replacement - (Apr 27, 2016)

<b>Subject:</b>	No Reverse, No Second After Upper Valve Body Replacement				
<b>Attention:</b>	This Bulletin also applies to any of the models that may be Export from North America vehicles.

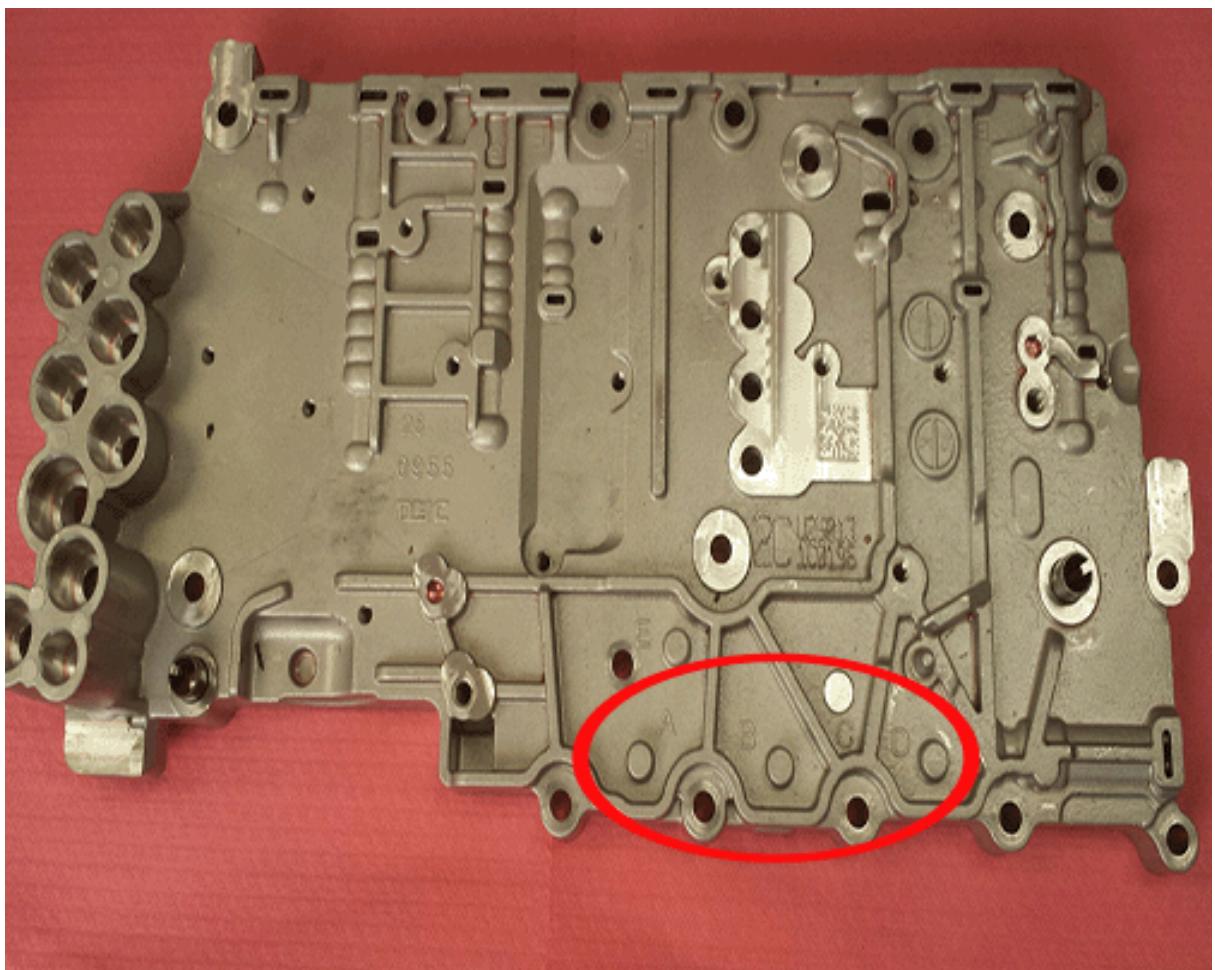
Location of the four post shown above.

Upper valve bodies are unique by transmission RPO. Each upper valve body has four posts labeled A, B, C and D on the top side of the upper valve body. Inspect the upper valve body as shown below to determine the correct RPO usage.

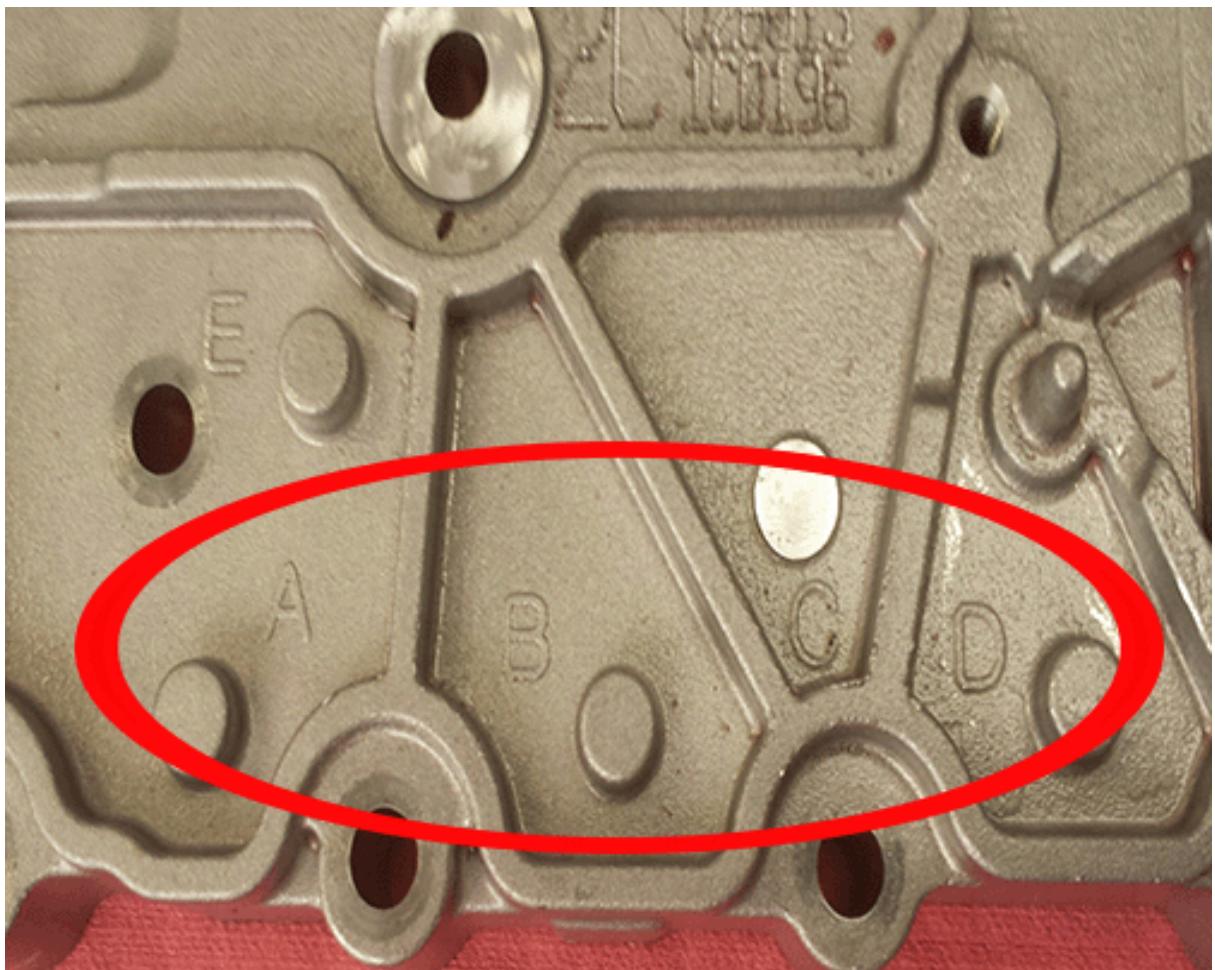
The post corresponding to the correct RPO will be milled off. In this case the "C" post is milled indicating that this is an MYC upper valve body. A milled "A" post indicates MYA, a milled "B" indicates MYB, a milled "C" indicates MYC and a milled "D" indicates MYD.

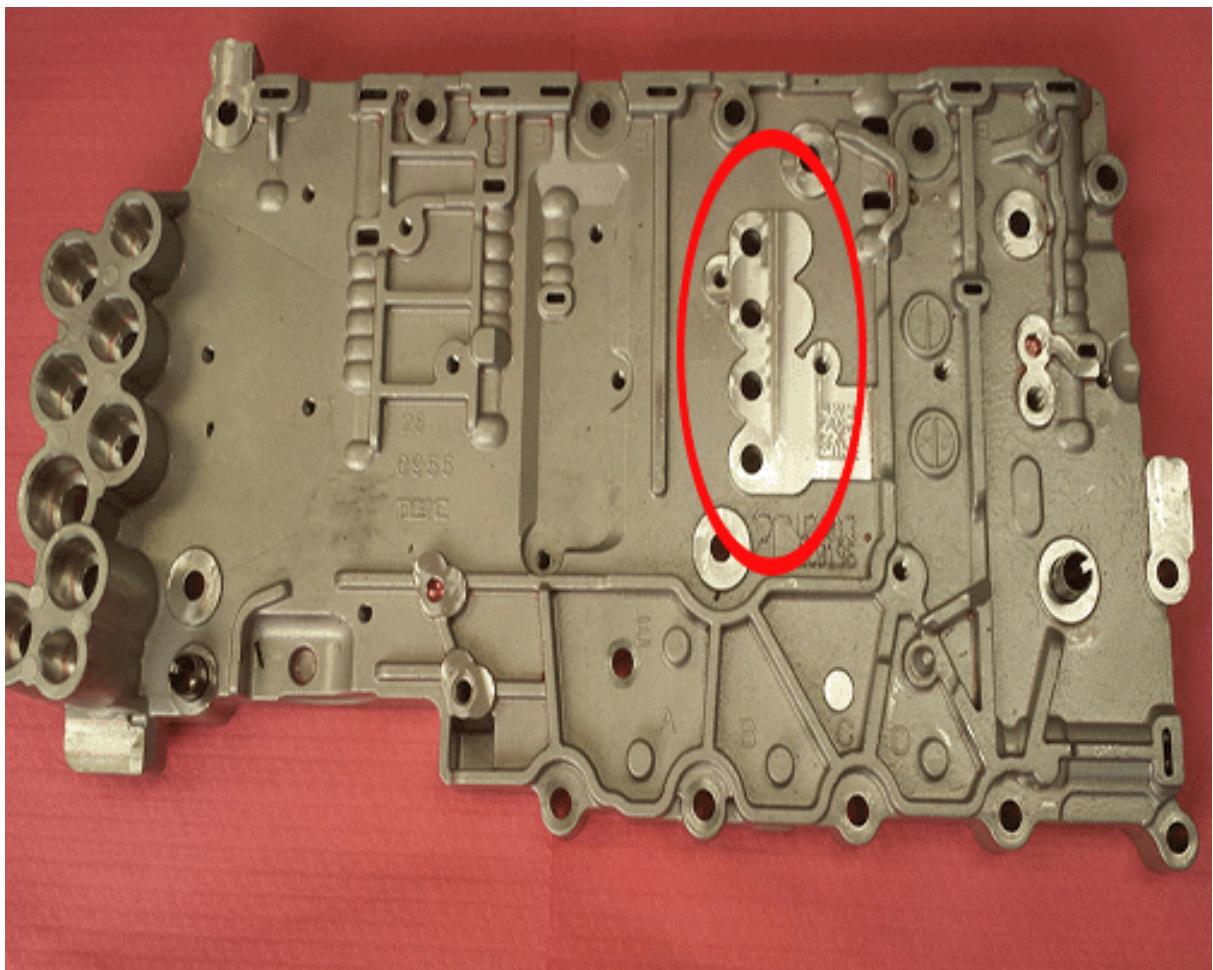
The oil passage holes that feed the center support and Low and Reverse Clutch and 2-6 Clutch contained within the center support vary location by transmission and corresponding upper valve body. The ISS and OSS mounting locations also vary by transmission. The incorrect valve body does not properly locate the oil feed holes and speed sensors.
