# 2006 - 2009 Cadillac XLR XLR-V: Service Bulletin: #16-NA-130: No Reverse, No Second After Upper Valve Body Replacement

## #16-NA-130: No Reverse, No Second After Upper Valve Body Replacement - (Apr 27, 2016)

**Subject:** No Reverse, No Second After Upper Valve Body Replacement

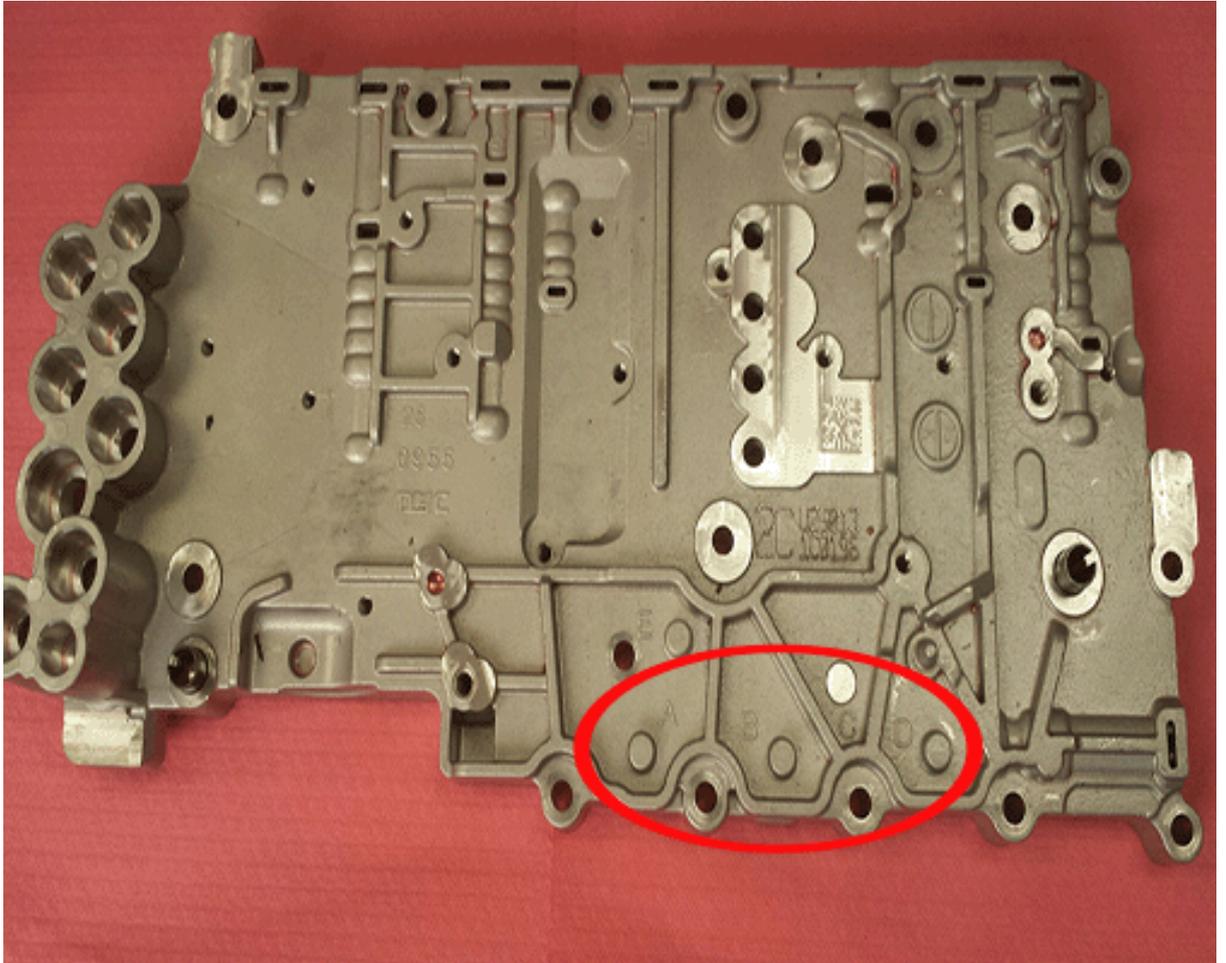
Location of the four post shown above.

Upper valve bodies are unique by transmission RPO. Each upper valve body has four posts labeled A, B, C and D on the top side of the upper valve body. Inspect the upper valve body as shown below to determine the correct RPO usage.

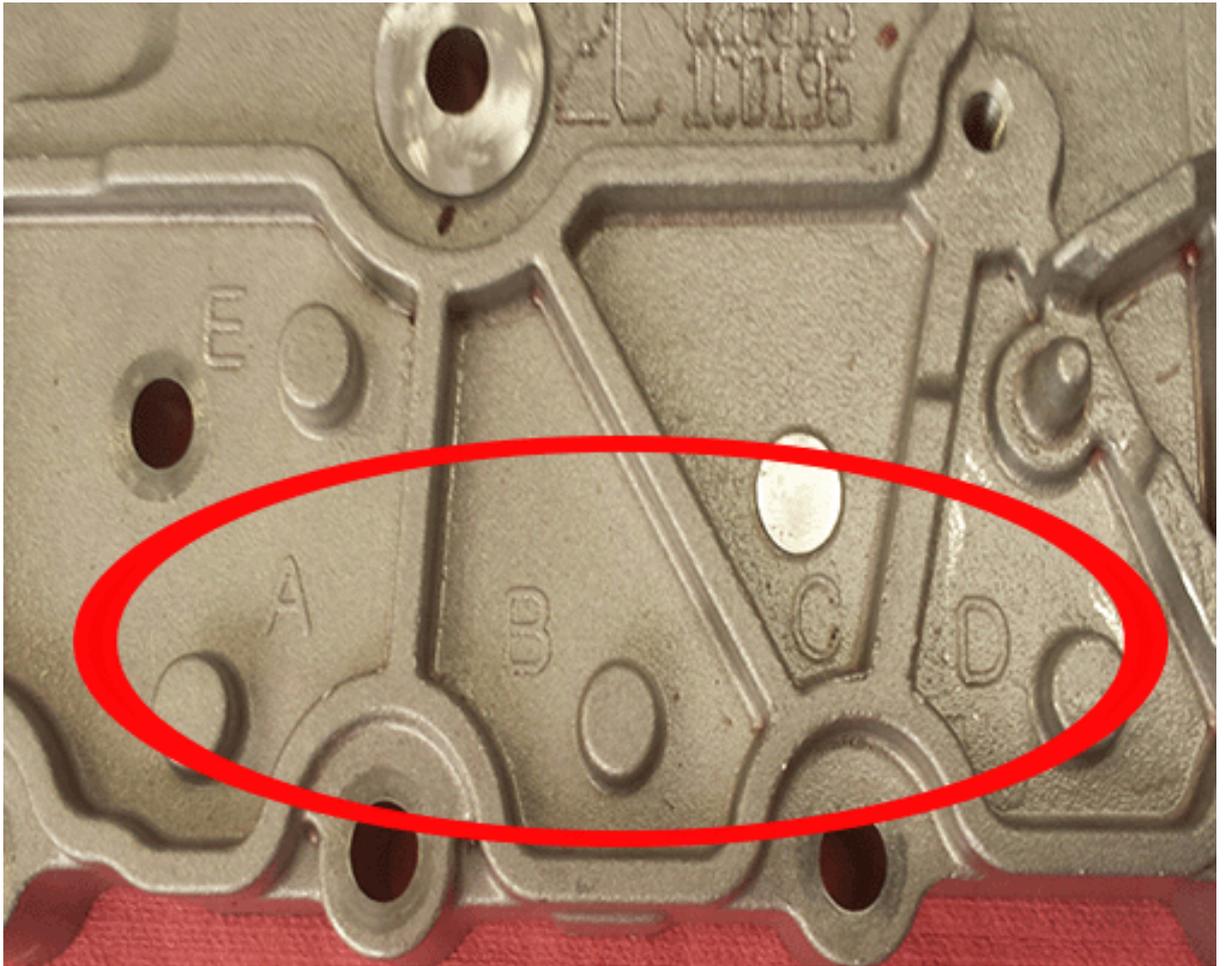
The post corresponding to the correct RPO will be milled off. In this case the “C” post is milled indicating that this is an MYC upper valve body. A milled “A” post indicates MYA, a milled “B” indicates MYB, a milled “C” indicates MYC and a milled “D” indicates MYD.

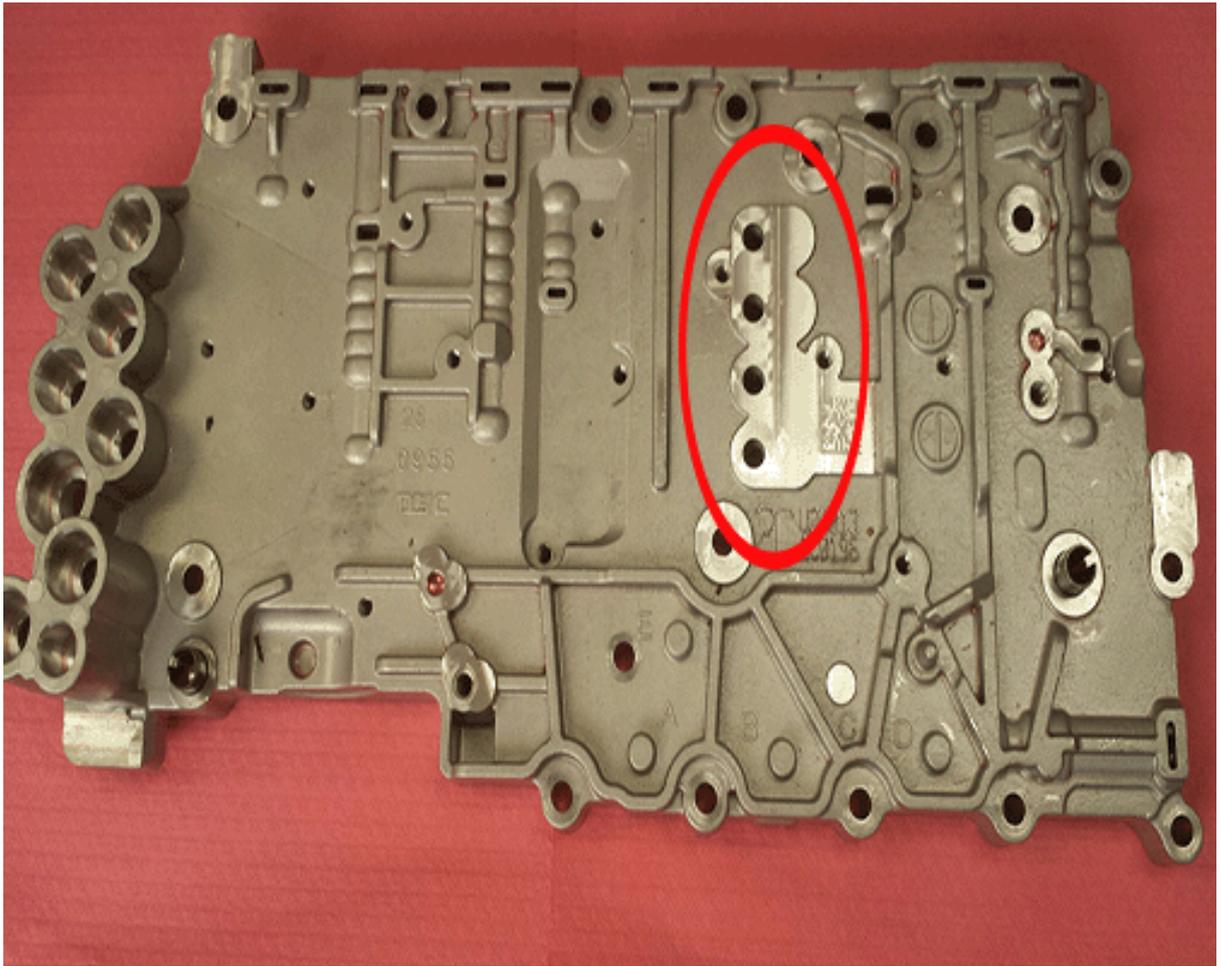
The oil passage holes that feed the center support and Low and Reverse Clutch and 2-6 Clutch contained within the center support vary location by transmission and corresponding upper valve body. The ISS and OSS mounting locations also vary by transmission. The incorrect valve body does not properly locate the oil feed holes and speed sensors.
