2006 - 2009 Cadillac XLR XLR-V: Service Bulletin: #16-NA-130: No Reverse, No Second After Upper Valve Body Replacement

#16-NA-130: No Reverse, No Second After Upper Valve Body Replacement - (Apr 27, 2016)

Subject: No Reverse, No Second After Upper Valve Body Replacement

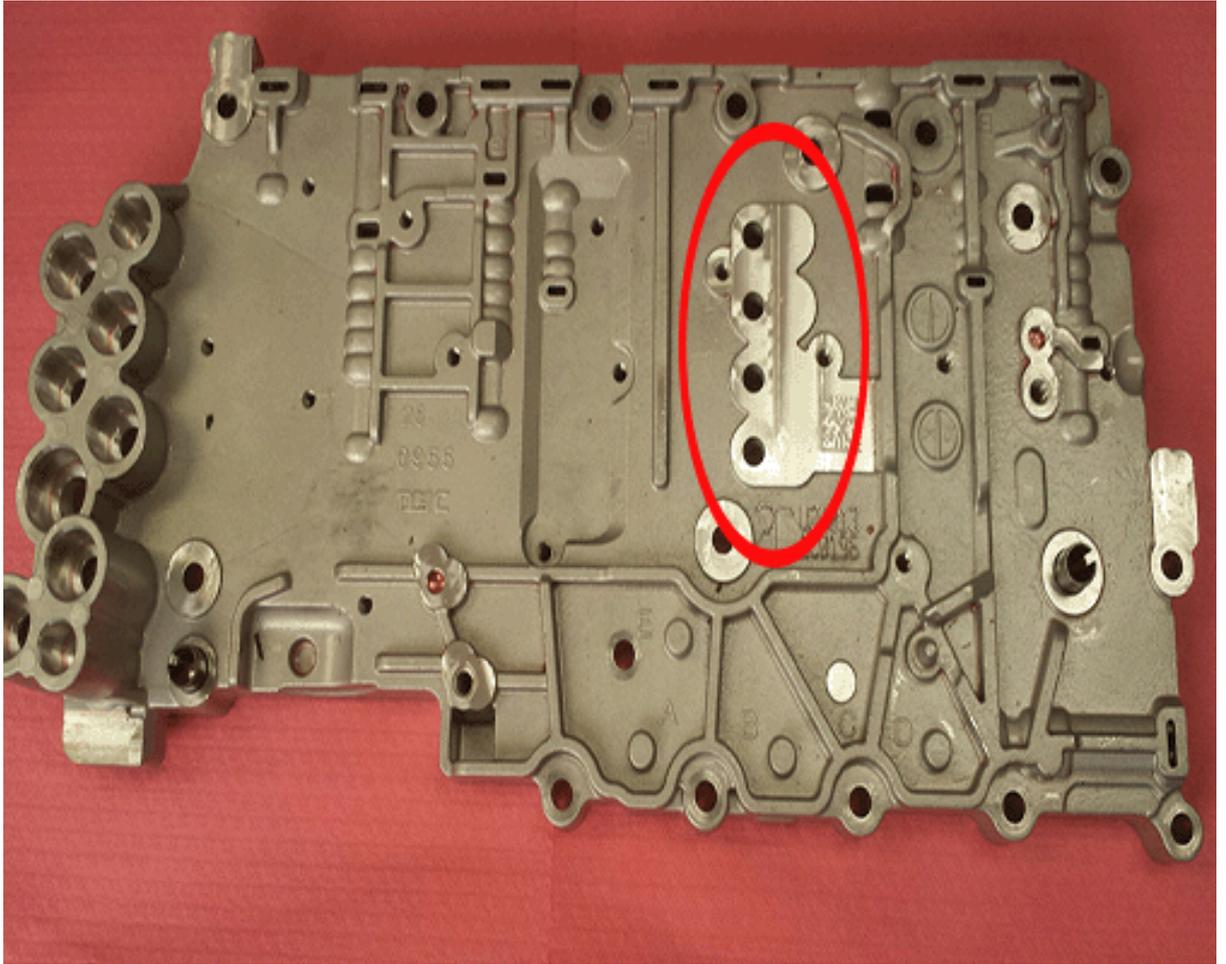
The oil passage holes that feed the center support and Low and Reverse Clutch and 2-6 Clutch contained within the center support vary location by transmission and corresponding upper valve body. The ISS and OSS mounting locations also vary by transmission. The incorrect valve body does not properly locate the oil feed holes and speed sensors.
