2006 - 2009 Cadillac XLR XLR-V: Service Bulletin: #16-NA-130: No Reverse, No Second After Upper Valve Body Replacement

#16-NA-130: No Reverse, No Second After Upper Valve Body Replacement - (Apr 27, 2016)

Subject: No Reverse, No Second After Upper Valve Body Replacement

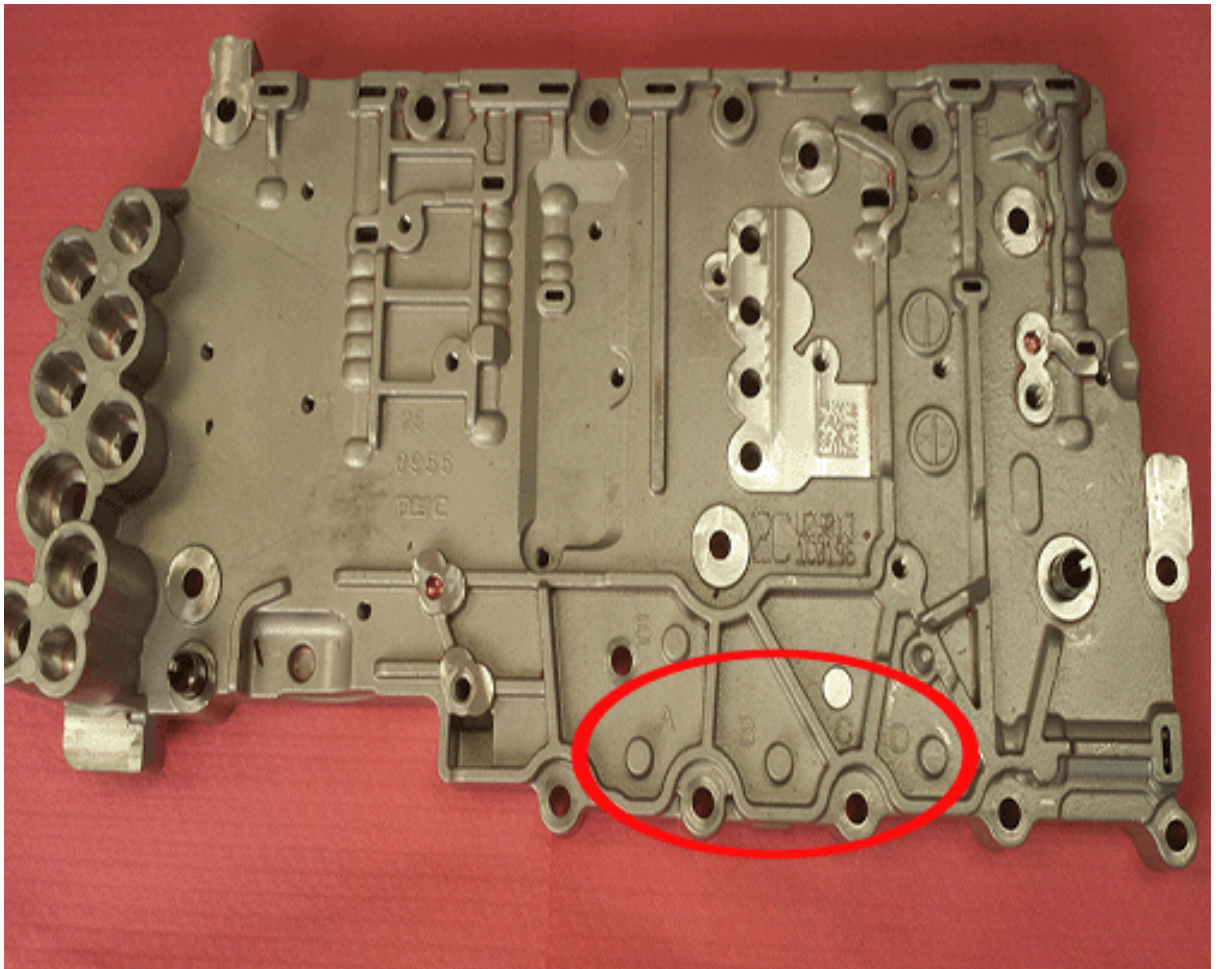
Upper valve bodies are unique by transmission RPO. Each upper valve body has four posts labeled A, B, C and D on the top side of the upper valve body. Inspect the upper valve body as shown below to determine the correct RPO usage.
