2006 - 2009 Cadillac XLR XLR-V: Service Bulletin: #16-NA-130: No Reverse, No Second After Upper Valve Body Replacement

#16-NA-130: No Reverse, No Second After Upper Valve Body Replacement - (Apr 27, 2016)

Subject: No Reverse, No Second After Upper Valve Body Replacement

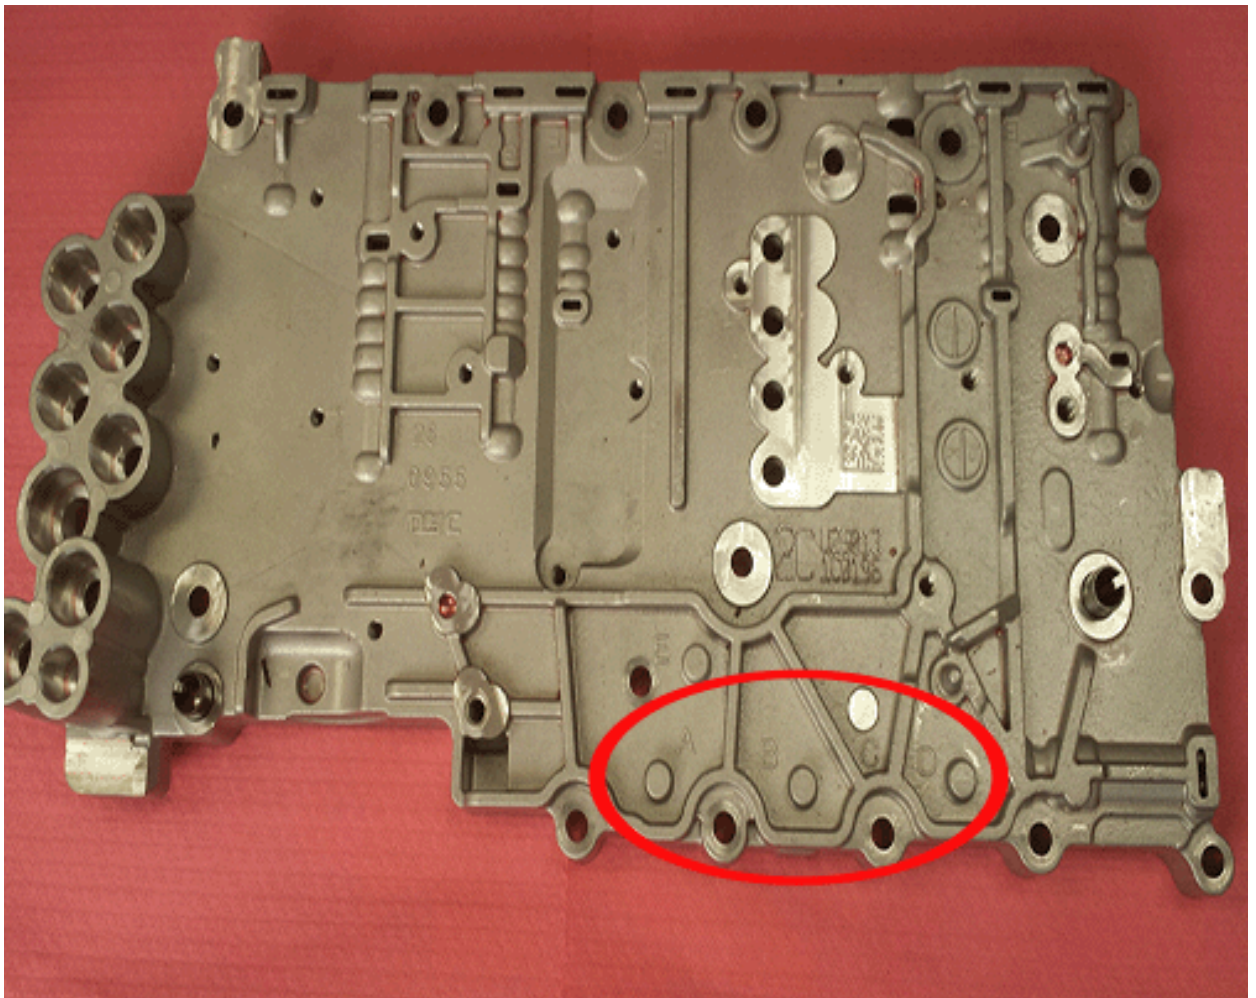
Upper valve bodies are unique by transmission RPO. Each upper valve body has four posts labeled A, B, C and D on the top side of the upper valve body. Inspect the upper valve body as shown below to determine the correct RPO usage.

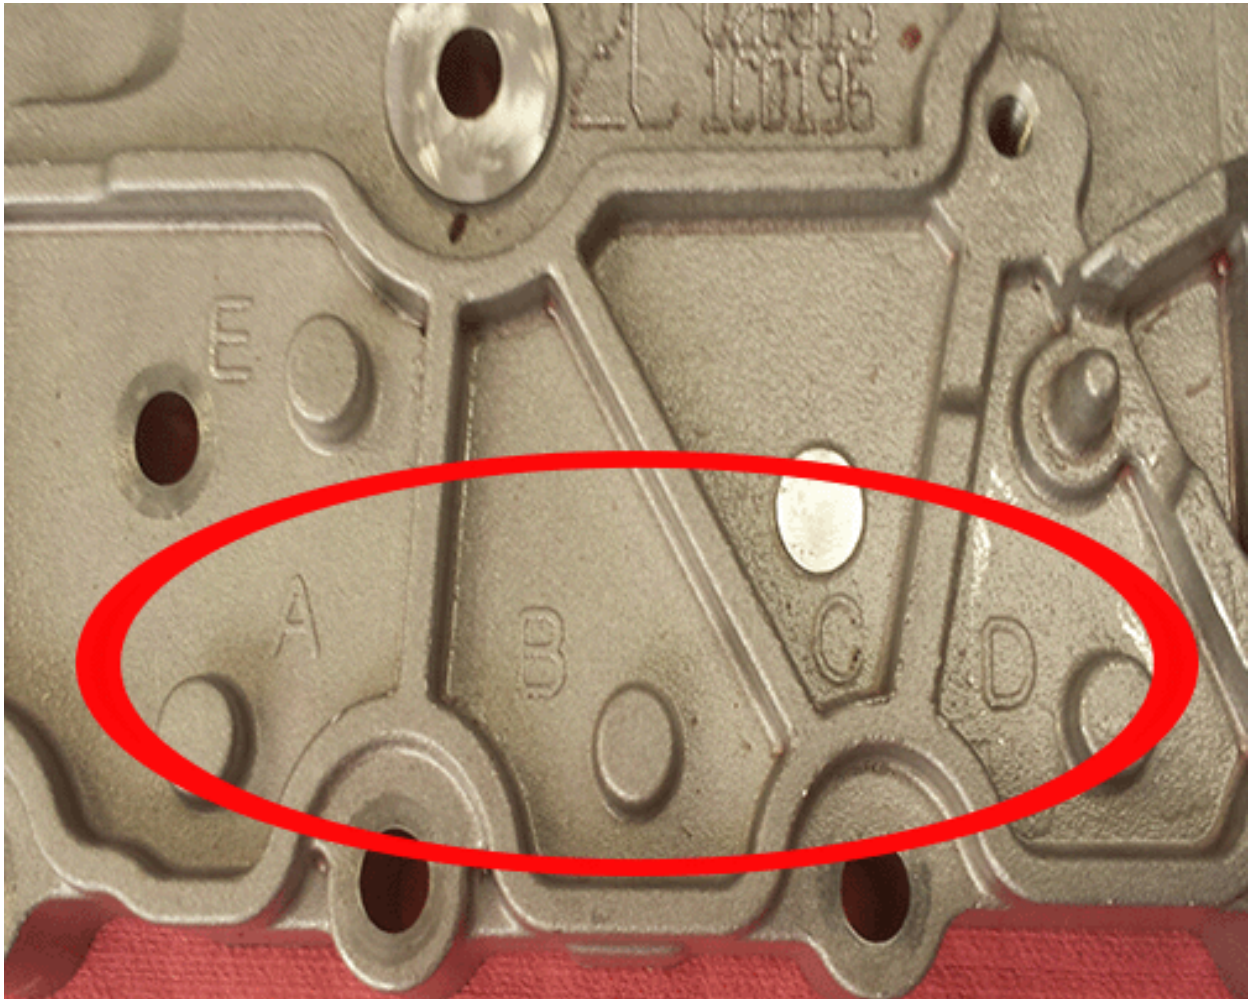
Location of the four post shown above.
