2004 - 2009 Cadillac XLR: Service Bulletin: #05-08-57-005B: General Waterleak Guide - (Oct 2, 2008)

Subject: General Waterleak
Guide

Models: 2004 - 2009 Cadillac
XLR

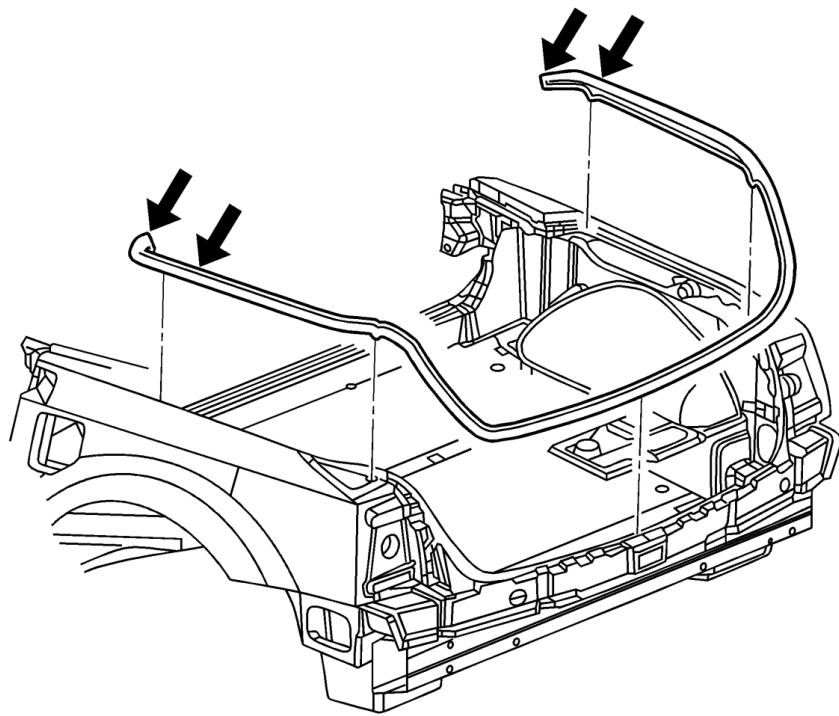
Water entry over the wheelhouse traced back to the joint between the rear compartment weatherstrip and quarter belt weatherstrip.

Separate the joints and lift each end 50-76 mm (2-3 in) enough to apply 3M™ Bedding and Glazing Compound, P/N 08509, inside the U-Channel of the weatherstrip. Refer to the illustration above. Apply enough compound so that it extends to both ends of the weatherstrip and will cause slight squeeze out when reinstalled. As you reinstall the weatherstrips, be sure the smaller weatherstrip is fully inserted into the opposite weatherstrip. Work the weatherstrips onto the flange and towards each other to ensure a tight joint when finished.

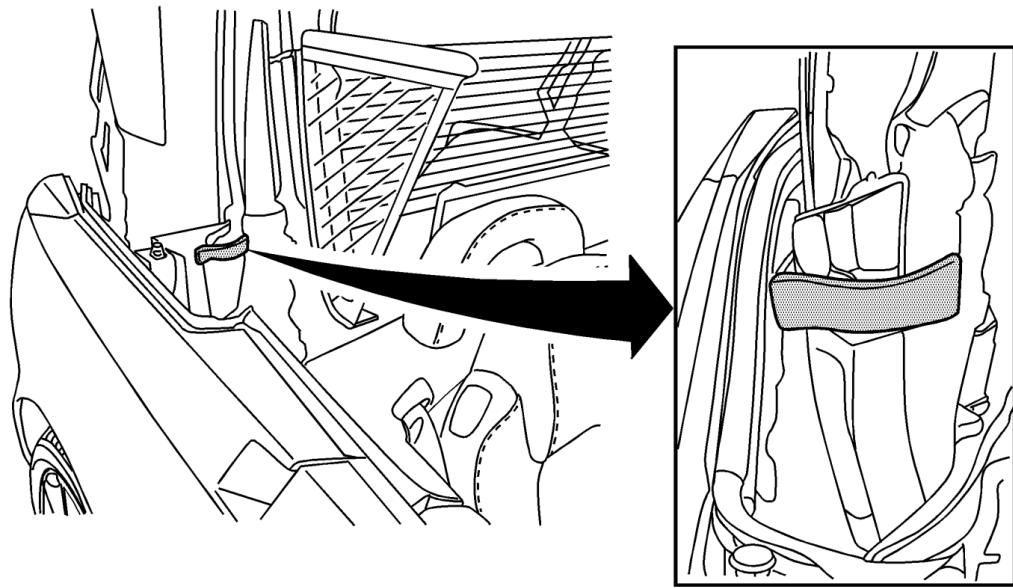
Water entry over wheel house and traced back to quarter belt cup. The cup drain is not large enough to allow water to drain adequately and floods over the dry side of the sealing system, which allows water to enter the trunk.

The cup joint is located at the rear of the quarter belt seal and it looks like a trough. This area is where the rear roof panel lower weatherstrip contacts when the roof is closed. The area just forward (toward front of car) of this cup is a “wet area” and to better manage the water into this wet area, a strip of foam must be added into the rear roof panel lower weatherstrip where it contacts the cup. Cut a strip of adhesive backed foam Kent Adhesive – Back Shim Stock, P/N P46475, 60 mm X 15 mm (2 1/4 in X 5/8 in). Clean the area of the rear roof panel lower weatherstrip where the foam will be added using de-natured alcohol before installing the foam strip to ensure adhesion. Refer to the illustration above.

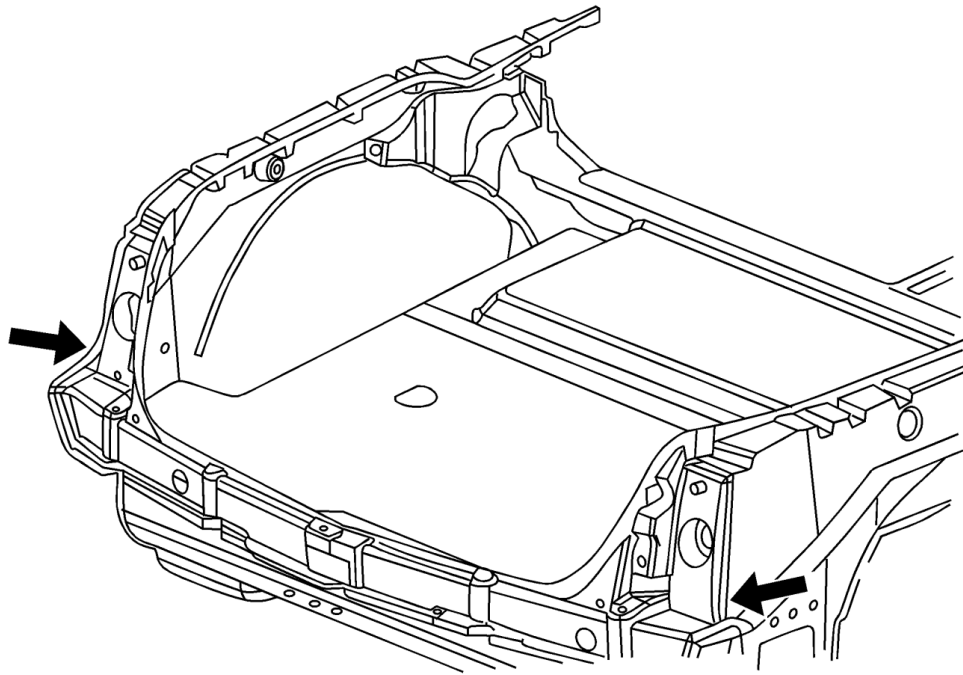
Water entry into rear tubs located behind the rear wheelhouses traced

to the area behind the rear tail lamps.

There are a number of panels that are bonded together in this area. If water entry is traced to this area, remove the rear tail lamp on the affected side to help gain access. Use Kent Seam Sealer, P/N P10200, to seal the affected joint. Refer to the illustration above.

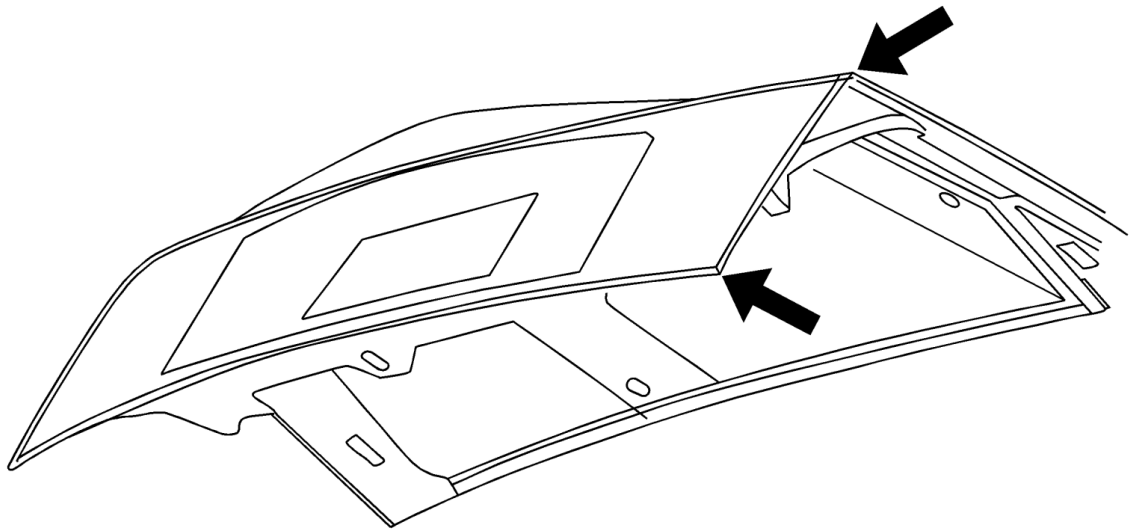
Water entry into the rear compartment. Water may be present on the sill of the lower rear compartment opening (near the latch). Water may be seen dripping from the rear compartment lid inner trim at the lower corners.

Seal the area of the rear compartment lid inner and outer panels at the outer most vertical seam (between arrows – either side). The seam is on the inside of the rear compartment lid. Refer to the illustration above. Use Kent Seam Sealer, P/N P10200, to seal the seam for best appearance.

Important: Inspect the rear tub drains to ensure that they are clear of any obstructions. Inspect to be sure that there is no loose material in the tub that could cover the drain on the inside of the tub. If the drain has a duck bill type drain at the end, use scissors to make one cut in the bottom opening so that if viewed from the bottom it will have an "X" instead of a slit in the opening.
