## **2004 - 2009 Cadillac XLR: Service Bulletin: #05-08-57-005B: General Waterleak Guide - (Oct 2, 2008)**

**Subject:** General Waterleak  
Guide

**Models:** 2004 - 2009 Cadillac  
XLR

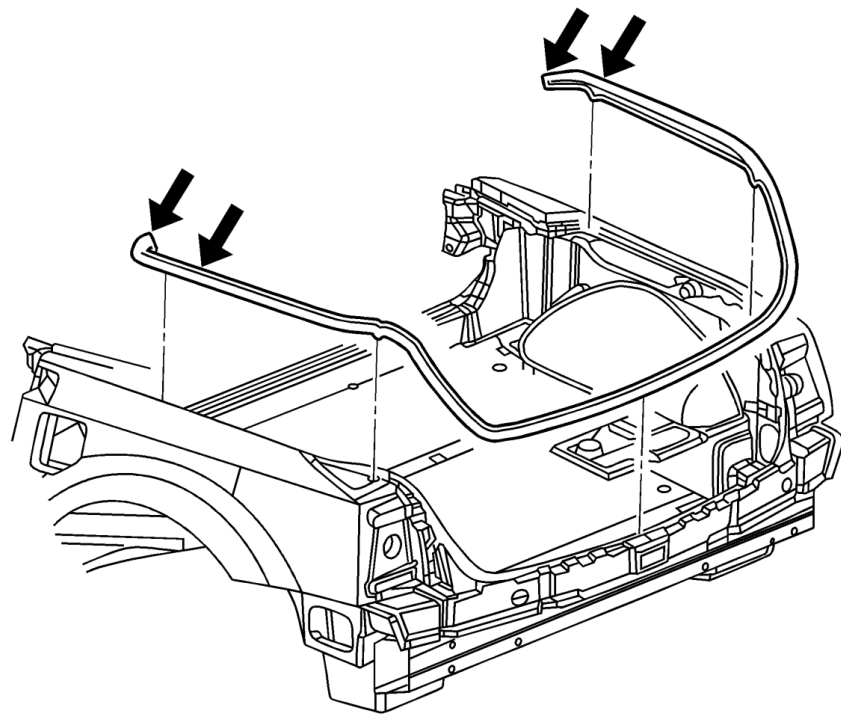
Water entry over the wheelhouse traced back to the joint between the rear compartment weatherstrip and quarter belt weatherstrip.

Separate the joints and lift each end 50-76 mm (2-3 in) enough to apply 3M™ Bedding and Glazing Compound, P/N 08509, inside the U-Channel of the weatherstrip. Refer to the illustration above. Apply enough compound so that it extends to both ends of the weatherstrip and will cause slight squeeze out when reinstalled. As you reinstall the weatherstrips, be sure the smaller weatherstrip is fully inserted into the opposite weatherstrip. Work the weatherstrips onto the flange and towards each other to ensure a tight joint when finished.
