2004 - 2009 Cadillac XLR: Service Bulletin: #05-08-57-005B: General Waterleak Guide - (Oct 2, 2008)

Subject: General Waterleak
Guide

Models: 2004 - 2009 Cadillac
XLR

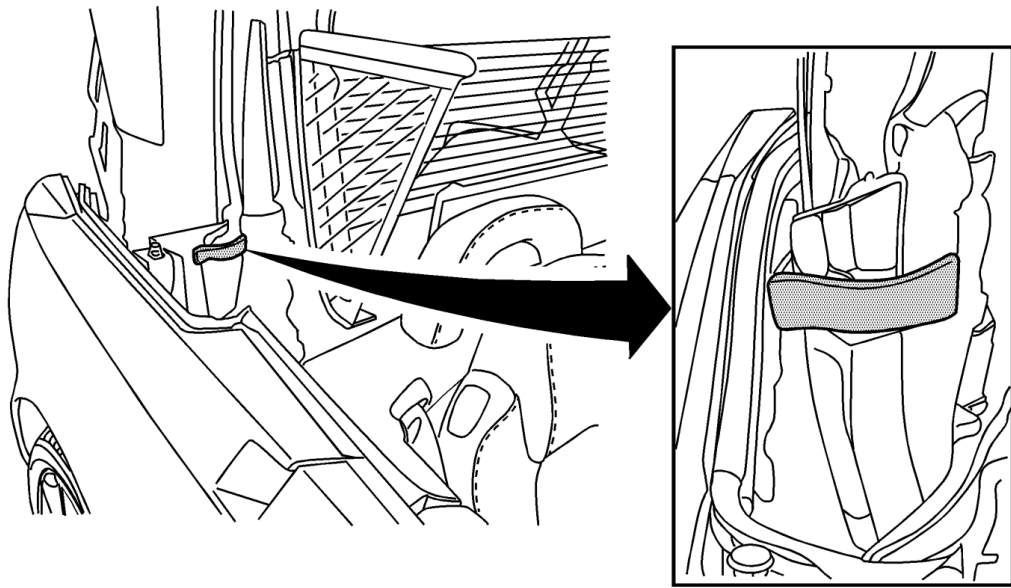
Water entry over wheel house and traced back to quarter belt cup. The cup drain is not large enough to allow water to drain adequately and floods over the dry side of the sealing system, which allows water to enter the trunk.

The cup joint is located at the rear of the quarter belt seal and it looks like a trough. This area is where the rear roof panel lower weatherstrip contacts when the roof is closed. The area just forward (toward front of car) of this cup is a “wet area” and to better manage the water into this wet area, a strip of foam must be added into the rear roof panel lower weatherstrip where it contacts the cup. Cut a strip of adhesive backed foam Kent Adhesive – Back Shim Stock, P/N P46475, 60 mm X 15 mm (2 1/4 in X 5/8 in). Clean the area of the rear roof panel lower weatherstrip where the foam will be added using de-natured alcohol before installing the foam strip to ensure adhesion. Refer to the illustration above.

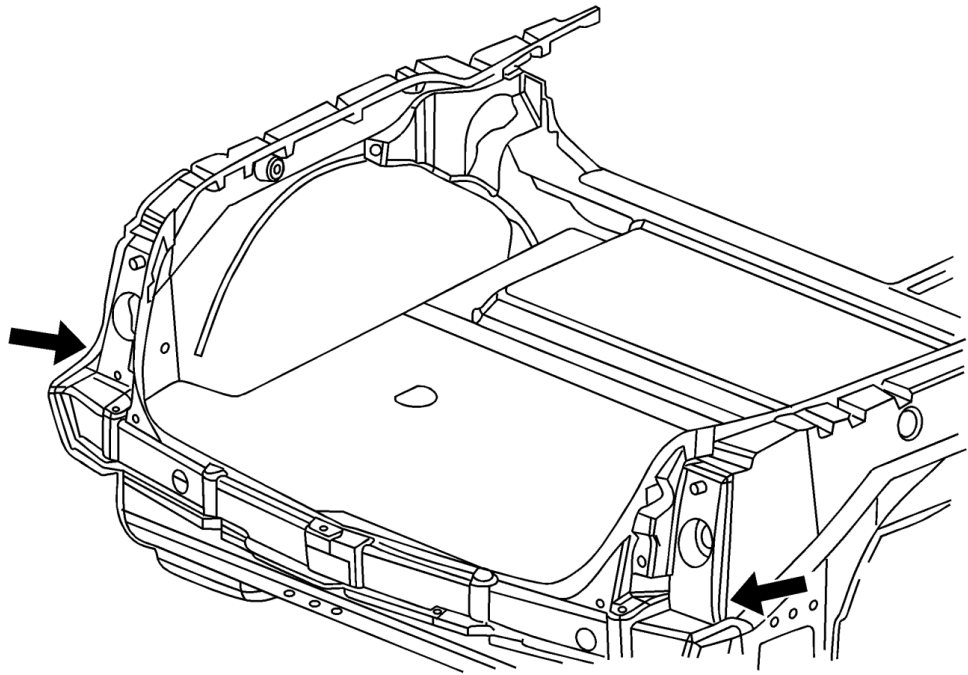
Water entry into rear tubs located behind the rear wheelhouses traced

to the area behind the rear tail lamps.

There are a number of panels that are bonded together in this area. If water entry is traced to this area, remove the rear tail lamp on the affected side to help gain access. Use Kent Seam Sealer, P/N P10200, to seal the affected joint. Refer to the illustration above.

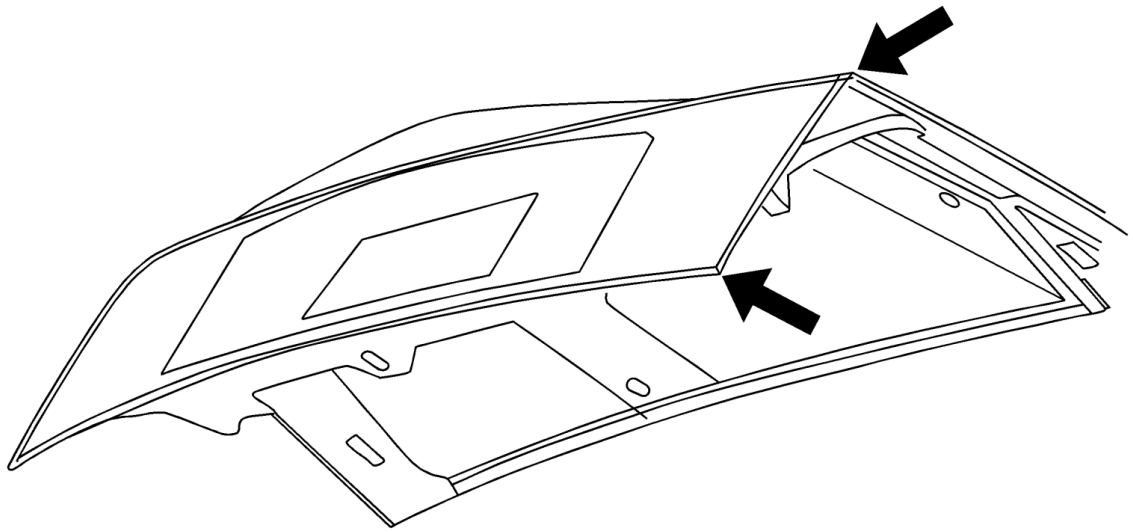
Water entry into the rear compartment. Water may be present on the sill of the lower rear compartment opening (near the latch). Water may be seen dripping from the rear compartment lid inner trim at the lower corners.

Seal the area of the rear compartment lid inner and outer panels at the outer most vertical seam (between arrows – either side). The seam is on the inside of the rear compartment lid. Refer to the illustration above. Use Kent Seam Sealer, P/N P10200, to seal the seam for best appearance.
