2004 - 2009 Cadillac XLR: Service Bulletin: #05-08-57-005B: General Waterleak Guide - (Oct 2, 2008)

Subject: General Waterleak
Guide

Models: 2004 - 2009 Cadillac
XLR

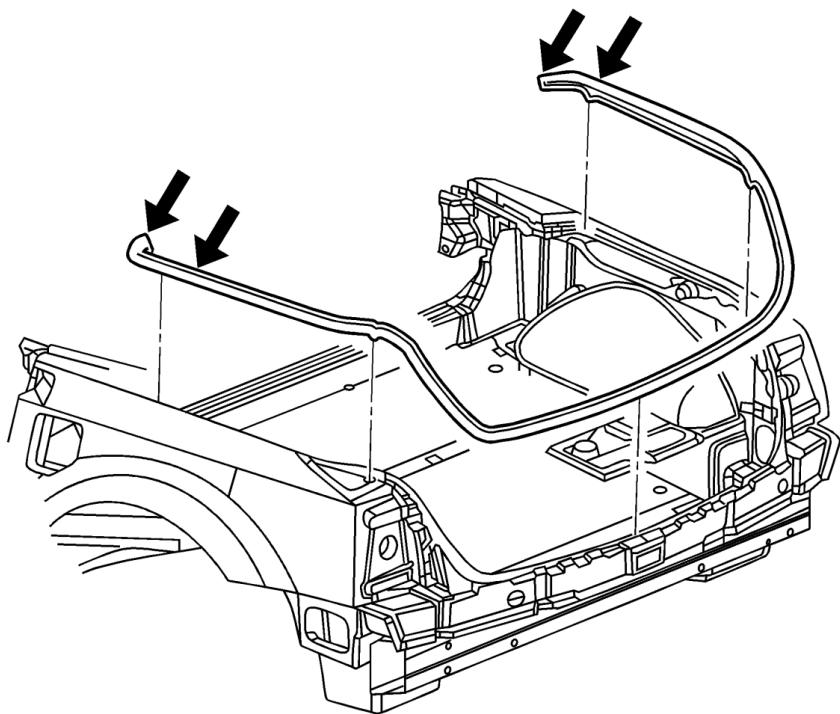
Water entry over the wheelhouse traced back to the joint between the rear compartment weatherstrip and quarter belt weatherstrip.

Separate the joints and lift each end 50-76 mm (2-3 in) enough to apply 3M™ Bedding and Glazing Compound, P/N 08509, inside the U-Channel of the weatherstrip. Refer to the illustration above. Apply enough compound so that it extends to both ends of the weatherstrip and will cause slight squeeze out when reinstalled. As you reinstall the weatherstrips, be sure the smaller weatherstrip is fully inserted into the opposite weatherstrip. Work the weatherstrips onto the flange and towards each other to ensure a tight joint when finished.

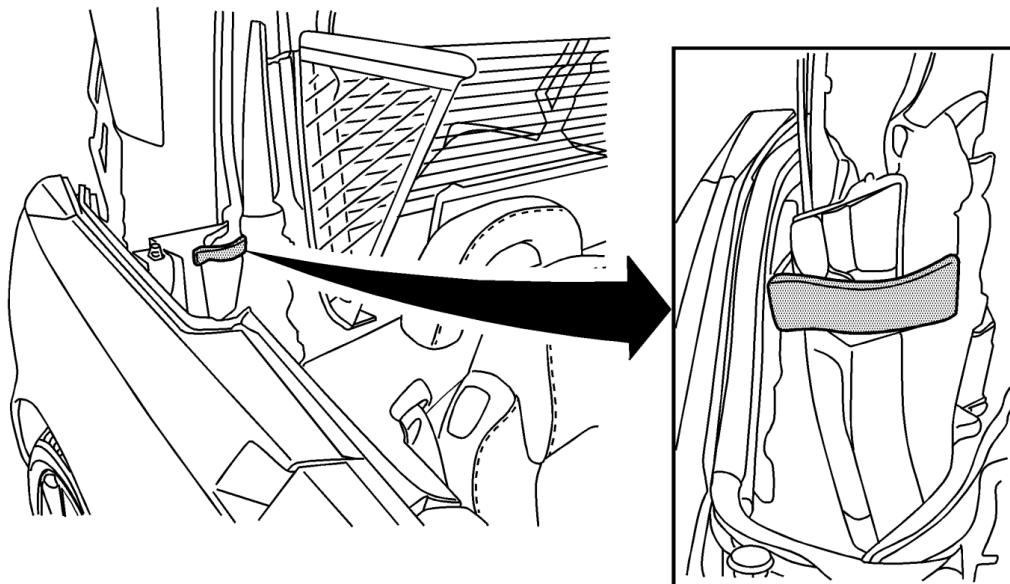
Water entry over wheel house and traced back to quarter belt cup. The cup drain is not large enough to allow water to drain adequately and floods over the dry side of the sealing system, which allows water to enter the trunk.

The cup joint is located at the rear of the quarter belt seal and it looks like a trough. This area is where the rear roof panel lower weatherstrip contacts when the roof is closed. The area just forward (toward front of car) of this cup is a “wet area” and to better manage the water into this wet area, a strip of foam must be added into the rear roof panel lower weatherstrip where it contacts the cup. Cut a strip of adhesive backed foam Kent Adhesive – Back Shim Stock, P/N P46475, 60 mm X 15 mm (2 1/4 in X 5/8 in). Clean the area of the rear roof panel lower weatherstrip where the foam will be added using de-natured alcohol before installing the foam strip to ensure adhesion. Refer to the illustration above.

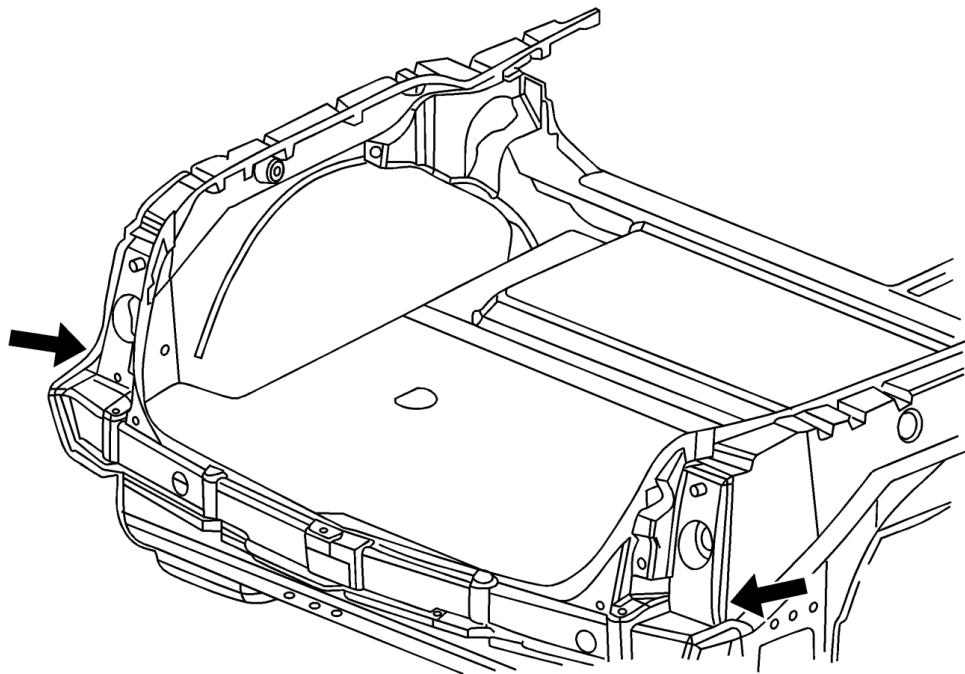
Water entry into rear tubs located behind the rear wheelhouses traced

to the area behind the rear tail lamps.

There are a number of panels that are bonded together in this area. If water entry is traced to this area, remove the rear tail lamp on the affected side to help gain access. Use Kent Seam Sealer, P/N P10200, to seal the affected joint. Refer to the illustration above.

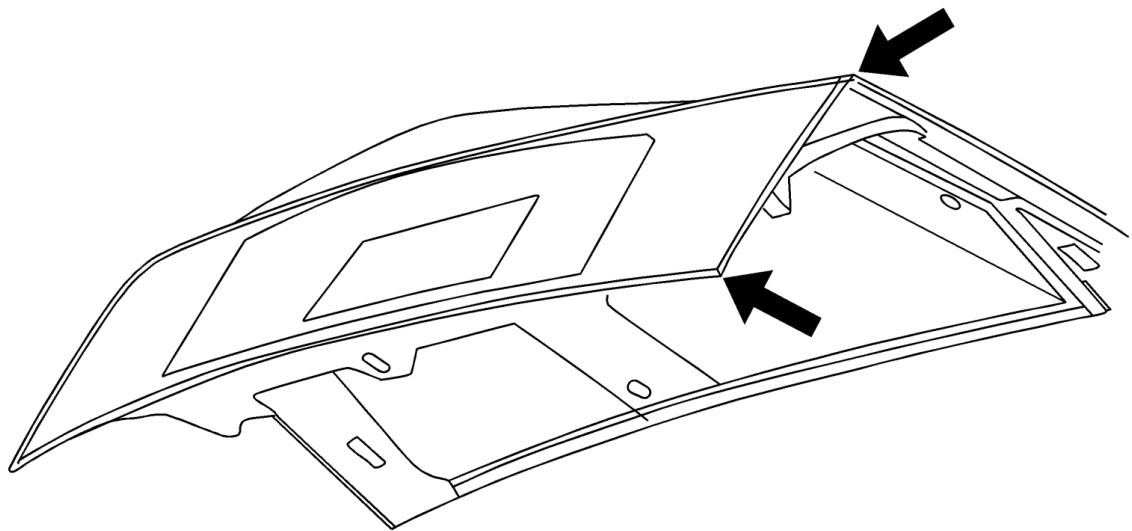
Water entry into the rear compartment. Water may be present on the sill of the lower rear compartment opening (near the latch). Water may be seen dripping from the rear compartment lid inner trim at the lower corners.

Seal the area of the rear compartment lid inner and outer panels at the outer most vertical seam (between arrows – either side). The seam is on the inside of the rear compartment lid. Refer to the illustration above. Use Kent Seam Sealer, P/N P10200, to seal the seam for best appearance.
