# **2004 - 2009 Cadillac XLR: Service Bulletin: #05-08-57-005B: General Waterleak Guide - (Oct 2, 2008)**

**Subject:** General Waterleak  
Guide

**Models:** 2004 - 2009 Cadillac  
XLR

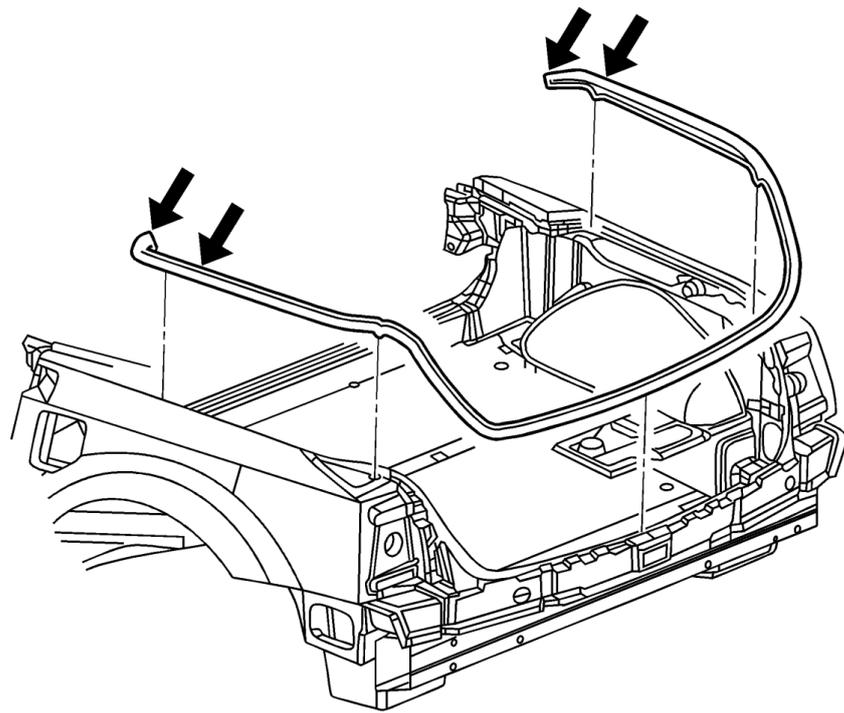
Water entry over the wheelhouse traced back to the joint between the rear compartment weatherstrip and quarter belt weatherstrip.

Separate the joints and lift each end 50-76 mm (2-3 in) enough to apply 3M™ Bedding and Glazing Compound, P/N 08509, inside the U-Channel of the weatherstrip. Refer to the illustration above. Apply enough compound so that it extends to both ends of the weatherstrip and will cause slight squeeze out when reinstalled. As you reinstall the weatherstrips, be sure the smaller weatherstrip is fully inserted into the opposite weatherstrip. Work the weatherstrips onto the flange and towards each other to ensure a tight joint when finished.

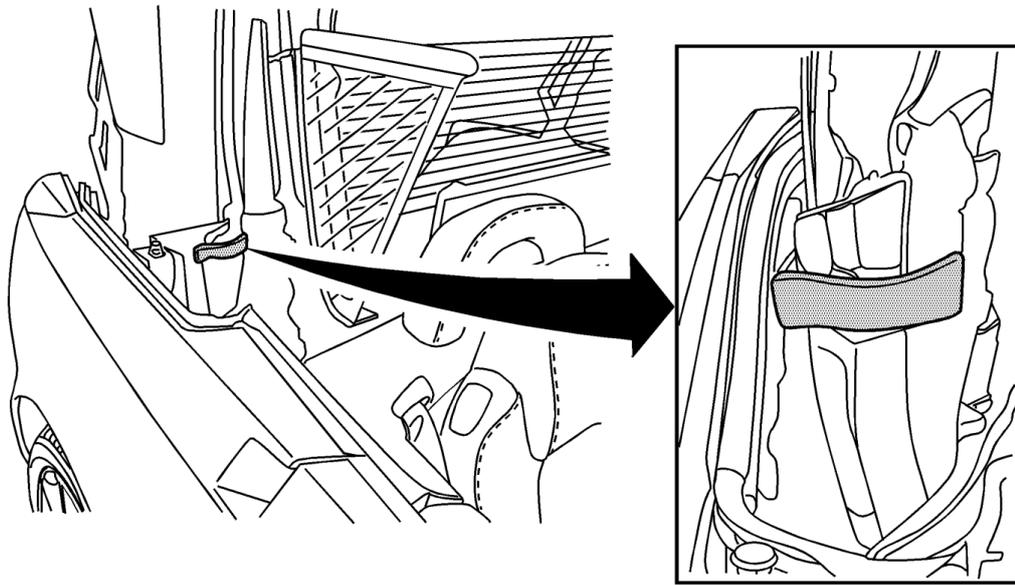
Water entry over wheel house and traced back to quarter belt cup. The cup drain is not large enough to allow water to drain adequately and floods over the dry side of the sealing system, which allows water to enter the trunk.

The cup joint is located at the rear of the quarter belt seal and it looks like a trough. This area is where the rear roof panel lower weatherstrip contacts when the roof is closed. The area just forward (toward front of car) of this cup is a “wet area” and to better manage the water into this wet area, a strip of foam must be added into the rear roof panel lower weatherstrip where it contacts the cup. Cut a strip of adhesive backed foam Kent Adhesive – Back Shim Stock, P/N P46475, 60 mm X 15 mm (2 1/4 in X 5/8 in). Clean the area of the rear roof panel lower weatherstrip where the foam will be added using de-natured alcohol before installing the foam strip to ensure adhesion. Refer to the illustration above.

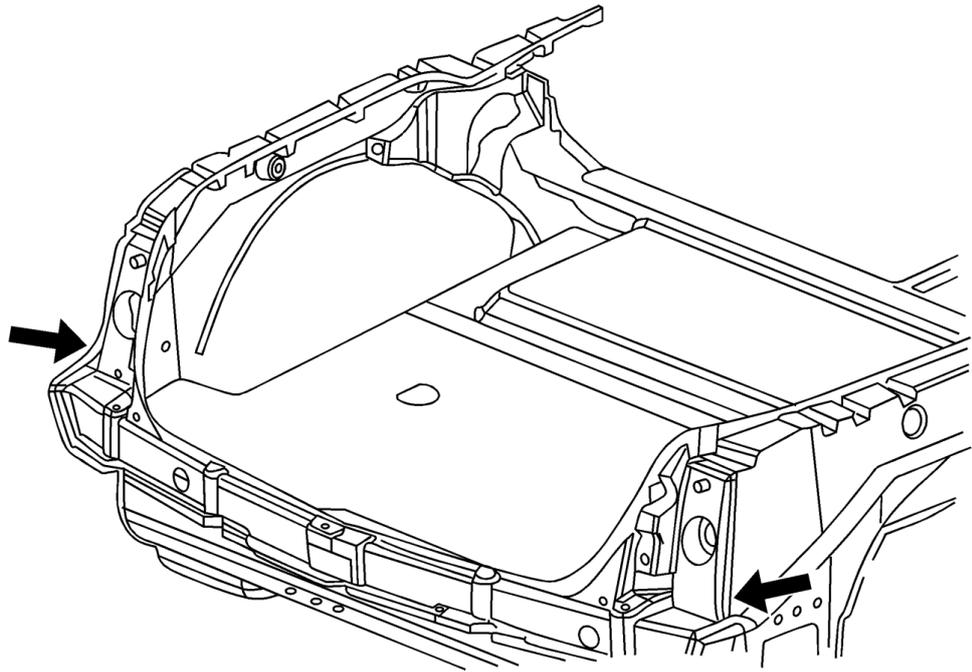
Water entry into rear tubs located behind the rear wheelhouses traced

to the area behind the rear tail lamps.

There are a number of panels that are bonded together in this area. If water entry is traced to this area, remove the rear tail lamp on the affected side to help gain access. Use Kent Seam Sealer, P/N P10200, to seal the affected joint. Refer to the illustration above.

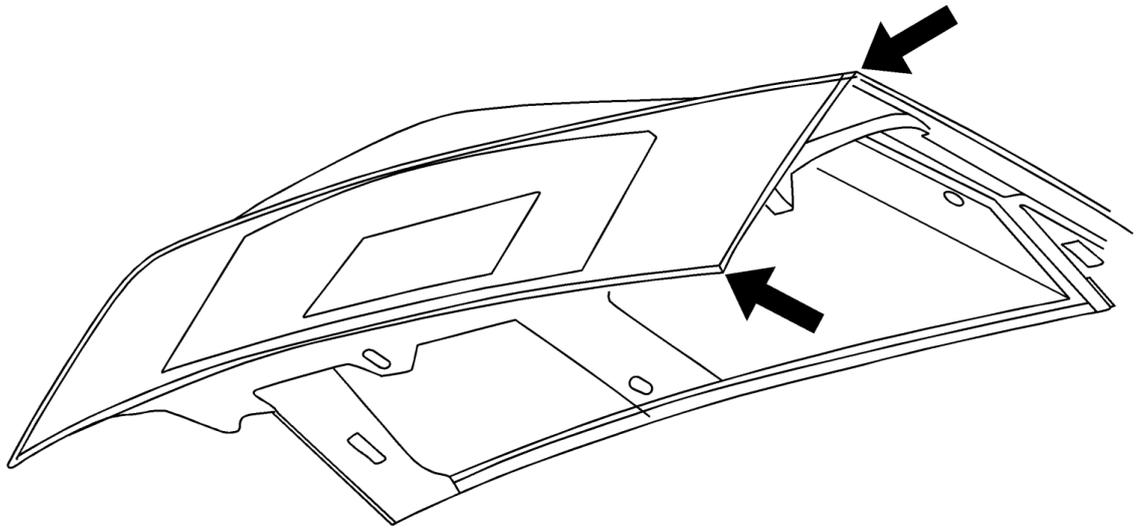
Water entry into the rear compartment. Water may be present on the sill of the lower rear compartment opening (near the latch). Water may be seen dripping from the rear compartment lid inner trim at the lower corners.

Seal the area of the rear compartment lid inner and outer panels at the outer most vertical seam (between arrows – either side). The seam is on the inside of the rear compartment lid. Refer to the illustration above. Use Kent Seam Sealer, P/N P10200, to seal the seam for best appearance.

**Important:** Inspect the rear tub drains to ensure that they are clear of any obstructions. Inspect to be sure that there is no loose material in the tub that could cover the drain on the inside of the tub. If the drain has a duck bill type drain at the end, use scissors to make one cut in the bottom opening so that if viewed from the bottom it will have an "X" instead of a slit in the opening.
