2004 - 2009 Cadillac XLR: Service Bulletin: #05-08-57-005B: General Waterleak Guide - (Oct 2, 2008)

Subject: General Waterleak
Guide

Models: 2004 - 2009 Cadillac
XLR

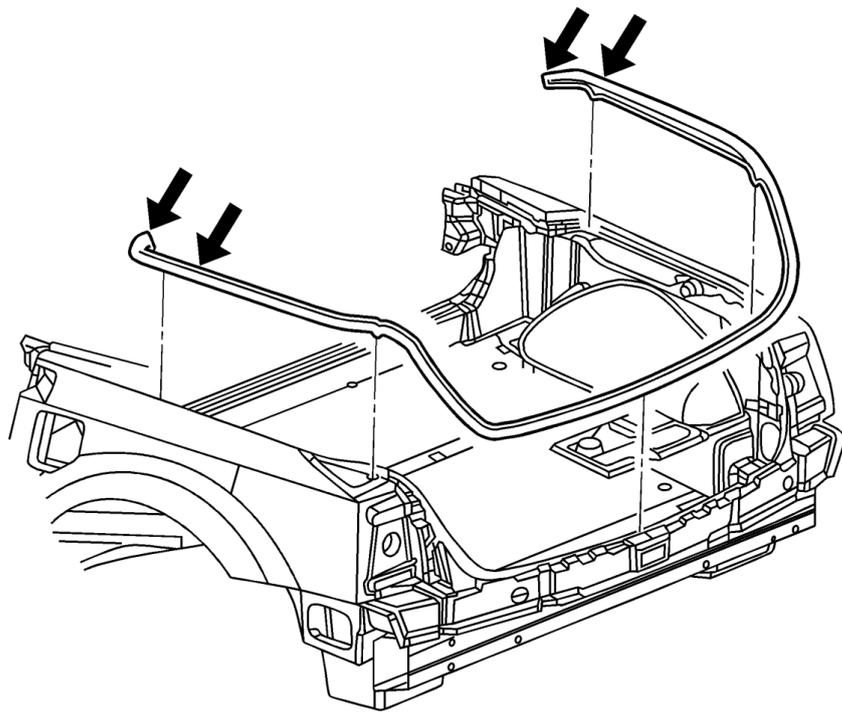
Water entry over the wheelhouse traced back to the joint between the rear compartment weatherstrip and quarter belt weatherstrip.

Separate the joints and lift each end 50-76 mm (2-3 in) enough to apply 3M™ Bedding and Glazing Compound, P/N 08509, inside the U-Channel of the weatherstrip. Refer to the illustration above. Apply enough compound so that it extends to both ends of the weatherstrip and will cause slight squeeze out when reinstalled. As you reinstall the weatherstrips, be sure the smaller weatherstrip is fully inserted into the opposite weatherstrip. Work the weatherstrips onto the flange and towards each other to ensure a tight joint when finished.
