# **2004 - 2009 Cadillac XLR: Service Bulletin: #07-08-57-003A: Waterleak in Trunk When Parked on Hill/Incline**

## **#07-08-57-003A: Waterleak in Trunk When Parked on Hill/Incline (Apply Adhesive Shim Stock) - (Oct 14, 2008)**

**Models:** 2004-2009 Cadillac  
XLR

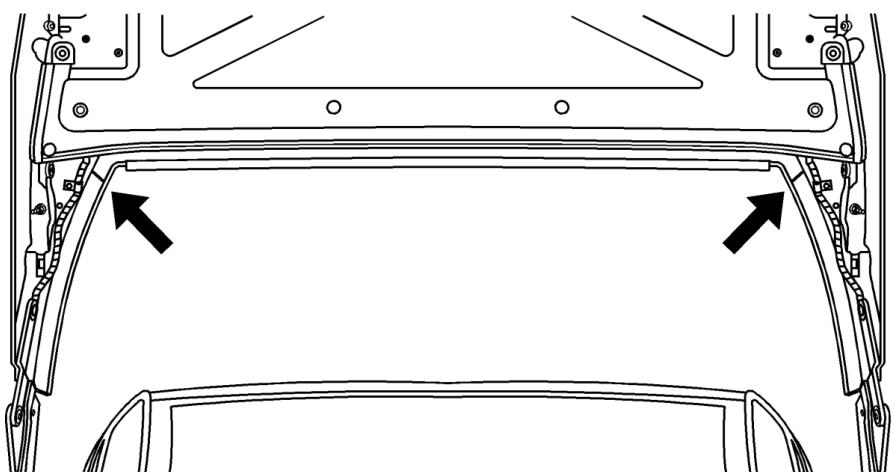
This condition may be caused by a dip in the two bond joints in the trunk inner panel.

1. Clean the shaded area shown in the first illustration above. Apply a small amount of weatherstrip adhesive to the center of the two bond joints. Refer to the second illustration above.
