2004 - 2009 Cadillac XLR: Service Bullletin: #07-08-57-003A: Waterleak in Trunk When Parked on Hill/Incline

#07-08-57-003A: Waterleak in Trunk When Parked on Hill/Incline (Apply Adhesive Shim Stock) - (Oct 14, 2008)

Models: 2004-2009 Cadillac

XLR

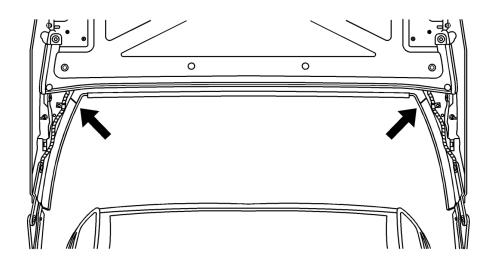
This condition may be caused by a dip in the two bond joints in the trunk inner panel.

1. Clean the shaded area shown in the first illustration above. Apply a small amount of weatherstrip adhesive to the center of the two bond joints. Refer to the second illustration above.
