2004 - 2009 Cadillac XLR: Service Bulletin: #PIC6378: Diagnosing Various Concerns On A Power Folding Top

#PIC6378: Diagnosing Various Concerns On A Power Folding Top - (Dec 17, 2019)

Subject: Diagnosing Various
Concerns On A Power
Folding Top

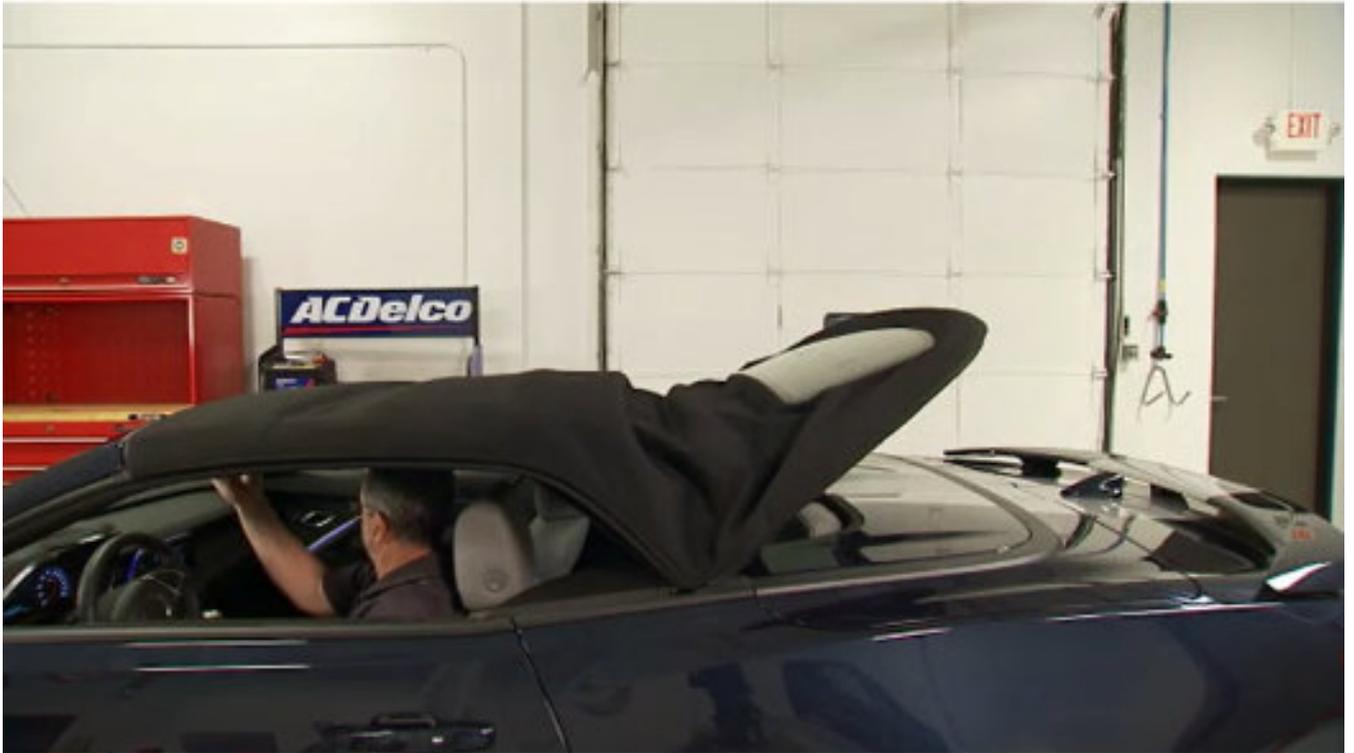
Example Case: Let's take a 2018 Chevrolet Camaro for instance, with a basic folding top concern. The customer states that the top will open fine, but it will not close all the way. A preliminary check will indicate that there is a "Top Not Secure" message in the DIC, but no DTCs are set. The tech is able to duplicate the concern each and every time. When closing, the top will lift up out of the stowage compartment, latch tightly to the windshield header, and the tension bow will lift up to a 45° angle. The Rear Stowage Compartment Lid will lower and lock into position, but the tension bow will not lower. It simply remains suspended in the air as seen in the photo below. The folding top pump quits working and the top stops moving at that point.

On a correctly working car, the stowage compartment lid must close completely before the tension bow is commanded down. Because the steps or phases must be completed in order, the technician must go to the point where the failure occurs, and then go back one step to look at the scan tool data.

Looking at the scan tool sensor data below, we can see that only one of the two Stowage Compartment Lid Closed Position Sensors read "On". Because the Folding Top Control Module will not command the tension bow to lower if both Stowage Compartment Lid Closed Position Sensors are not showing that they are closed, the module thinks that the stowage lid is still raised. As a matter of operation, it will not continue the top cycle. In this instance, the technician must further inspect the Right Folding Top Stowage Compartment Lid Closed Position Sensor to determine what the fault is.
