# 2004 - 2009 Cadillac XLR: Service Bulletin: #PIC6378: Diagnosing Various Concerns On A Power Folding Top

## #PIC6378: Diagnosing Various Concerns On A Power Folding Top - (Dec 17, 2019)

**Subject:** Diagnosing Various  
Concerns On A Power  
Folding Top

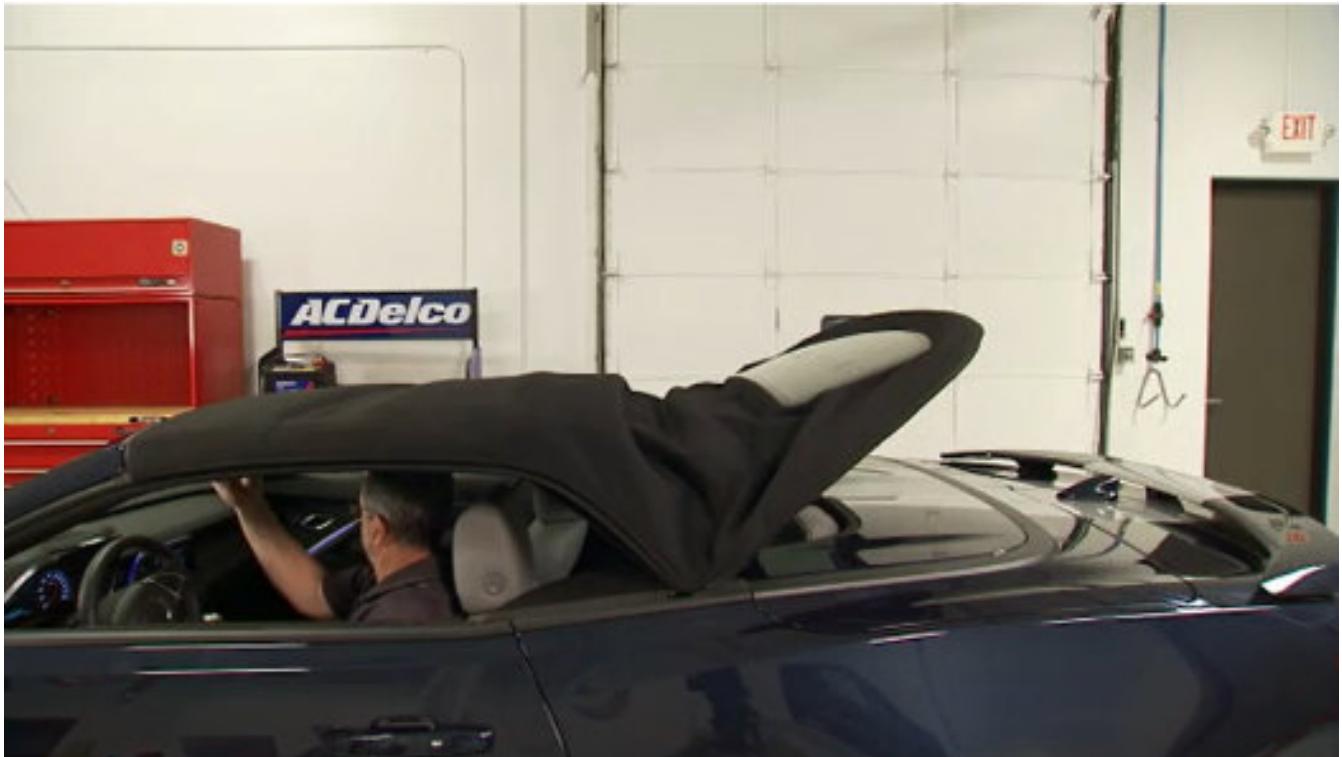
Example Case: Let's take a 2018 Chevrolet Camaro for instance, with a basic folding top concern. The customer states that the top will open fine, but it will not close all the way. A preliminary check will indicate that there is a "Top Not Secure" message in the DIC, but no DTCs are set. The tech is able to duplicate the concern each and every time. When closing, the top will lift up out of the stowage compartment, latch tightly to the windshield header, and the tension bow will lift up to a 45° angle. The Rear Stowage Compartment Lid will lower and lock into position, but the tension bow will not lower. It simply remains suspended in the air as seen in the photo below. The folding top pump quits working and the top stops moving at that point.

On a correctly working car, the stowage compartment lid must close completely before the tension bow is commanded down. Because the steps or phases must be completed in order, the technician must go to the point where the failure occurs, and then go back one step to look at the scan tool data.

Looking at the scan tool sensor data below, we can see that only one of the two Stowage Compartment Lid Closed Position Sensors read "On". Because the Folding Top Control Module will not command the tension bow to lower if both Stowage Compartment Lid Closed Position Sensors are not showing that they are closed, the module thinks that the stowage lid is still raised. As a matter of operation, it will not continue the top cycle. In this instance, the technician must further inspect the Right Folding Top Stowage Compartment Lid Closed Position Sensor to determine what the fault is.
