2004 - 2009 Cadillac XLR: Service Bulletin: #PIC6378: Diagnosing Various Concerns On A Power Folding Top

#PIC6378: Diagnosing Various Concerns On A Power Folding Top - (Dec 17, 2019)

Subject: Diagnosing Various Concerns
On A Power Folding Top

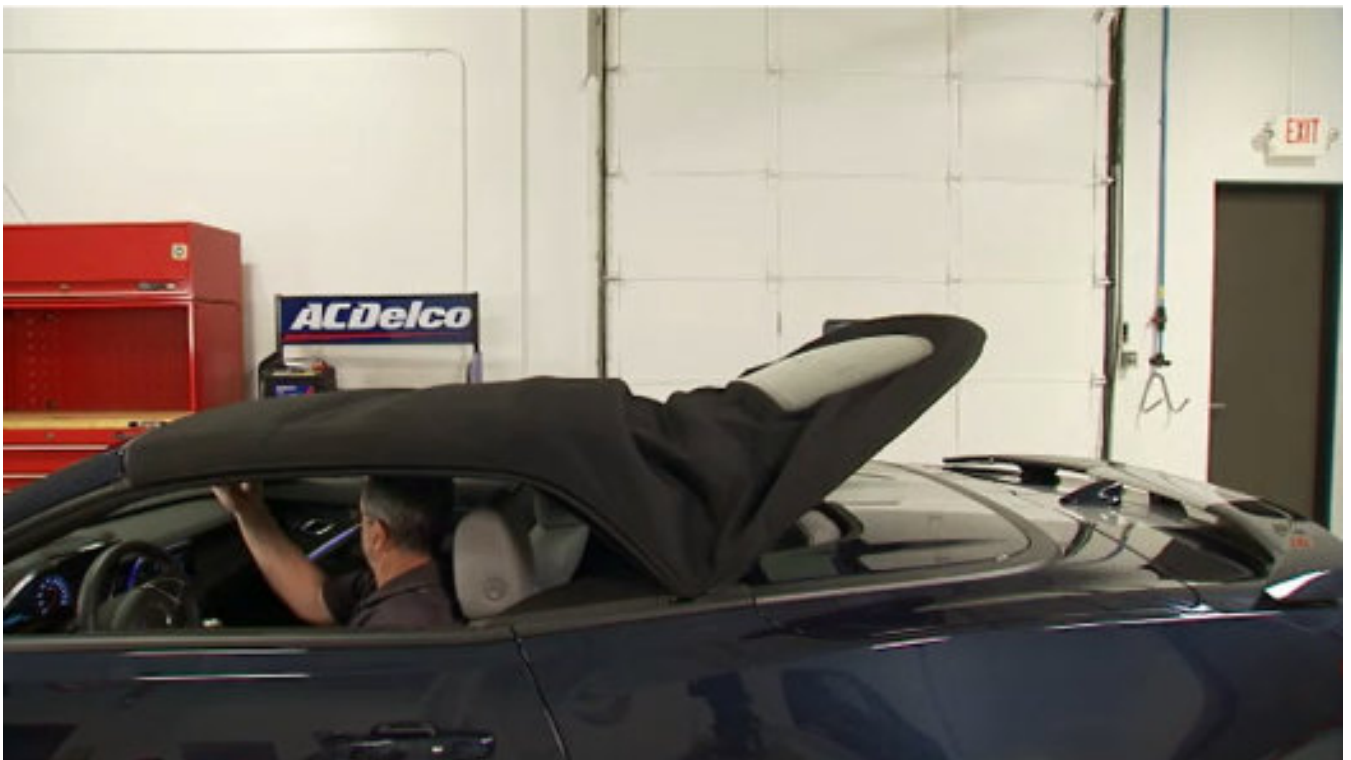
Camaro for instance, with a basic folding top concern. The customer states that the top will open fine, but it will not close all the way. A preliminary check will indicate that there is a "Top Not Secure" message in the DIC, but no DTCs are set. The tech is able to duplicate the concern each and every time. When closing, the top will lift up out of the stowage compartment, latch tightly to the windshield header, and the tension bow will lift up to a 45° angle. The Rear Stowage Compartment Lid will lower and lock into position, but the tension bow will not lower. It simply remains suspended in the air as seen in the photo below. The folding top pump quits working and the top stops moving at that point.

On a correctly working car, the stowage compartment lid must close completely before the tension bow is commanded down. Because the steps or phases must be completed in order, the technician must go to the point where the failure occurs, and then go back one step to look at the scan tool data.

Looking at the scan tool sensor data below, we can see that only one of the two Stowage Compartment Lid Closed Position Sensors read "On". Because the Folding Top Control Module will not command the tension bow to lower if both Stowage Compartment Lid Closed Position Sensors are not showing that they are closed, the module thinks that the stowage lid is still raised. As a matter of operation, it will not continue the top cycle. In this instance, the technician must further inspect the Right Folding Top Stowage Compartment Lid Closed Position Sensor to determine what the fault is.
