2009 Cadillac XLR: Service Bulletin: #PIC4930: Audible Click Noise When turning The Steering Wheel Left Or Right

Subject: Audible Click Noise
When Turning the
Steering Wheel Left or
Right

Models: 2009 Cadillac XLR
2009 Chevrolet Corvette

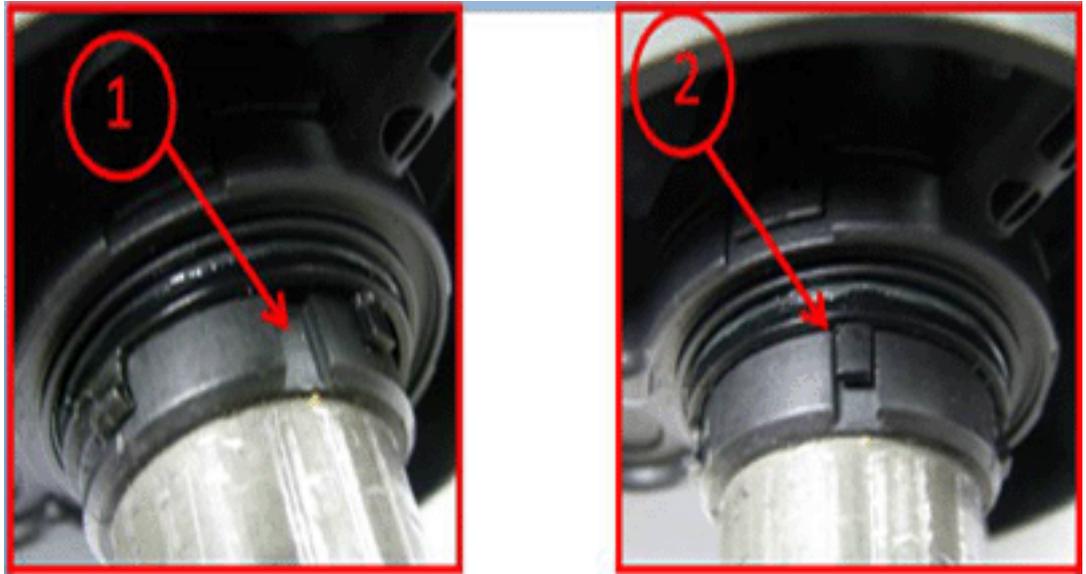
Some customers may comment of a click noise from the steering column when turning the steering wheel left or right. This will typically occur when the vehicle is not moving and the steering wheel is turned either left or right. This may be caused by the Steering Wheel Position Sensor (SWPS) not being installed correctly on the steering column.

2. Refer to the image above. Inspect the vehicle to be sure the Steering Wheel Position Sensor (SWPS) is installed correctly. In call out number 1 above, the SWPS is not installed correctly. Note: the SWPS has a tab that should rest in the opening as called out in number 2 above. In call out number 2 above, the SWPS is installed correctly. Note: The tab of the SWPS is secured in the opening. If the sensor is found to be installed incorrectly, remove or rotate the sensor so that it is installed correctly as shown in call out number 2 above.

1. Remove the close out panel just below the steering column.
