2009 Cadillac XLR: Service Bulletin: #PIC4930: Audible Click Noise When turning The Steering Wheel Left Or Right

Subject: Audible Click Noise

Models: 2009 Cadillac XLR

2009 Chevrolet Corvette

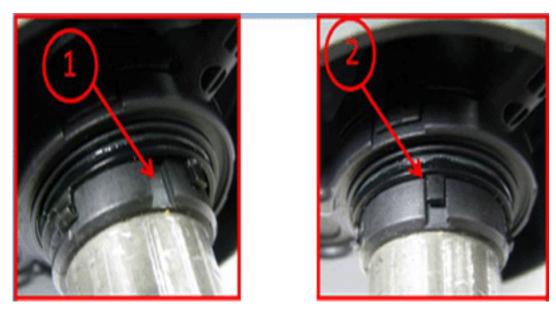
Some customers may comment of a click noise from the steering column when turning the steering wheel left or right. This will typically occur when the vehicle is not moving and the steering wheel is turned either left or right. This may be caused by the Steering Wheel Position Sensor (SWPS) not being installed correctly on the steering column.

2. Refer to the image above. Inspect the vehicle to be sure the Steering Wheel Position Sensor (SWPS) is installed correctly. In call out number 1 above, the SWPS is not installed correctly. Note: the SWPS has a tab that should rest in the opening as called out in number 2 above. In call out number 2 above, the SWPS is installed correctly. Note: The tab of the SWPS is secured in the opening. If the sensor is found to be installed incorrectly, remove or rotate the sensor so that it is installed correctly as shown in call out number 2 above.

1. Remove the close out panel just below the steering column.
