2009 Cadillac XLR: Service Bulletin: #PIC4930: Audible Click Noise When turning The Steering Wheel Left Or Right

Subject: Audible Click Noise When
Turning the Steering Wheel Left
or Right

Models: 2009 Cadillac XLR
2009 Chevrolet Corvette

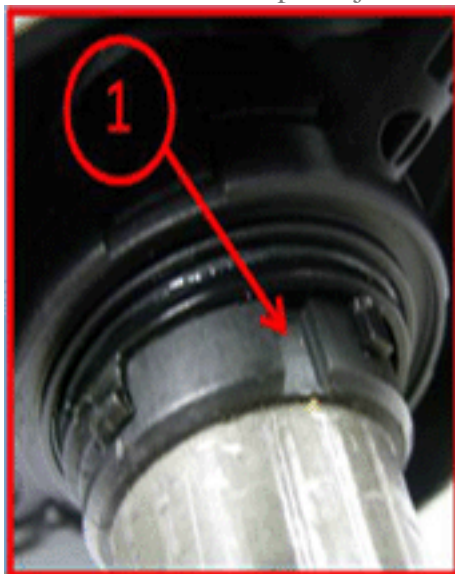
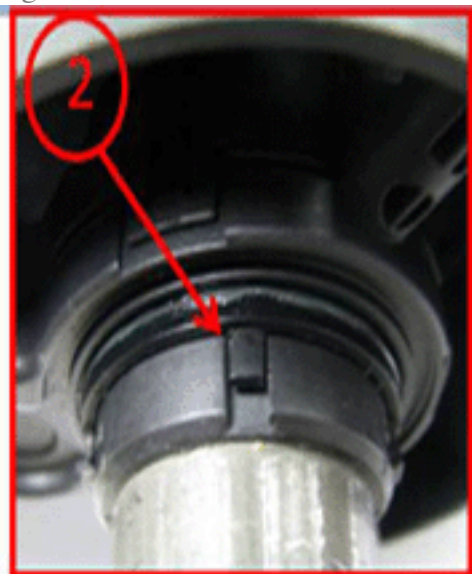
Some customers may comment of a click noise from the steering column when turning the steering wheel left or right. This will typically occur when the vehicle is not moving and the steering wheel is turned either left or right. This may be caused by the Steering Wheel Position Sensor (SWPS) not being installed correctly on the steering column.

2. Refer to the image above. Inspect the vehicle to be sure the Steering Wheel Position Sensor (SWPS) is installed correctly. In call out number 1 above, the SWPS is not installed correctly. Note: the SWPS has a tab that should rest in the opening as called out in number 2 above. In call out number 2 above, the SWPS is installed correctly. Note: The tab of the SWPS is secured in the opening. If the sensor is found to be installed incorrectly, remove or rotate the sensor so that it is installed correctly as shown in call out number 2 above.

1. Remove the close out panel just below the steering column.
