2006 - 2009 Cadillac XLR: Service Bulletin: #PI0299: Harsh Shifts After Replacement of 1-2-3-4 / 3-5-R Clutch Housing

#PI0299: Harsh Shifts After Replacement of 1-2-3-4 / 3-5-R Clutch Housing - (Nov 16, 2010)

Models: 2006 - 2009 Cadillac XLR
2006-2011 Cadillac STS
2007-2011 Cadillac Escalade
Models
2008-2011 Cadillac CTS
2006-2011 Chevrolet Corvette
2007-2011 Chevrolet Silverado
2008-2011 Chevrolet Suburban
2009-2011 Chevrolet Avalanche, Tahoe
2010-2011 Chevrolet Camaro, Express
2007-2011 GMC Sierra, Yukon Denali, Yukon Denali XL
2008-2011 GMC Yukon XL
2009-2011 GMC Yukon
2010-2011 GMC Savana
2008-2009 HUMMER H2
2008-2009 Pontiac G8
Equipped with 6L45, 6L50, 6L80 or 6L90 Automatic Transmission (RPOs MYA, MYB, MYC, MYD)

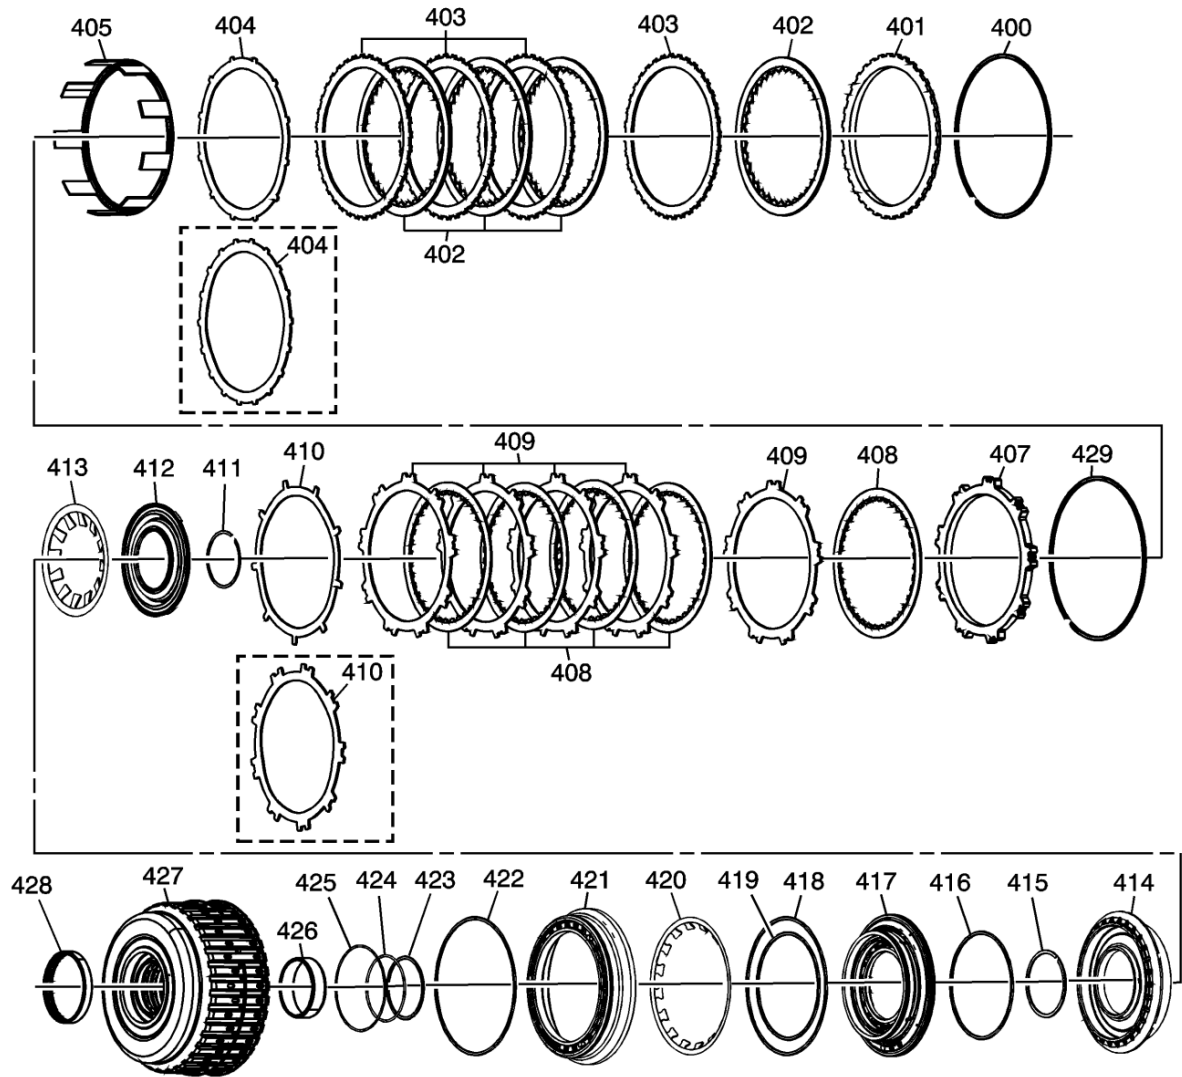
Some customers may comment on harsh shifts after replacement of the 1-2-3-4 / 3-5-R clutch housing (427).

This condition may be caused if the 1-2-3-4 / 3-5-R bearing (428) is not installed into the housing (427). The 1-2-3-4 / 3-5-R clutch housing is currently serviced through parts without this bearing installed and failure to order and install this bearing may result in harsh shifts. Plans are being implemented to service this housing as a kit that will include the bearing.

Note: The parts catalog calls out to order the bearing when the housing is also replaced.
