2006 - 2009 Cadillac XLR: Service Bulletin: #PI0299: Harsh Shifts After Replacement of 1-2-3-4 / 3-5-R Clutch Housing

#PI0299: Harsh Shifts After Replacement of 1-2-3-4 / 3-5-R Clutch Housing - (Nov 16, 2010)

Models: 2006 - 2009 Cadillac
XLR
2006-2011 Cadillac STS
2007-2011 Cadillac
Escalade Models
2008-2011 Cadillac CTS
2006-2011 Chevrolet
Corvette
2007-2011 Chevrolet
Silverado
2008-2011 Chevrolet
Suburban
2009-2011 Chevrolet
Avalanche, Tahoe
2010-2011 Chevrolet
Camaro, Express
2007-2011 GMC Sierra,
Yukon Denali, Yukon
Denali XL
2008-2011 GMC Yukon
XL
2009-2011 GMC Yukon

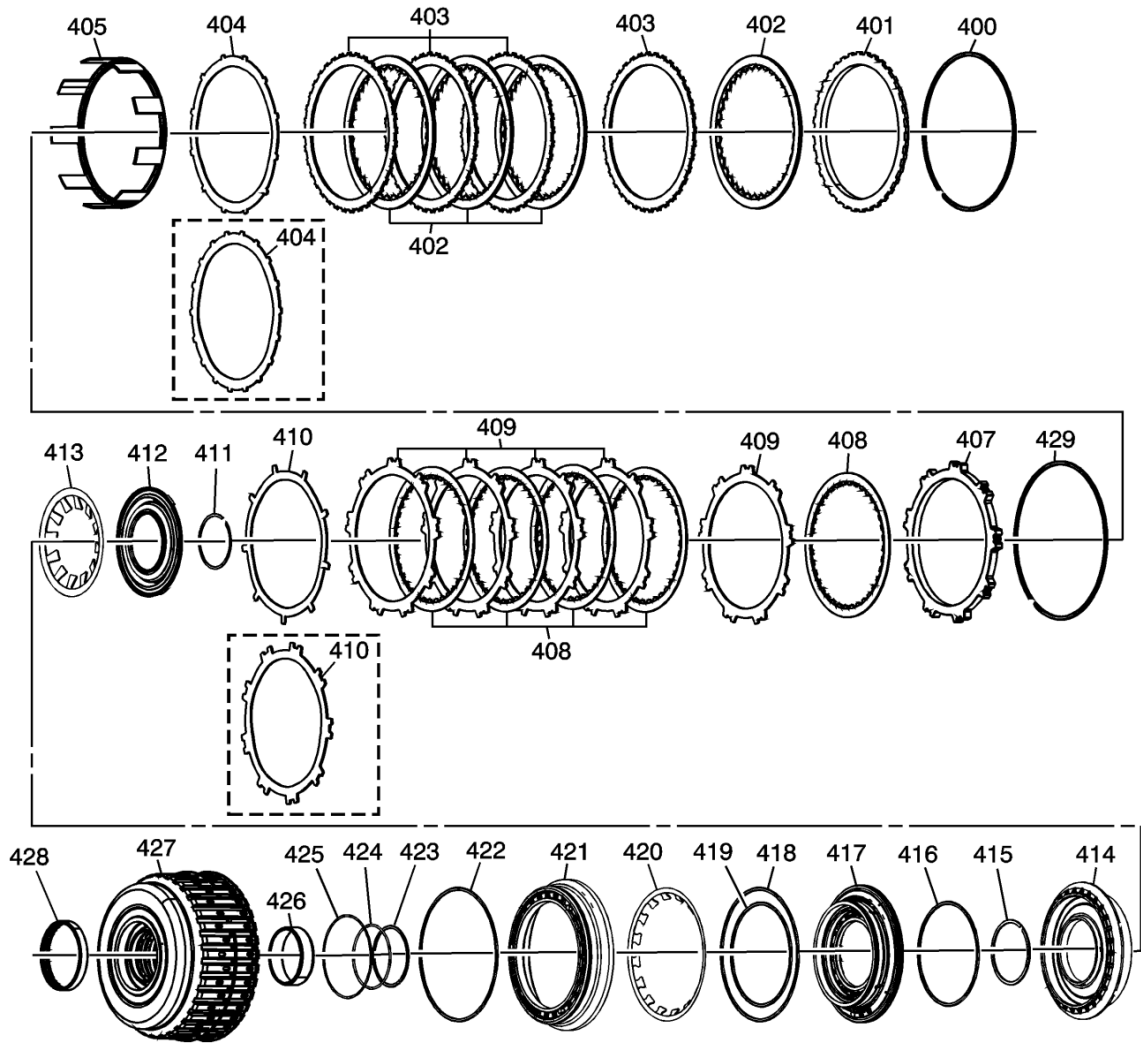
Some customers may comment on harsh shifts after replacement of the 1-2-3-4 / 3-5-R clutch housing (427).

This condition may be caused if the 1-2-3-4 / 3-5-R bearing (428) is not installed into the housing (427). The 1-2-3-4 / 3-5-R clutch housing is currently serviced through parts without this bearing installed and failure to order and install this bearing may result in harsh shifts. Plans are being implemented to service this housing as a kit that will include the bearing.

Note: The parts catalog calls out to order the bearing when the housing is also replaced.
