# **2006 - 2009 Cadillac XLR: Service Bulletin: #PI0299: Harsh Shifts After Replacement of 1-2-3-4 / 3-5-R Clutch Housing**

## **#PI0299: Harsh Shifts After Replacement of 1-2-3-4 / 3-5-R Clutch Housing - (Nov 16, 2010)**

**Subject:** Harsh Shifts After  
Replacement of 1-2-3-4 /  
3-5-R Clutch Housing

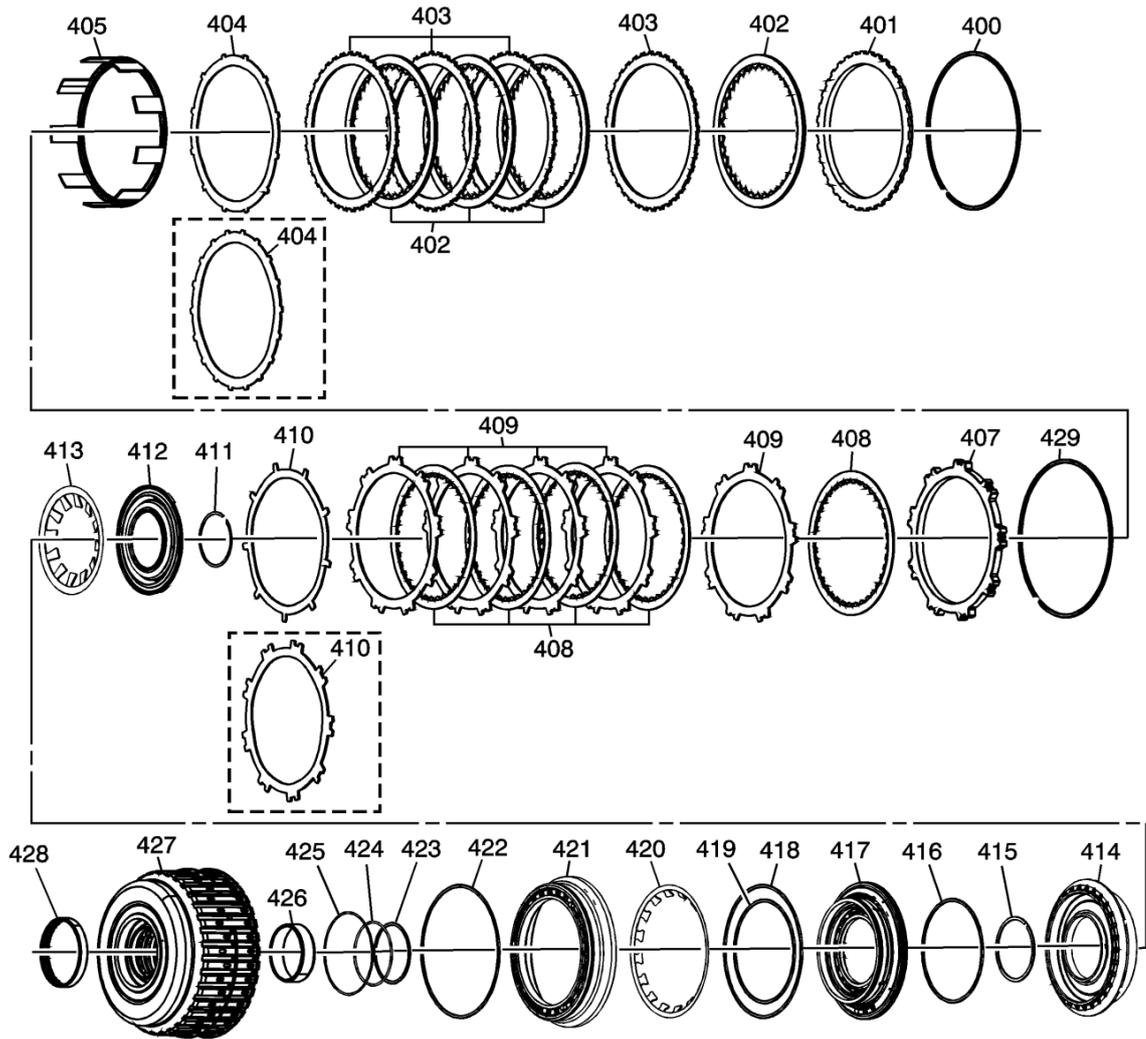
Some customers may comment on harsh shifts after replacement of the 1-2-3-4 / 3-5-R clutch housing (427).

This condition may be caused if the 1-2-3-4 / 3-5-R bearing (428) is not installed into the housing (427). The 1-2-3-4 / 3-5-R clutch housing is currently serviced through parts without this bearing installed and failure to order and install this bearing may result in harsh shifts. Plans are being implemented to service this housing as a kit that will include the bearing.

**Note:** The parts catalog calls out to order the bearing when the housing is also replaced.
