# 2006 - 2009 Cadillac XLR-V: Service Bulletin: #PIP4493: SES Light due to DTCs P0171 and/or P0174 - Inspect Air Cleaner Outlet Duct and Supercharger Inlet Duct Clamps

## #PIP4493: SES Light due to DTCs P0171 and/or P0174 - Inspect Air Cleaner Outlet Duct and Supercharger Inlet Duct Clamps - (Oct 3, 2008)

**Subject:** SES Light due to DTCs P0171 and/or P0174 - Inspect Air Cleaner Outlet Duct and Supercharger Inlet Duct Clamps

**Models:** 2006 - 2009 Cadillac STS-V, XLR-V  
with 4.4L Supercharged V8 Engine (RPO LC3)

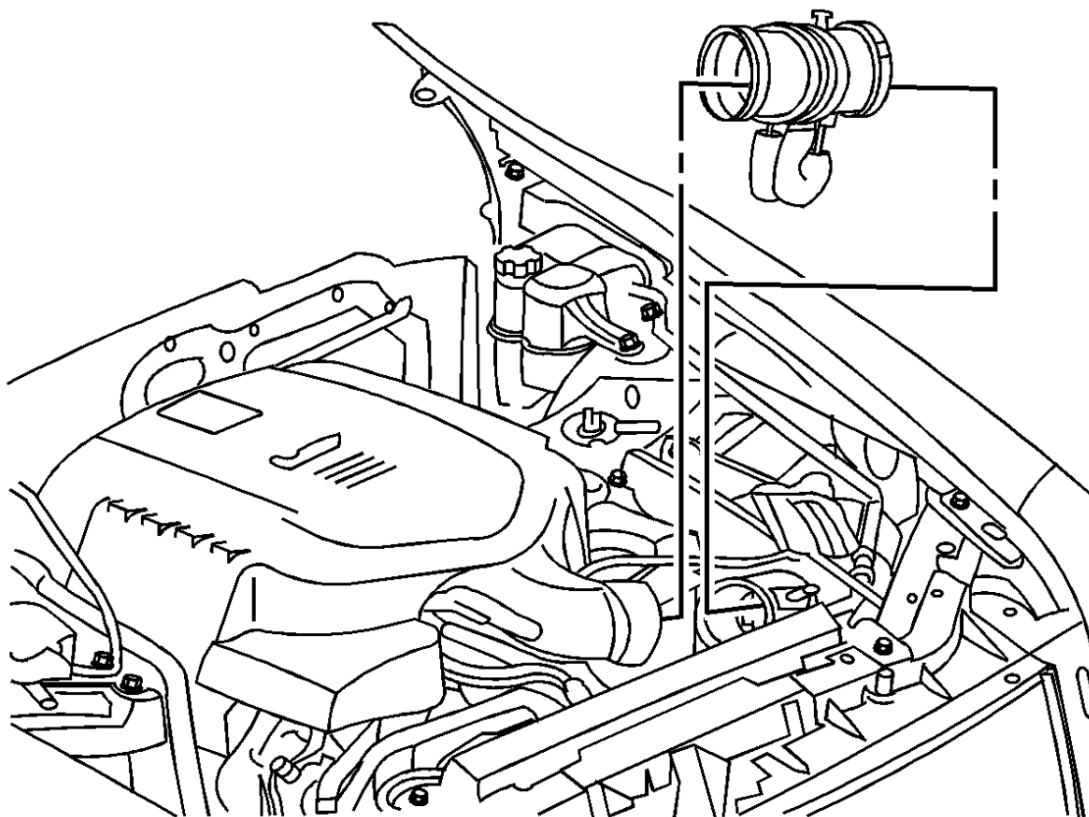
For STS-V:

A SES light may be experienced as a result of DTCs P0171 and/or P0174 stored. This may be the result of unmetered air entering the engine through the air cleaner outlet duct or supercharger inlet duct connections due to a mis-assembled connection or loose clamps.

- 1) Tighten the air cleaner outlet duct clamps to 3 NM (27 lb-in).
