2004 - 2009 Cadillac XLR Service Bulletin: #PIC5000: Quarter Glass Lands On Top Of Quarter Belt Seal

#PIC5000: Quarter Glass Lands On Top Of Quarter Belt Seal - (Oct 13, 2008)

Models: 2004 - 2009 Cadillac
XLR model vehicles.

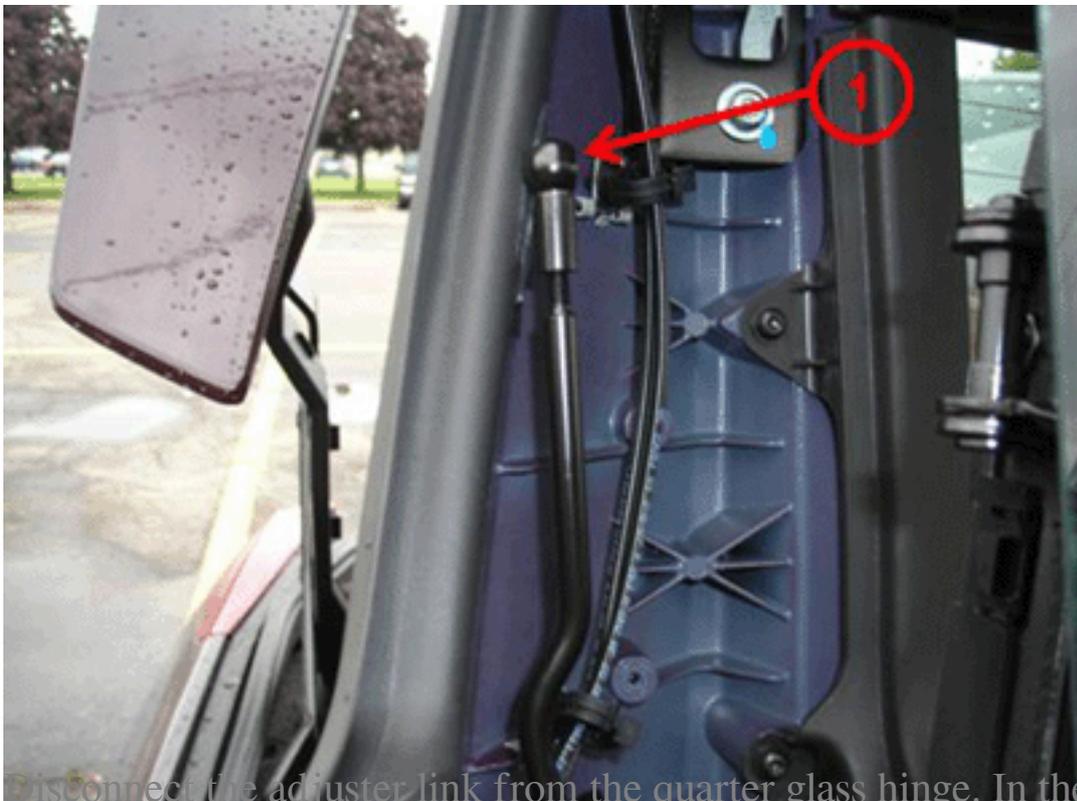
Disconnect the adjuster link from the quarter glass hinge. In the illustration above, call out 1, shows the position when it is NOT bent.
