2004 - 2009 Cadillac XLR Service Bulletin: #PIC5000: Quarter Glass Lands On Top Of Quarter Belt Seal

#PIC5000: Quarter Glass Lands On Top Of Quarter Belt Seal - (Oct 13, 2008)

Models: 2004 - 2009 Cadillac XLR
model vehicles.

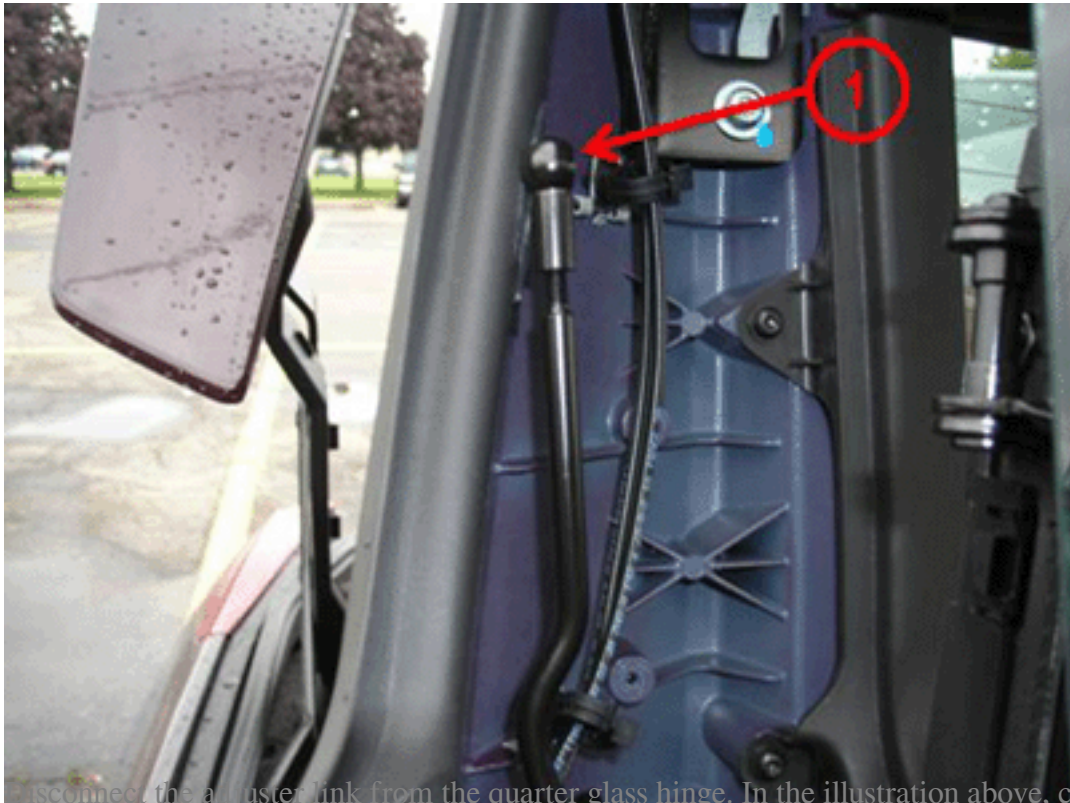
Disconnect the adjuster link from the quarter glass hinge. In the illustration above, call out 1, shows the position when it is NOT bent.

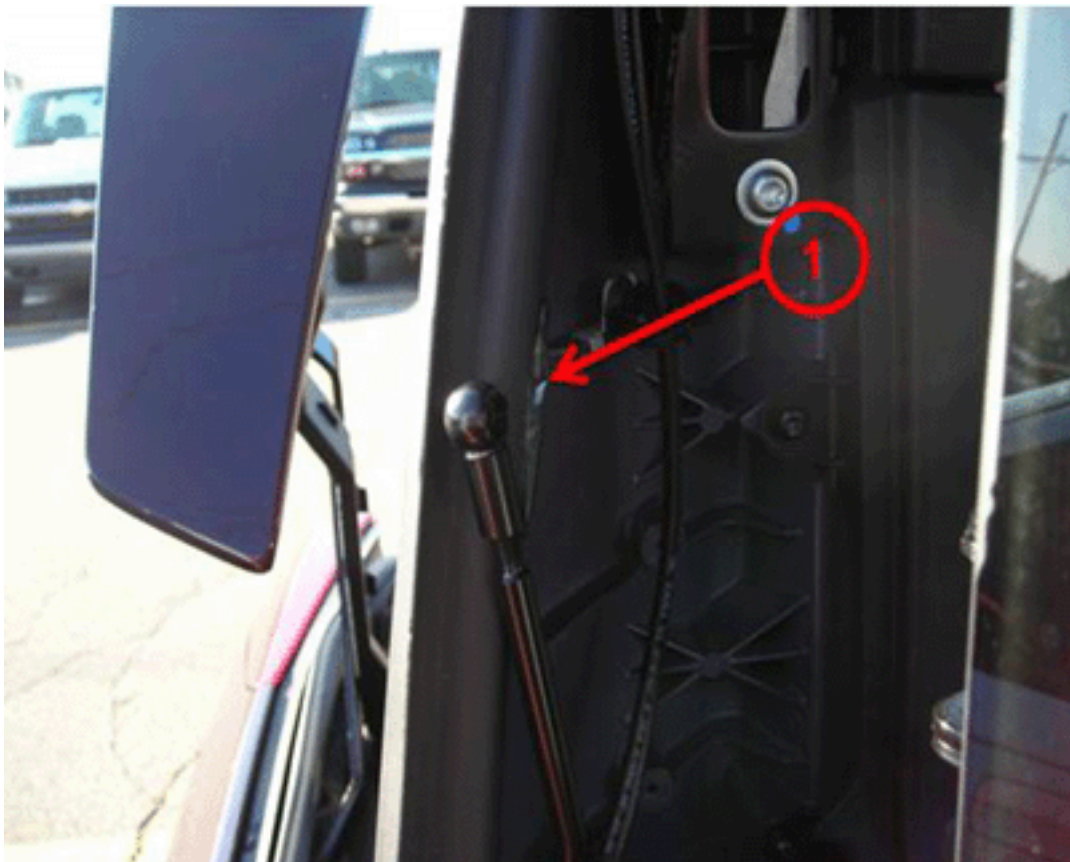
When the adjuster link from the quarter glass hinge is bent, it is outboard. Refer to call out 1 in the illustration above. Bend the link back inboard until it will just touch the inside surface of the

weatherstrip. When in the right position it could be forced passed the weather strip with minimal effort.

- If you have attempted to adjust the quarter glass using the adjuster, put it back to the original position.
- With the weather strip installed in the retainer cycle the roof down to ensure that the quarter glass is landing in the channel of the weather strip.
- It should contact at the rear inboard lip of the quarter belt seal first. Watch the opposite side for a reference.
- If not quite right you can slightly bend the adjuster rod again to correct.
- Once the quarter glass is landing properly apply adhesive to the to the quarter belt seal per
