# 2004 - 2009 Cadillac XLR Service Bulletin: #PIC5000: Quarter Glass Lands On Top Of Quarter Belt Seal

## #PIC5000: Quarter Glass Lands On Top Of Quarter Belt Seal - (Oct 13, 2008)

**Subject:** Quarter Glass Lands On  
Top Of Quarter Belt  
Seal

**Models:** 2004 - 2009 Cadillac  
XLR model vehicles.

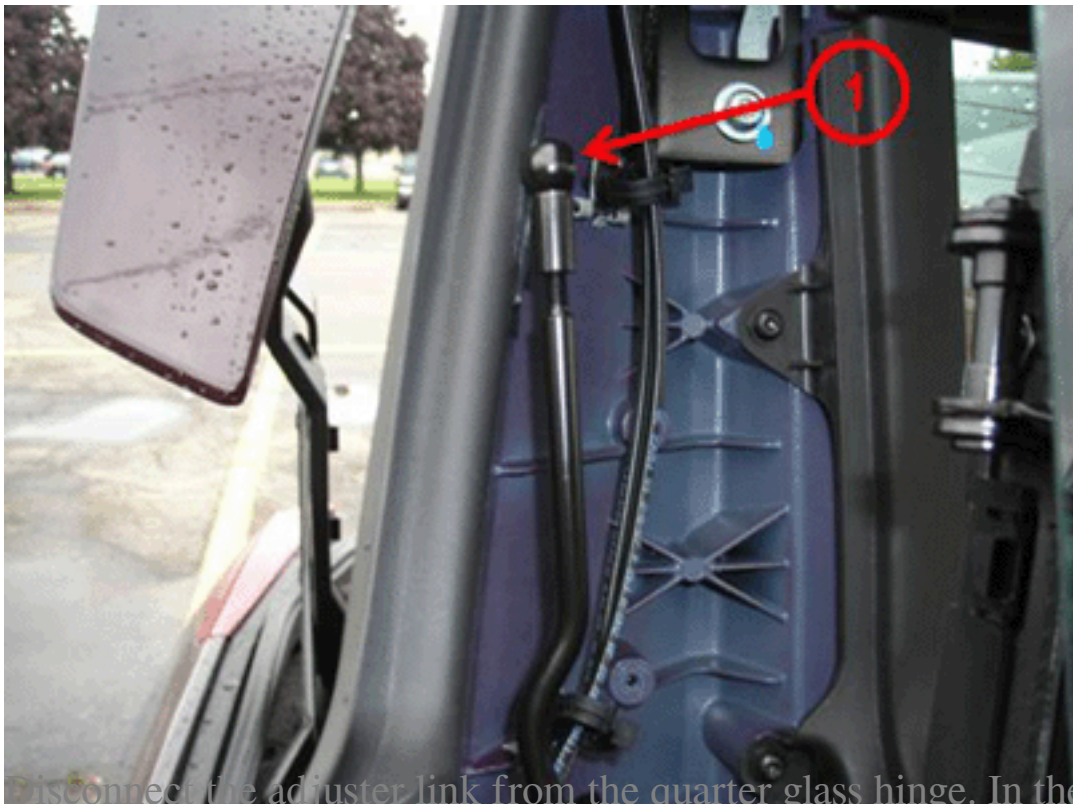
Disconnect the adjuster link from the quarter glass hinge. In the illustration above, call out 1, shows the position when it is NOT bent.
