2004 - 2009 Cadillac XLR Service Bulletin: #PIC5000: Quarter Glass Lands On Top Of Quarter Belt Seal

#PIC5000: Quarter Glass Lands On Top Of Quarter Belt Seal - (Oct 13, 2008)

Models: 2004 - 2009 Cadillac
XLR model vehicles.

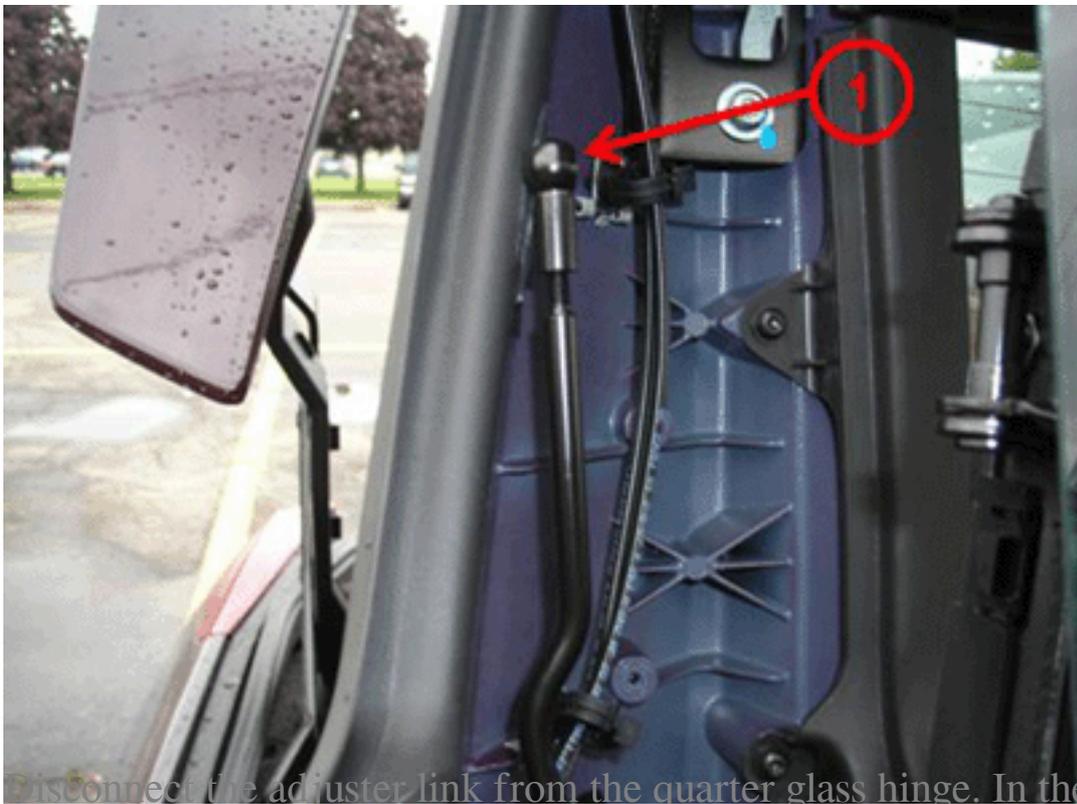
Some customers may comment that the quarter glass lands on top of the quarter belt seal when closing the retractable roof. The cause of the issue is typically that the quarter glass (QG) has pulled the quarter belt seal (QBS) out of the retainer during the previous cycle. It then lands on the seal when closing the roof which bends the quarter glass adjuster link. If bent far enough, it can cause the quarter glass to be outboard enough that the door glass will come up on the inside of the quarter glass and prevent the door from opening when the door glass is up. When the QG lands on top of the QBS it bends the QG adjuster link outboard. The following procedure shows how to correct the bent link and retain the QBS so the condition will not reoccur.

Disconnect the adjuster link from the quarter glass hinge. In the illustration above, call out 1, shows the position when it is NOT bent.

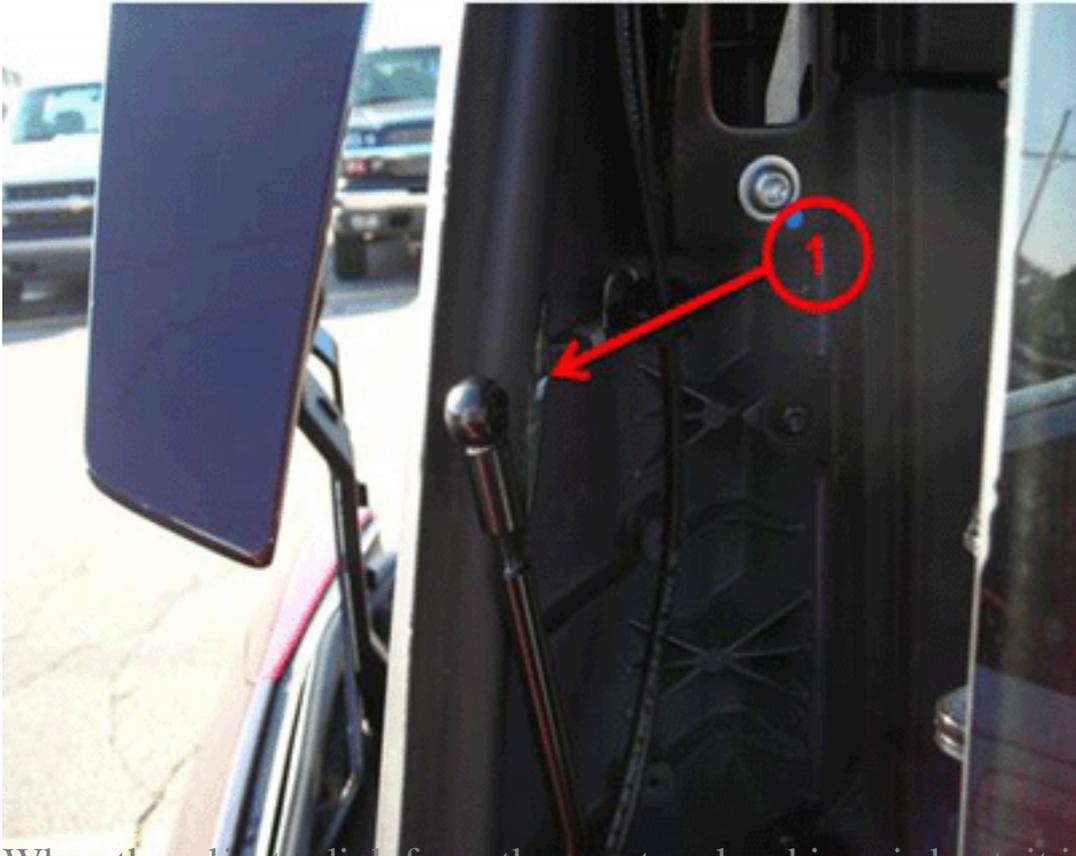
When the adjuster link from the quarter glass hinge is bent, it is outboard. Refer to call out 1 in the illustration above. Bend the link back inboard until it will just touch the inside surface of the weatherstrip. When in the right position it could be forced passed the weather strip with minimal effort.

- If you have attempted to adjust the quarter glass using the adjuster, put it back to the original position.
- With the weather strip installed in the retainer cycle the roof down to ensure that the quarter glass is landing in the channel of the weather strip.
- It should contact at the rear inboard lip of the quarter belt seal first. Watch the opposite side for a reference.
- If not quite right you can slightly bend the adjuster rod again to correct.
- Once the quarter glass is landing properly apply adhesive to the to the quarter belt seal per the next step. Perform this on both sides of the vehicle.
