# **2004 - 2009 Cadillac XLR Service Bulletin: #PIC5000: Quarter Glass Lands On Top Of Quarter Belt Seal**

## **#PIC5000: Quarter Glass Lands On Top Of Quarter Belt Seal - (Oct 13, 2008)**

**Subject:** Quarter Glass Lands On  
Top Of Quarter Belt  
Seal

**Models:** 2004 - 2009 Cadillac  
XLR model vehicles.

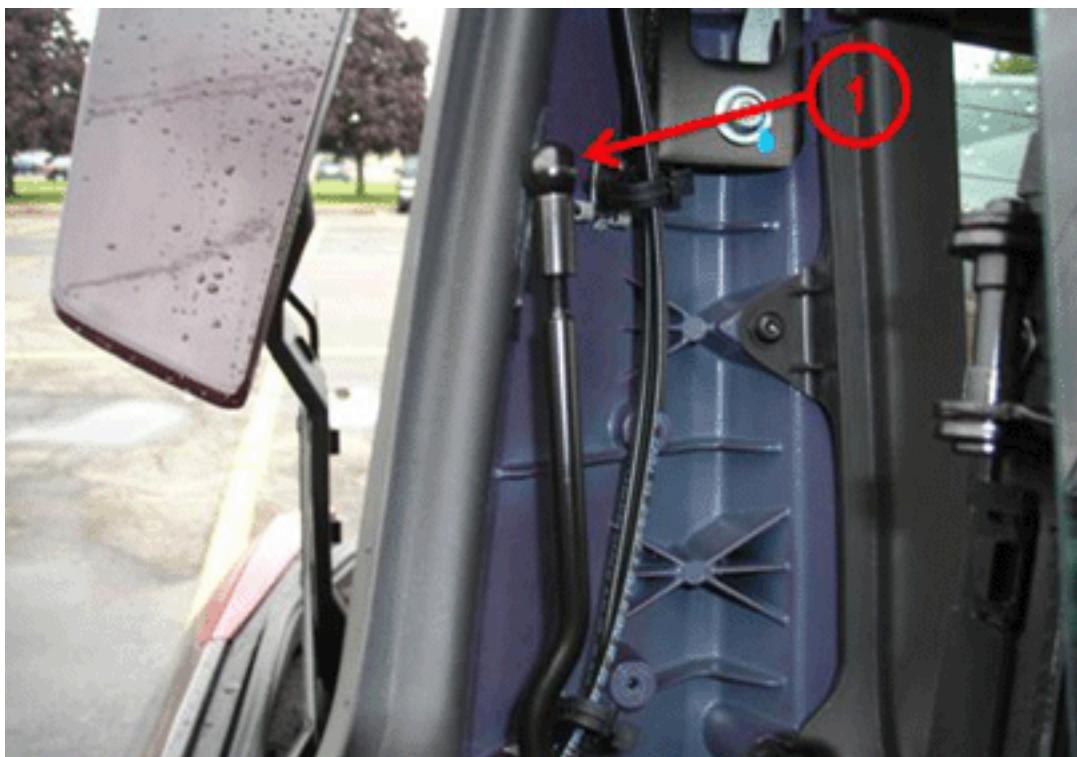
Disconnect the adjuster link from the quarter glass hinge. In the illustration above, call out 1, shows the position when it is NOT bent.
