2006 - 2009 Cadillac XLR XLR-V: Service Bulletin: Slips in Reverse or Third, Delayed Reverse or Drive Engagement

#09-07-30-004J: Slips in Reverse or Third, Delayed Reverse or Drive Engagement, DTC P0776, P2715, P2723, Harsh 2-3 Shifts (Inspect 1-2-3-4 / 3-5-R Housing and Pump Seal Rings) - (Feb 25, 2014)

Models: 2006 - 2009 Cadillac STS-V, XLR, XLR-V
2007 - 2008 Cadillac Escalade, Escalade ESV, Escalade EXT
2006 - 2009 Chevrolet Corvette
2007 - 2008 Chevrolet Silverado
2008 Chevrolet Suburban
2007 - 2008 GMC Sierra, Sierra Denali, Yukon Denali, Yukon XL Denali
2008 GMC Yukon XL
2008 - 2009 HUMMER H2
2008 - 2009 Pontiac G8
Equipped with 6L80 or 6L90 Automatic Transmission (RPOs MYC, MYD)

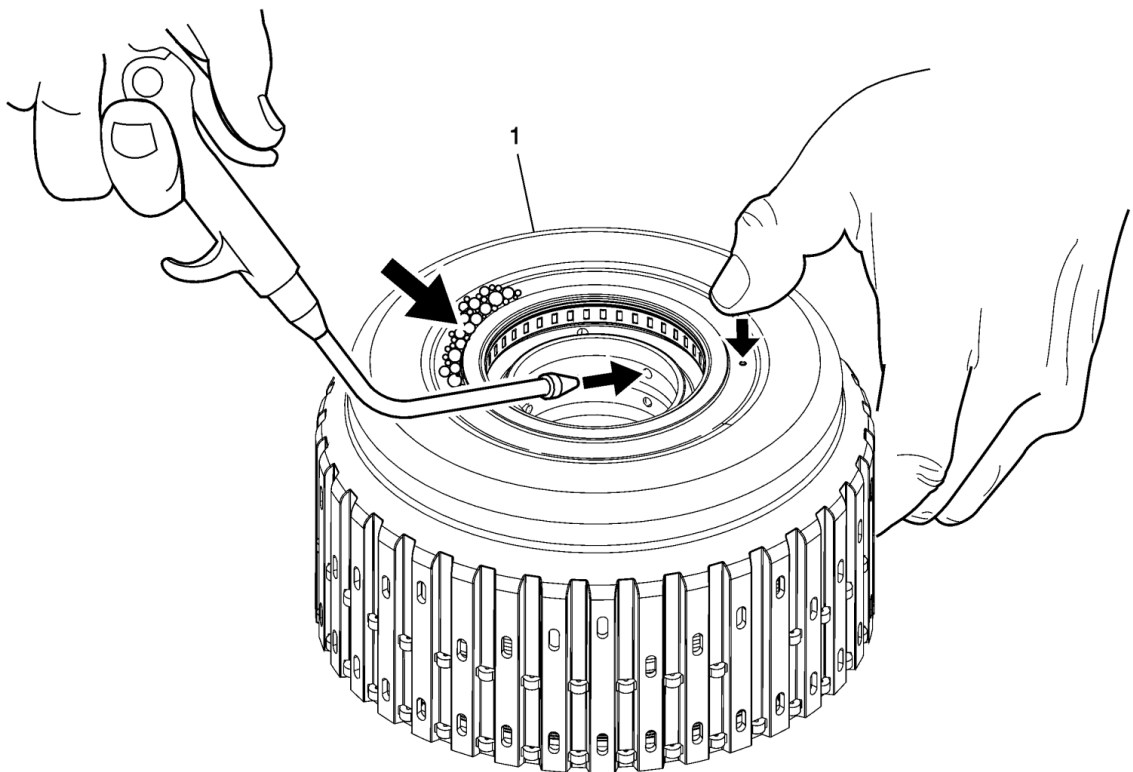
Housing Assembled

This condition may be caused by a cracked 1-2-3-4 / 3-5-R clutch housing.

Inspect the 1-2-3-4 / 3-5-R clutch housing for a possible cracked weld. The housing can be inspected either assembled or disassembled.

Important: If a cracked housing is identified, it must be replaced. Complete, assembled 1-2-3-4 / 3-5-R clutch housings are now available for most applications. These clutch housings come complete with all pistons, seals, clutches, bearing and internal parts. No assembly of the clutch housing is required before it is installed. For applications without a complete, assembled 1-2-3-4 / 3-5-R clutch housing, individual parts must be ordered and the housing assembled in the

1. Apply soap compound to the weld area of the housing.
2. Hold your thumb over the air bleed passage.
3. For a fully assembled 1-2-3-4 and 3-5 reverse clutch housing, spray compressed air into the 3-5R clutch feed hole and inspect the weld area for bubbles.
4. If bubbles are detected, a new housing is required.

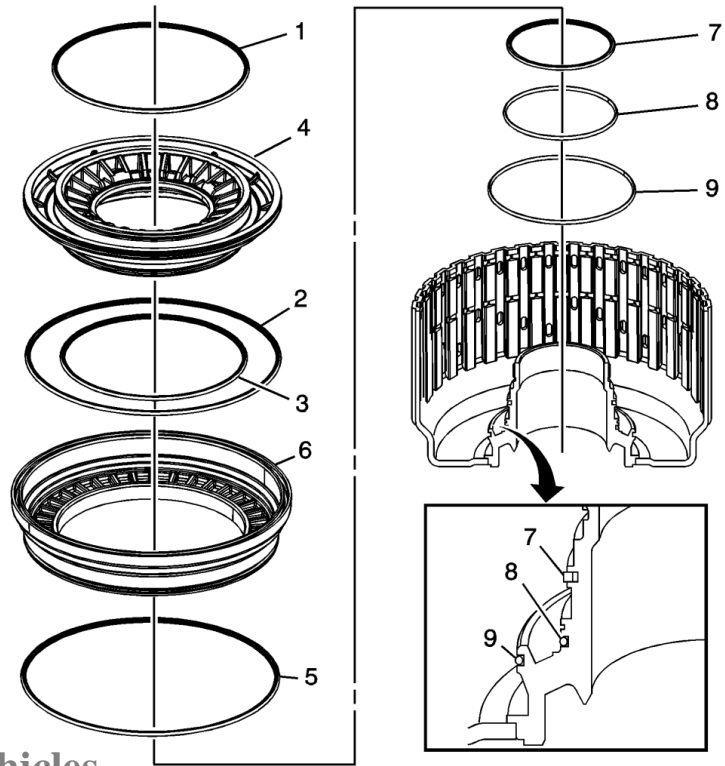
Important: When installing a new 1-2-3-4 / 3-5-R housing into a 2007 or older 6L80, be sure to install all three (3) inner seals (7, 8, 9 in illustration below). Failure to install these seals can result in no reverse, no forward or distressed clutches.

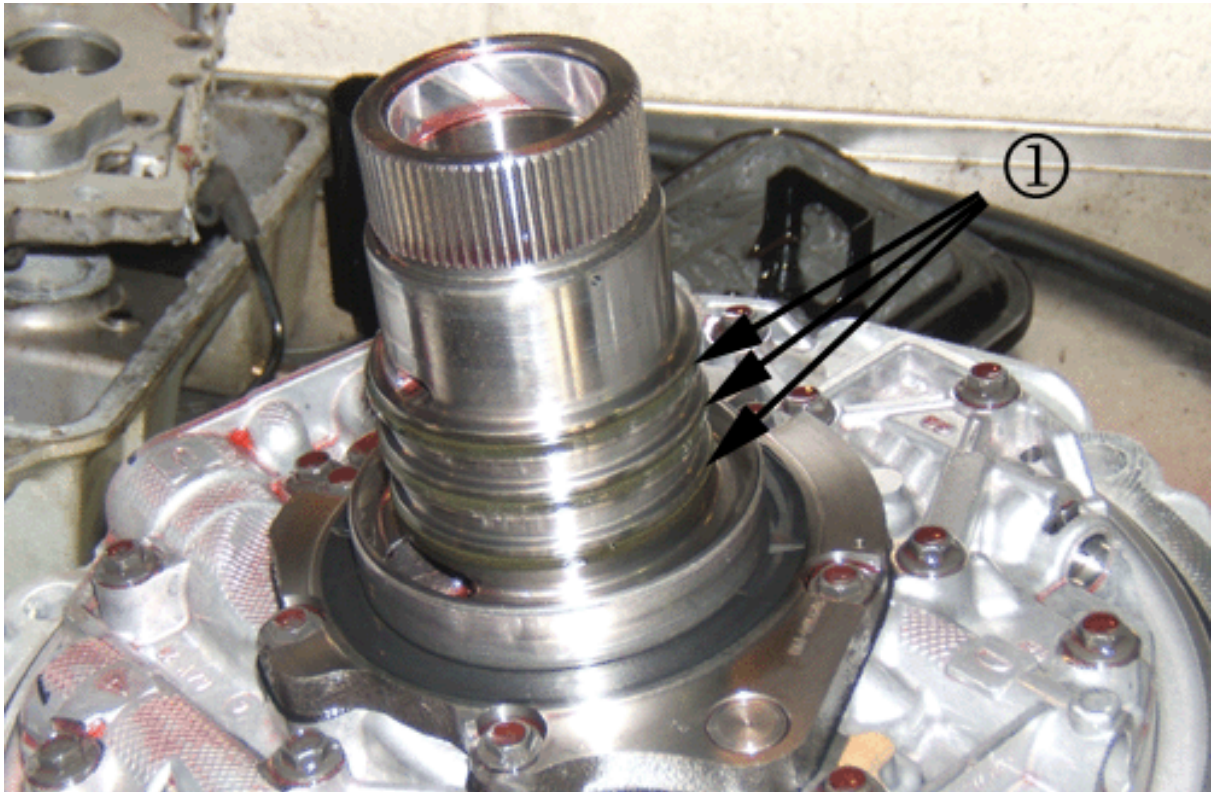
A harsh 2-3 shift condition may be caused by leaking 1-2-3-4 and 3-5-R clutch fluid seal rings (1) on the transmission fluid pump cover assembly.

Inspect the fluid seal rings. Transmissions in 2006, 2007, 2008 and early build 2009 models used a 1- piece design seal ring in production. Starting December 2008, a 2-piece seal ring design was implemented. The 1-piece seal ring design may cause a harsh 2-3 shift due to leakage. This is typically a low mileage issue. If the seal rings are a 1-piece design they should be replaced with new 1-piece design seal rings. It is not necessary to replace the pump cover.

Notice: The clutch fluid seal rings must be installed in a specific way. Failure to install new clutch fluid seal rings in the proper orientation may cause a repeat harsh 2-3 shift. Refer to 1-2-3-4 and 3-5 Reverse Clutch Fluid Seal Ring Installation (6L80/90) in SI for correct installation.

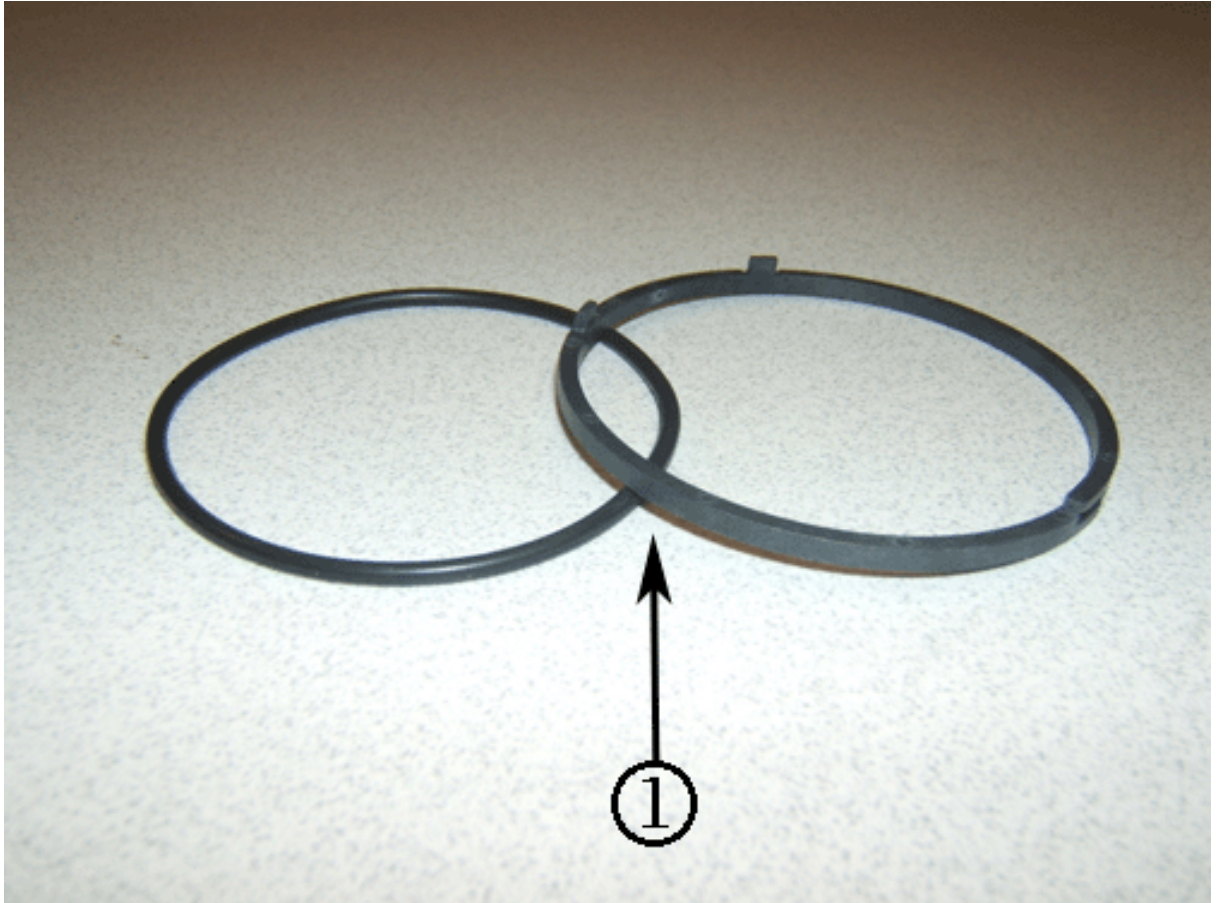
If the seals are the 2-piece design shown below, they do not need to be replaced unless they are worn or damaged.

ring design pump cover. The 2-piece seal ring design pump cover can be identified by the notch in the seal ring grooves that accepts the tab on the 2-piece design seal rings.

Important: Do not install 1-piece design seal rings on a 2-piece seal
