2006 - 2009 Cadillac XLR XLR-V: Service Bulletin: Slips in Reverse or Third, Delayed Reverse or Drive Engagement

#09-07-30-004J: Slips in Reverse or Third, Delayed Reverse or Drive Engagement, DTC P0776, P2715, P2723, Harsh 2-3 Shifts (Inspect 1-2-3-4 / 3-5-R Housing and Pump Seal Rings) - (Feb 25, 2014)

Models: 2006 - 2009 Cadillac STS-V, XLR, XLR-V
2007 - 2008 Cadillac Escalade, Escalade ESV, Escalade EXT
2006 - 2009 Chevrolet Corvette
2007 - 2008 Chevrolet Silverado
2008 Chevrolet Suburban
2007 - 2008 GMC Sierra, Sierra Denali, Yukon Denali, Yukon XL Denali
2008 GMC Yukon XL
2008 - 2009 HUMMER H2
2008 - 2009 Pontiac G8
Equipped with 6L80 or 6L90 Automatic Transmission (RPOs MYC, MYD)

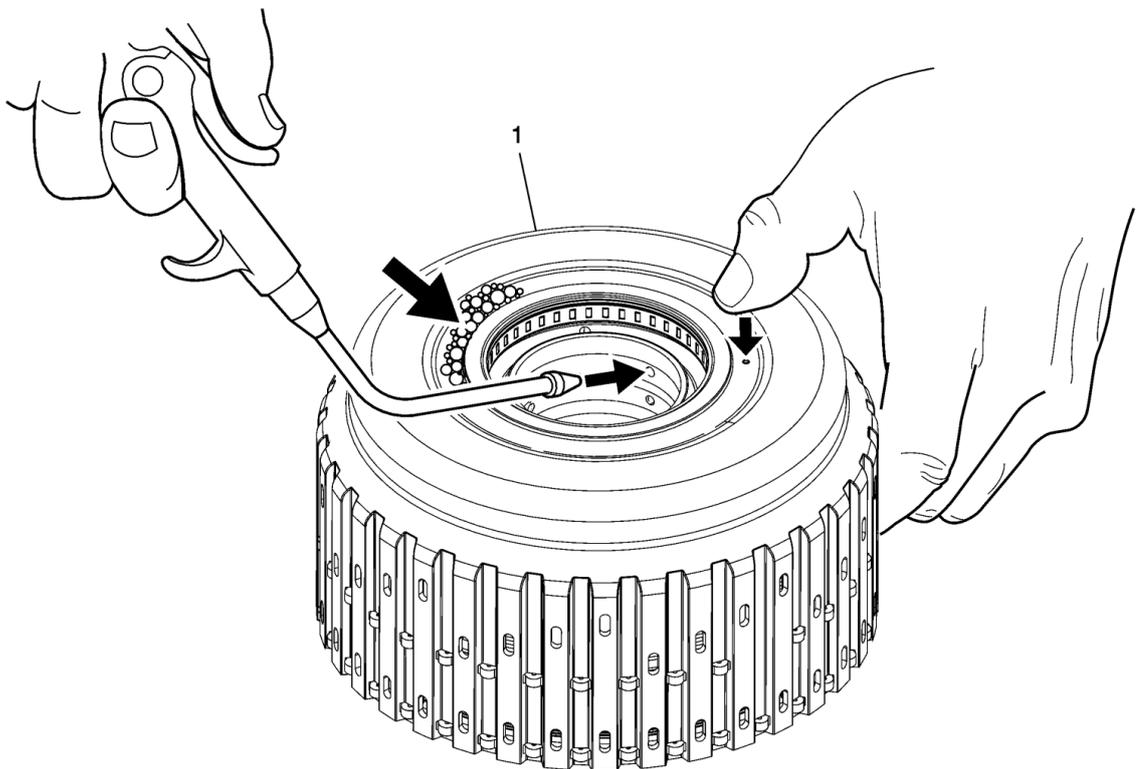
Housing Assembled

Inspect the 1-2-3-4 / 3-5-R clutch housing for a possible cracked weld. The housing can be inspected either assembled or disassembled.

1. Apply soap compound to the weld area of the housing.
2. Hold your thumb over the air bleed passage.
3. For a fully assembled 1-2-3-4 and 3-5 reverse clutch housing, spray compressed air into the 3-5R clutch feed hole and inspect the weld area for bubbles.
4. If bubbles are detected, a new housing is required.

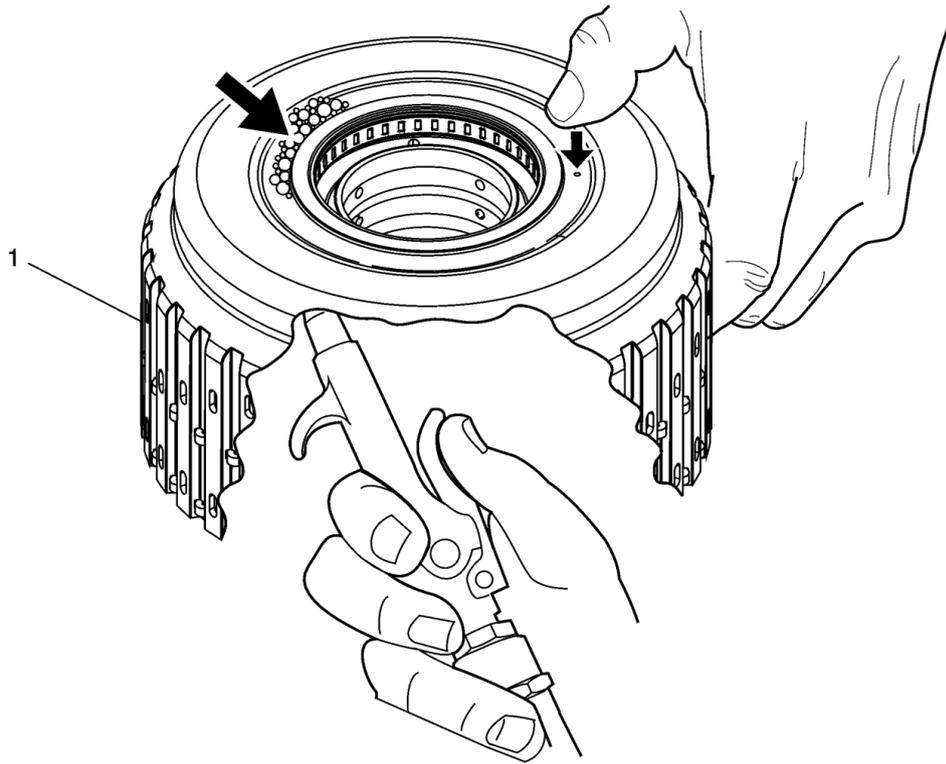
Housing Disassembled

Inspect the 1-2-3-4 / 3-5-R clutch housing for a possible cracked weld.

1. Apply soap compound to weld area of the housing.
2. Hold your thumb over the air bleed passage.
3. Spray compressed air into the housing and inspect the weld area for bubbles.
4. If bubbles are detected, a new housing is required.

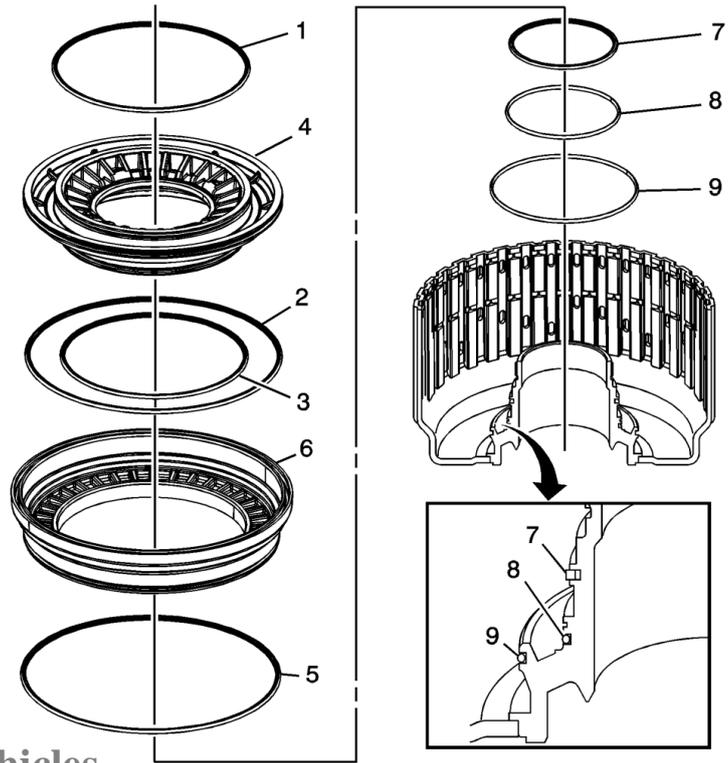
Important: The 6L80 transmission had a design change to the 1-2-3-4 piston, 1-2-3-4 piston housing and the 3-5-R piston for the 2008 model year. Installation of a 2008, 6L80 complete housing assembly into a 2007 or older 6L80 may result in a 2-3 shift flare or 3-5-R clutch distress.

Important: When installing a new 1-2-3-4 / 3-5-R housing into a 2007 or older 6L80, be sure to install all three (3) inner seals (7, 8, 9 in illustration below). Failure to install these seals can result in no reverse, no forward or distressed clutches.

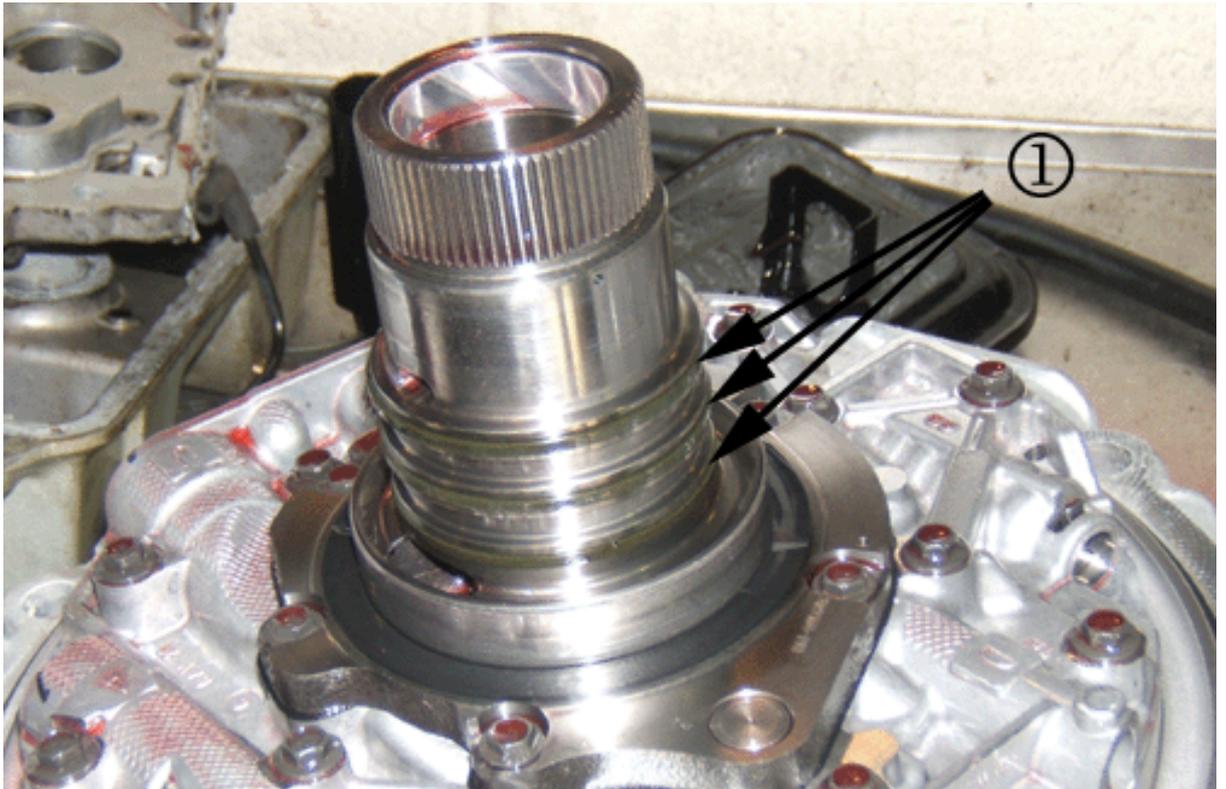
A harsh 2-3 shift condition may be caused by leaking 1-2-3-4 and 3-5-R clutch fluid seal rings (1) on the transmission fluid pump cover assembly.

Inspect the fluid seal rings. Transmissions in 2006, 2007, 2008 and early build 2009 models used a 1- piece design seal ring in production. Starting December 2008, a 2-piece seal ring design was implemented. The 1-piece seal ring design may cause a harsh 2-3 shift due to leakage. This is typically a low mileage issue. If the seal rings are a 1-piece design they should be replaced with new 1-piece design seal rings. It is not necessary to replace the pump cover.

Notice: The clutch fluid seal rings must be installed in a specific way. Failure to install new clutch fluid seal rings in the proper orientation may cause a repeat harsh 2-3 shift. Refer to 1-2-3-4 and 3-5 Reverse Clutch Fluid Seal Ring Installation (6L80/90) in SI for correct installation.

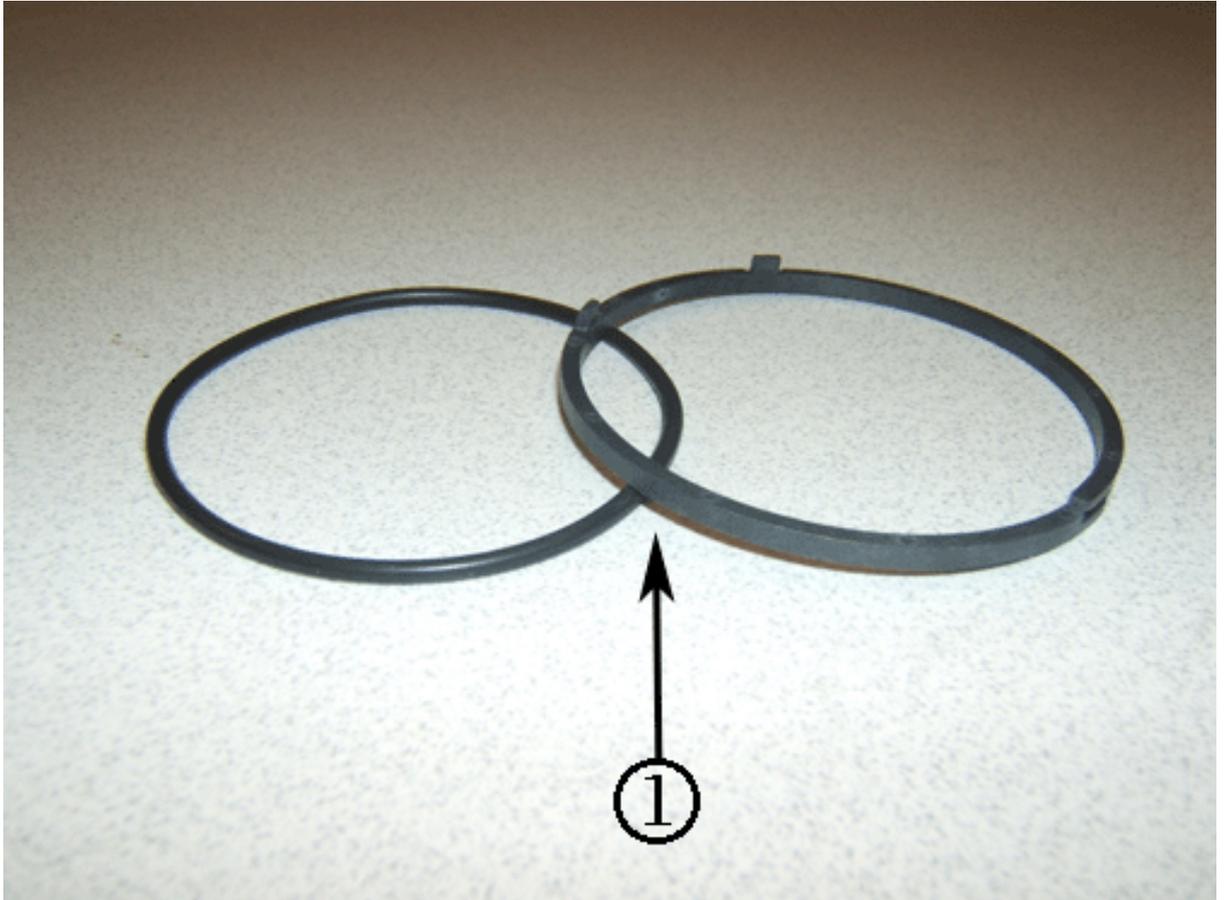
If the seals are the 2-piece design shown below, they do not need to be replaced unless they are worn or damaged.

Important: Do not install 1-piece design seal rings on a 2-piece seal

ring design pump cover. The 2-piece seal ring design pump cover can be identified by the notch in the seal ring grooves that accepts the tab on the 2-piece design seal rings.
