2006 - 2009 Cadillac XLR XLR-V: Service Bulletin: Slips in Reverse or Third, Delayed Reverse or Drive Engagement

#09-07-30-004J: Slips in Reverse or Third, Delayed Reverse or Drive Engagement, DTC P0776, P2715, P2723, Harsh 2-3 Shifts (Inspect 1-2-3-4 / 3-5-R Housing and Pump Seal Rings) - (Feb 25, 2014)

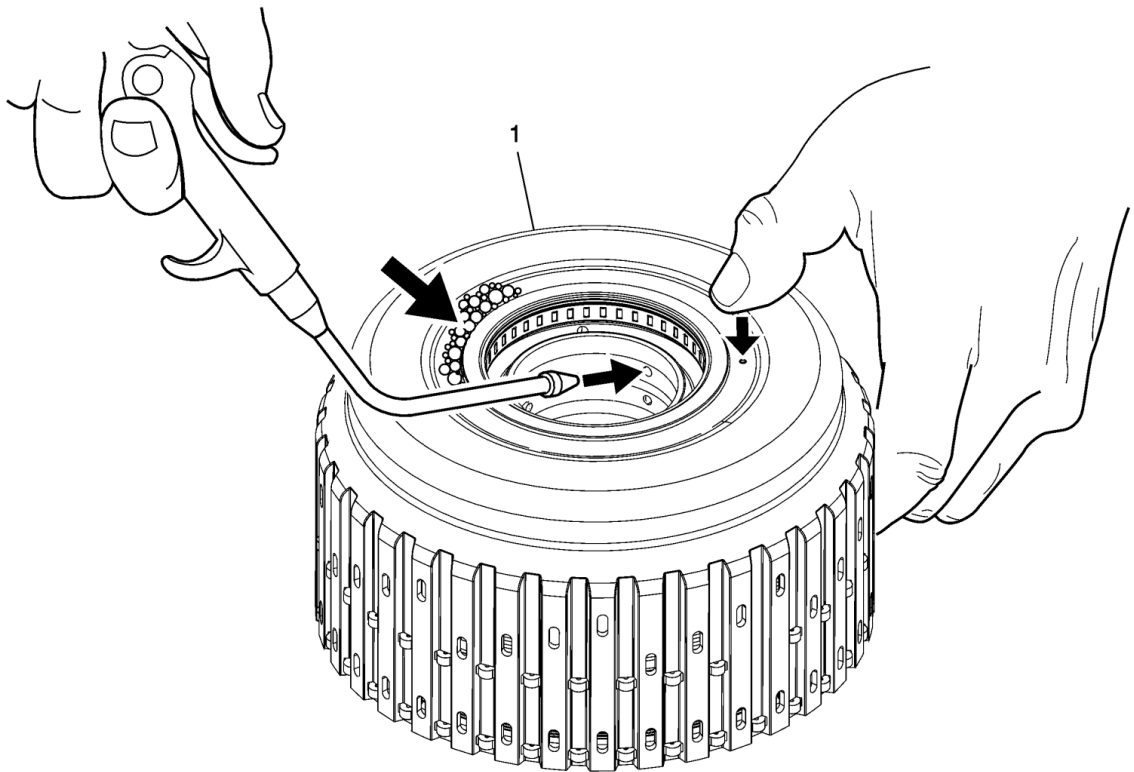
Housing Assembled

This condition may be caused by a cracked 1-2-3-4 / 3-5-R clutch housing.

Inspect the 1-2-3-4 / 3-5-R clutch housing for a possible cracked weld. The housing can be inspected either assembled or disassembled.

1. Apply soap compound to the weld area of the housing.
2. Hold your thumb over the air bleed passage.
3. For a fully assembled 1-2-3-4 and 3-5 reverse clutch housing, spray compressed air into the 3-5R clutch feed hole and inspect the weld area for bubbles.
4. If bubbles are detected, a new housing is required.

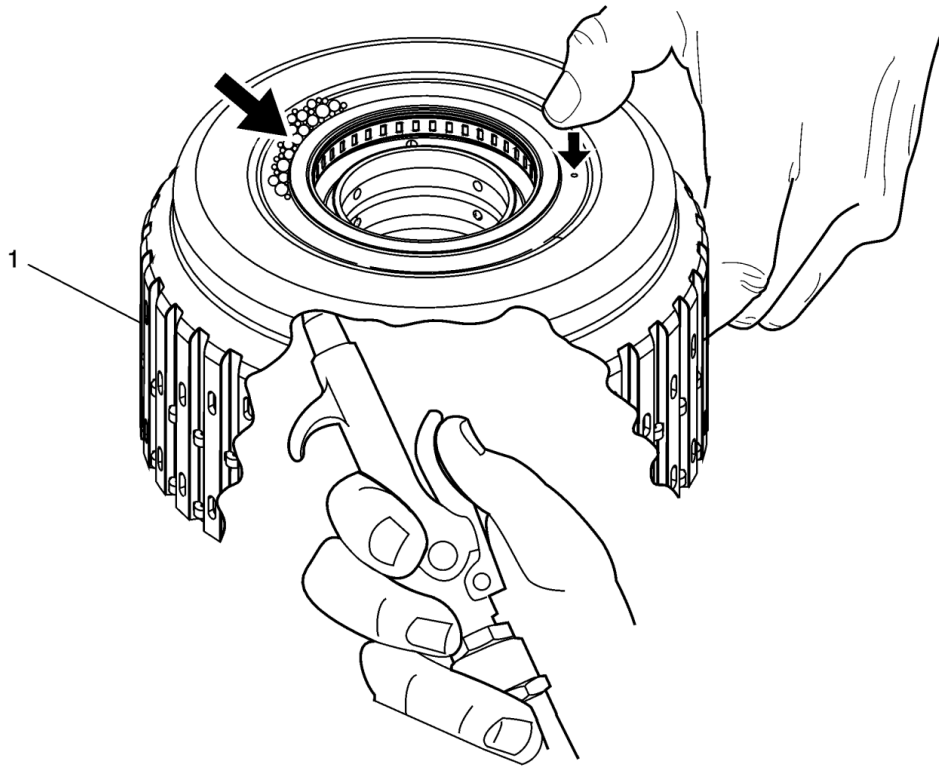
Housing Disassembled

Inspect the 1-2-3-4 / 3-5-R clutch housing for a possible cracked weld.

1. Apply soap compound to weld area of the housing.
2. Hold your thumb over the air bleed passage.
3. Spray compressed air into the housing and inspect the weld area for bubbles.
4. If bubbles are detected, a new housing is required.

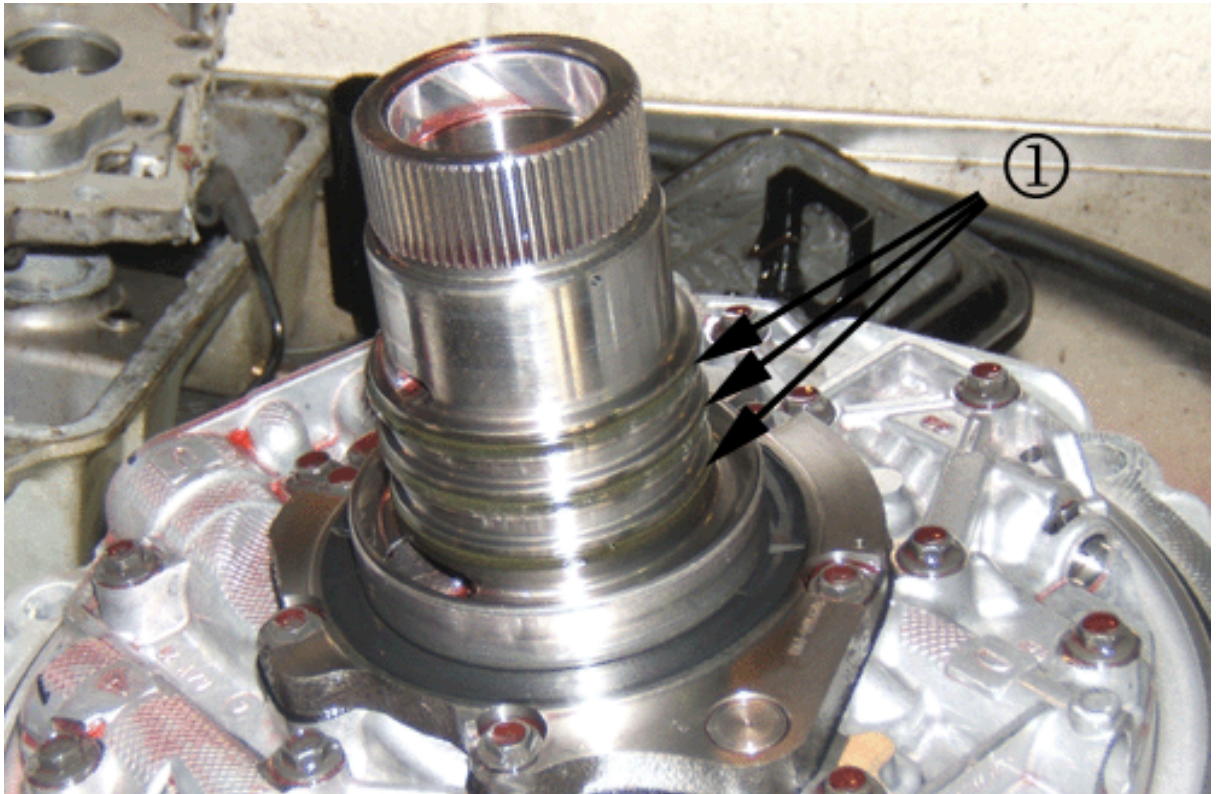
A harsh 2-3 shift condition may be caused by leaking 1-2-3-4 and 3-5-R clutch fluid seal rings (1) on the transmission fluid pump cover assembly.

Inspect the fluid seal rings. Transmissions in 2006, 2007, 2008 and early build 2009 models used a 1- piece design seal ring in production. Starting December 2008, a 2-piece seal ring design was implemented. The 1-piece seal ring design may cause a harsh 2-3 shift due to leakage. This is typically a low mileage issue. If the seal rings are a 1-piece design they should be replaced with new 1-piece design seal rings. It is not necessary to replace the pump cover.

Notice: The clutch fluid seal rings must be installed in a specific way. Failure to install new clutch fluid seal rings in the proper orientation may cause a repeat harsh 2-3 shift. Refer to 1-2-3-4 and 3-5 Reverse Clutch Fluid Seal Ring Installation (6L80/90) in SI for correct installation.

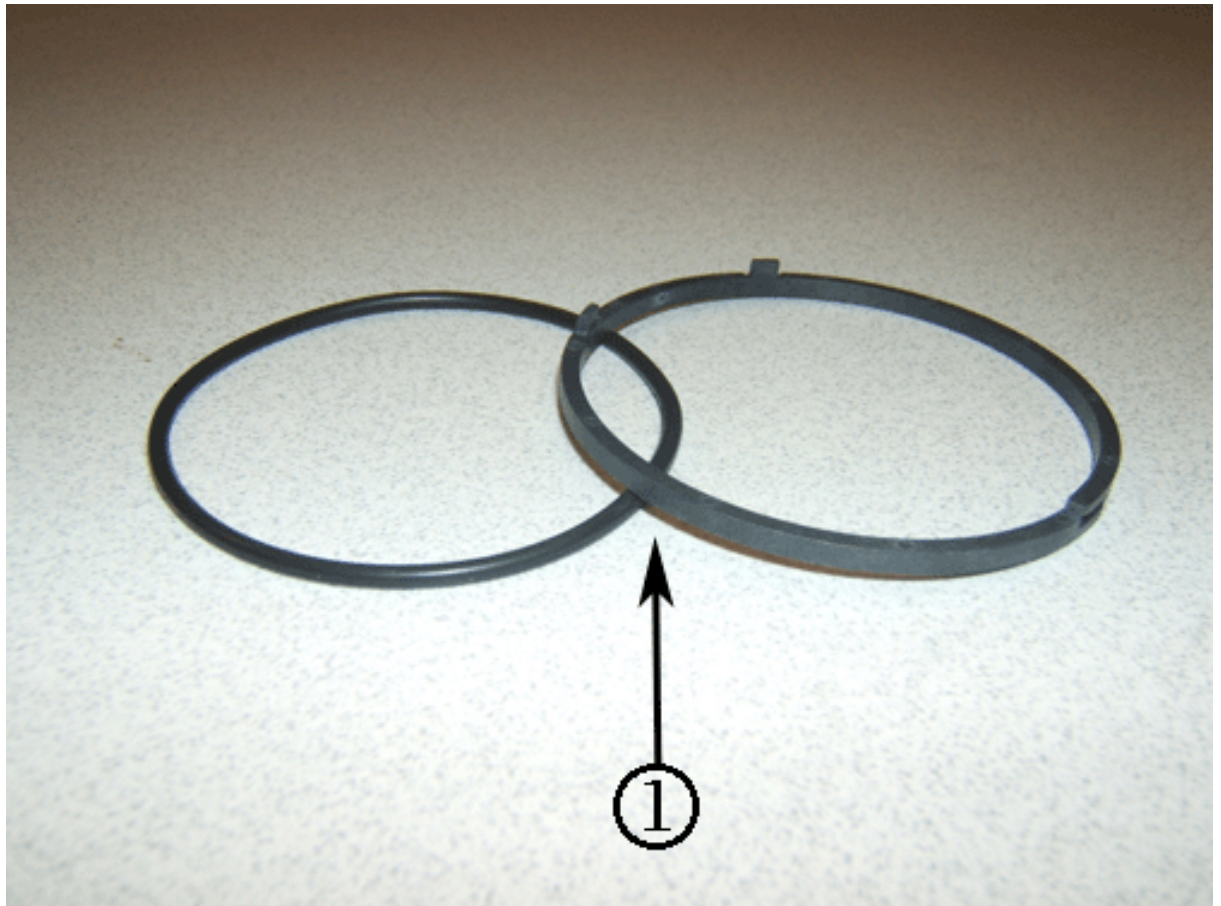
If the seals are the 2-piece design shown below, they do not need to be replaced unless they are worn or damaged.

ring design pump cover. The 2-piece seal ring design pump cover can be identified by the notch in the seal ring grooves that accepts the tab on the 2-piece design seal rings.

Important: Do not install 1-piece design seal rings on a 2-piece seal
