2006 - 2009 Cadillac XLR XLR-V: Service Bulletin: Slips in Reverse or Third, Delayed Reverse or Drive Engagement

#09-07-30-004J: Slips in Reverse or Third, Delayed Reverse or Drive Engagement, DTC P0776, P2715, P2723, Harsh 2-3 Shifts (Inspect 1-2-3-4 / 3-5-R Housing and Pump Seal Rings) - (Feb 25, 2014)

Subject:	Slips in Reverse or Third, Delayed Reverse or Drive Engagement, DTC P0776, P2715, P2723, Harsh 2-3 Shifts (Inspect 1-2-3-4 / 3-5-R Housing and Pump Seal Rings)
Models:	2006 - 2009 Cadillac STS-V, XLR, XLR-V 2007 - 2008 Cadillac Escalade, Escalade ESV, Escalade EXT 2006 - 2009 Chevrolet Corvette 2007 - 2008 Chevrolet Silverado 2008 Chevrolet Suburban 2007 - 2008 GMC Sierra, Sierra Denali, Yukon Denali, Yukon XL Denali 2008 GMC Yukon XL 2008 - 2009 HUMMER H2 2008 - 2009 Pontiac G8 Equipped with 6L80 or 6L90 Automatic Transmission (RPOs MYC, MYD)

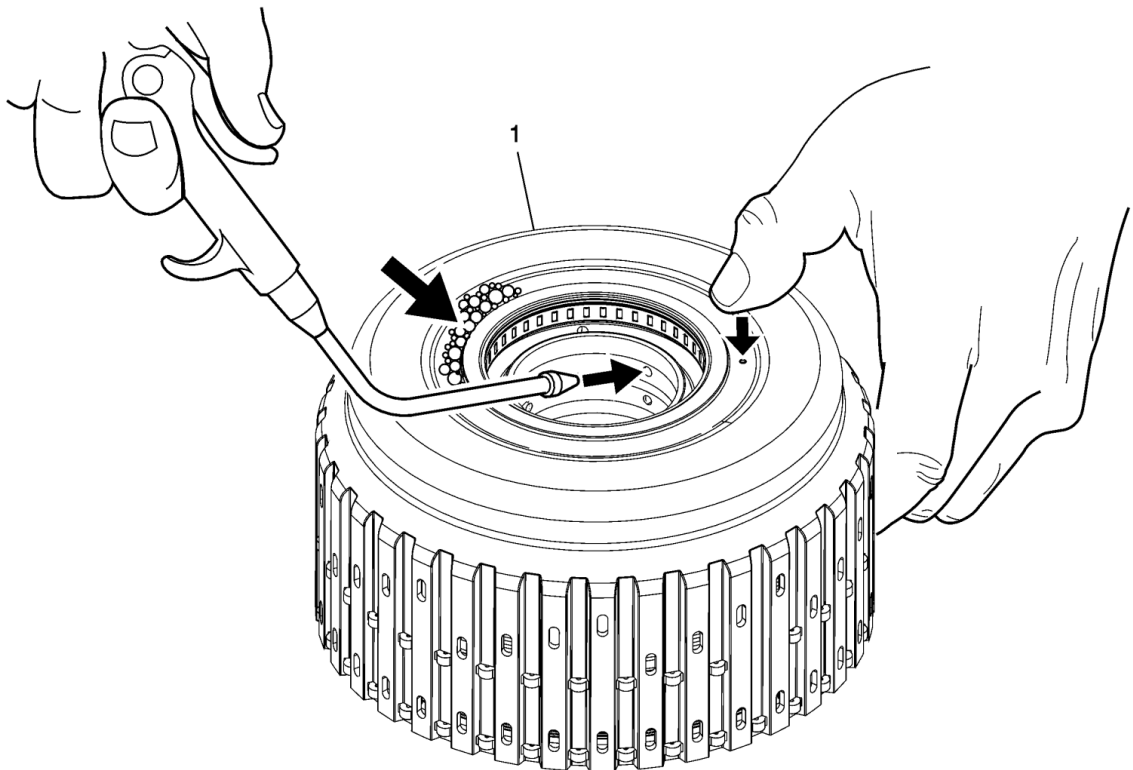
Housing Assembled

This condition may be caused by a cracked 1-2-3-4 / 3-5-R clutch housing.

Inspect the 1-2-3-4 / 3-5-R clutch housing for a possible cracked weld. The housing can be inspected either assembled or disassembled.

1. Apply soap compound to the weld area of the housing.
2. Hold your thumb over the air bleed passage.
3. For a fully assembled 1-2-3-4 and 3-5 reverse clutch housing, spray compressed air into the 3-5R clutch feed hole and inspect the weld area for bubbles.
4. If bubbles are detected, a new housing is required.
