2006 - 2009 Cadillac XLR XLR-V: Service Bulletin: Slips in Reverse or Third, Delayed Reverse or Drive Engagement

#09-07-30-004J: Slips in Reverse or Third, Delayed Reverse or Drive Engagement, DTC P0776, P2715, P2723, Harsh 2-3 Shifts (Inspect 1-2-3-4 / 3-5-R Housing and Pump Seal Rings) - (Feb 25, 2014)

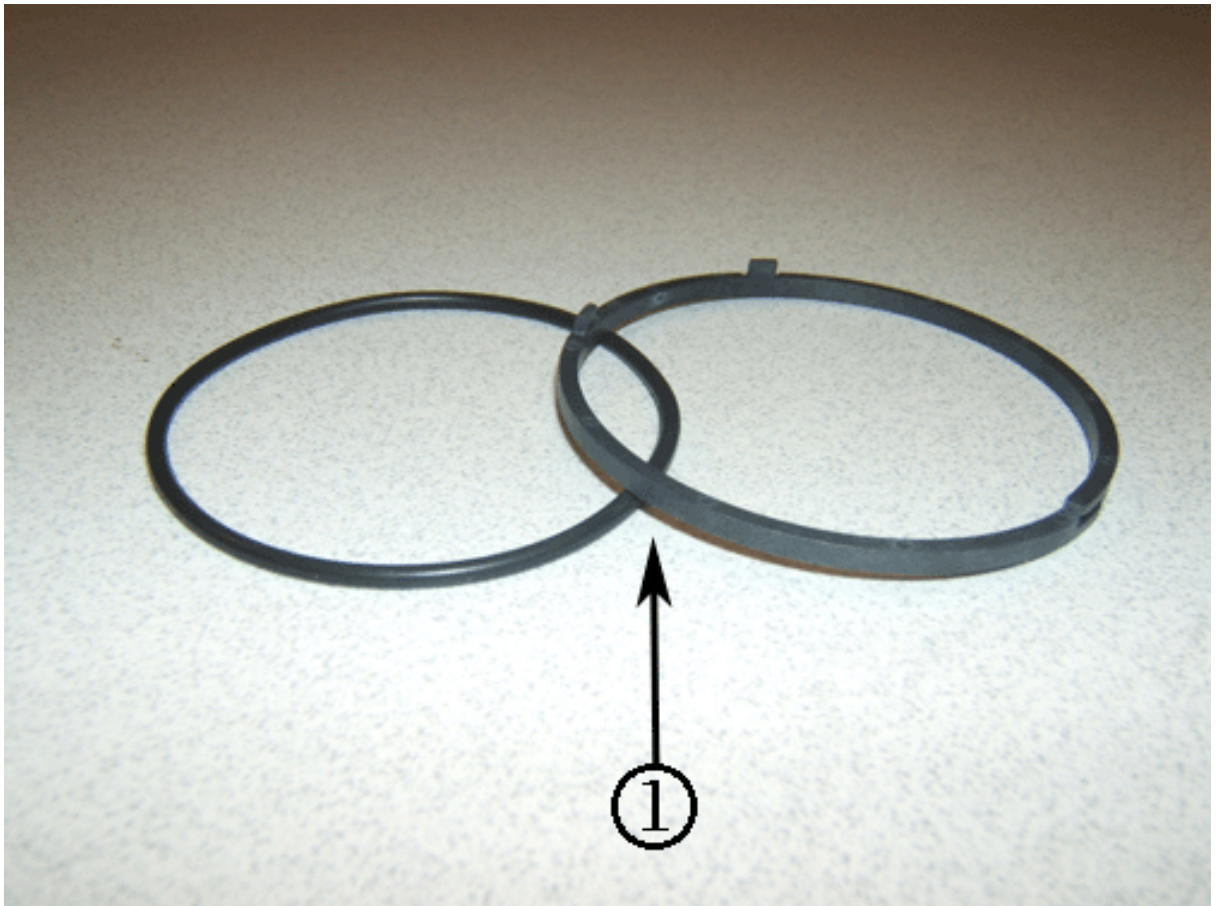
If the seals are the 2-piece design shown below, they do not need to be replaced unless they are worn or damaged.

Important: Do not install 1-piece design seal rings on a 2-piece seal

ring design pump cover. The 2-piece seal ring design pump cover can be identified by the notch in the seal ring grooves that accepts the tab on the 2-piece design seal rings.
