2006 - 2009 Cadillac XLR XLR-V: Service Bulletin: Slips in Reverse or Third, Delayed Reverse or Drive Engagement

#09-07-30-004J: Slips in Reverse or Third, Delayed Reverse or Drive Engagement, DTC P0776, P2715, P2723, Harsh 2-3 Shifts (Inspect 1-2-3-4 / 3-5-R Housing and Pump Seal Rings) - (Feb 25, 2014)

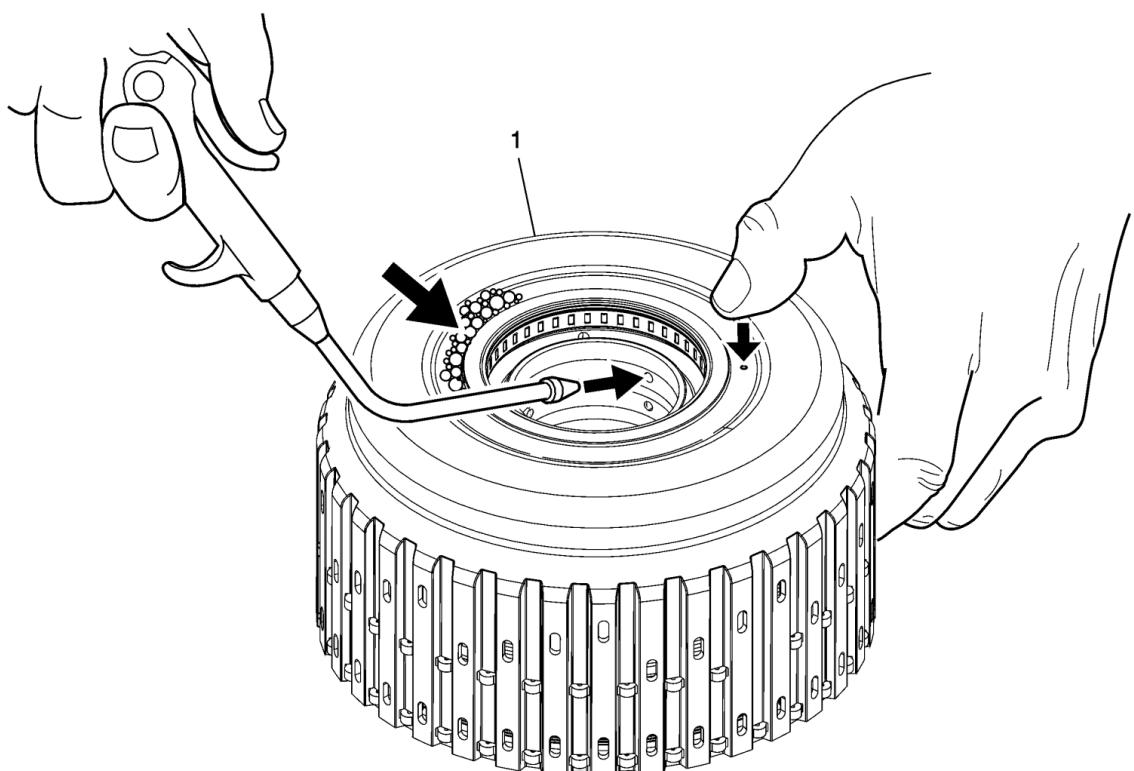
Housing Assembled

This condition may be caused by a cracked 1-2-3-4 / 3-5-R clutch housing.

Inspect the 1-2-3-4 / 3-5-R clutch housing for a possible cracked weld. The housing can be inspected either assembled or disassembled.

Important: If a cracked housing is identified, it must be replaced. Complete, assembled 1-2-3-4 / 3-5-R clutch housings are now available for most applications. These clutch housings come complete with all pistons, seals, clutches, bearing and internal parts. No assembly of the clutch housing is required before it is installed. For applications without a complete, assembled 1-2-3-4 / 3-5-R clutch housing, individual parts must be ordered and the housing assembled in the

1. Apply soap compound to the weld area of the housing.
2. Hold your thumb over the air bleed passage.
3. For a fully assembled 1-2-3-4 and 3-5 reverse clutch housing, spray compressed air into the 3-5R clutch feed hole and inspect the weld area for bubbles.
4. If bubbles are detected, a new housing is required.

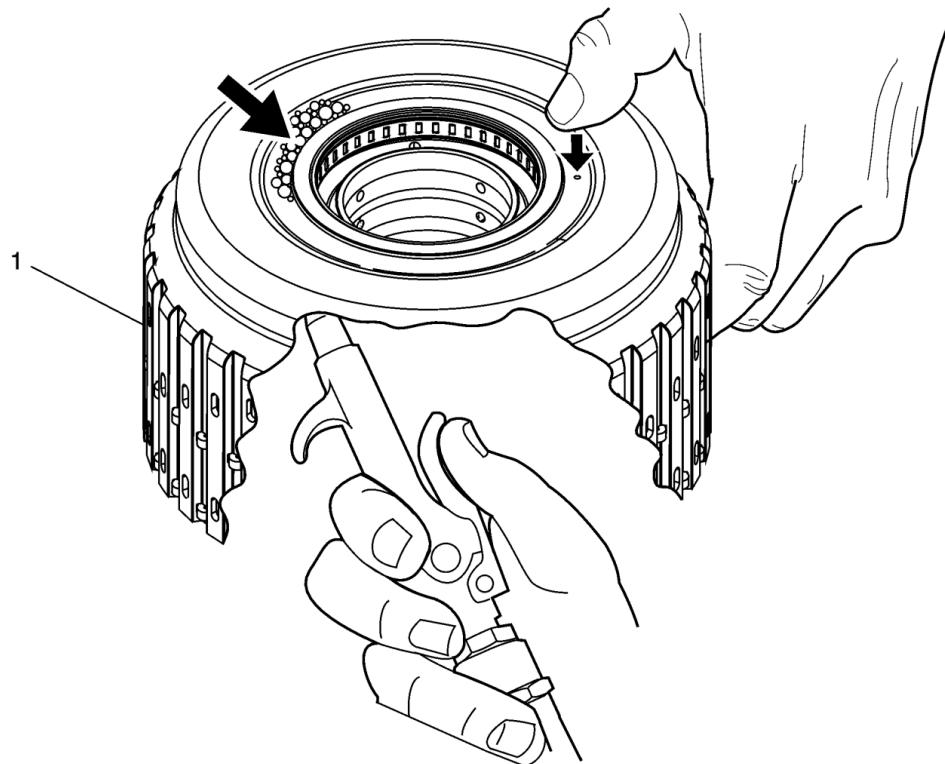
Housing Disassembled

Inspect the 1-2-3-4 / 3-5-R clutch housing for a possible cracked weld.

1. Apply soap compound to weld area of the housing.
2. Hold your thumb over the air bleed passage.
3. Spray compressed air into the housing and inspect the weld area for bubbles.
4. If bubbles are detected, a new housing is required.

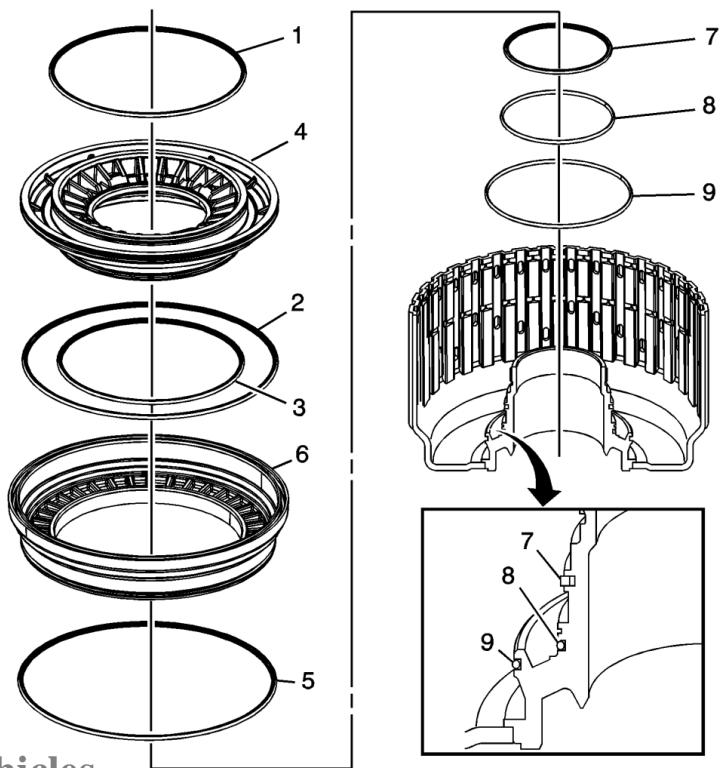
Important: When installing a new 1-2-3-4 / 3-5-R housing into a 2007 or older 6L80, be sure to install all three (3) inner seals (7, 8, 9 in illustration below). Failure to install these seals can result in no reverse, no forward or distressed clutches.

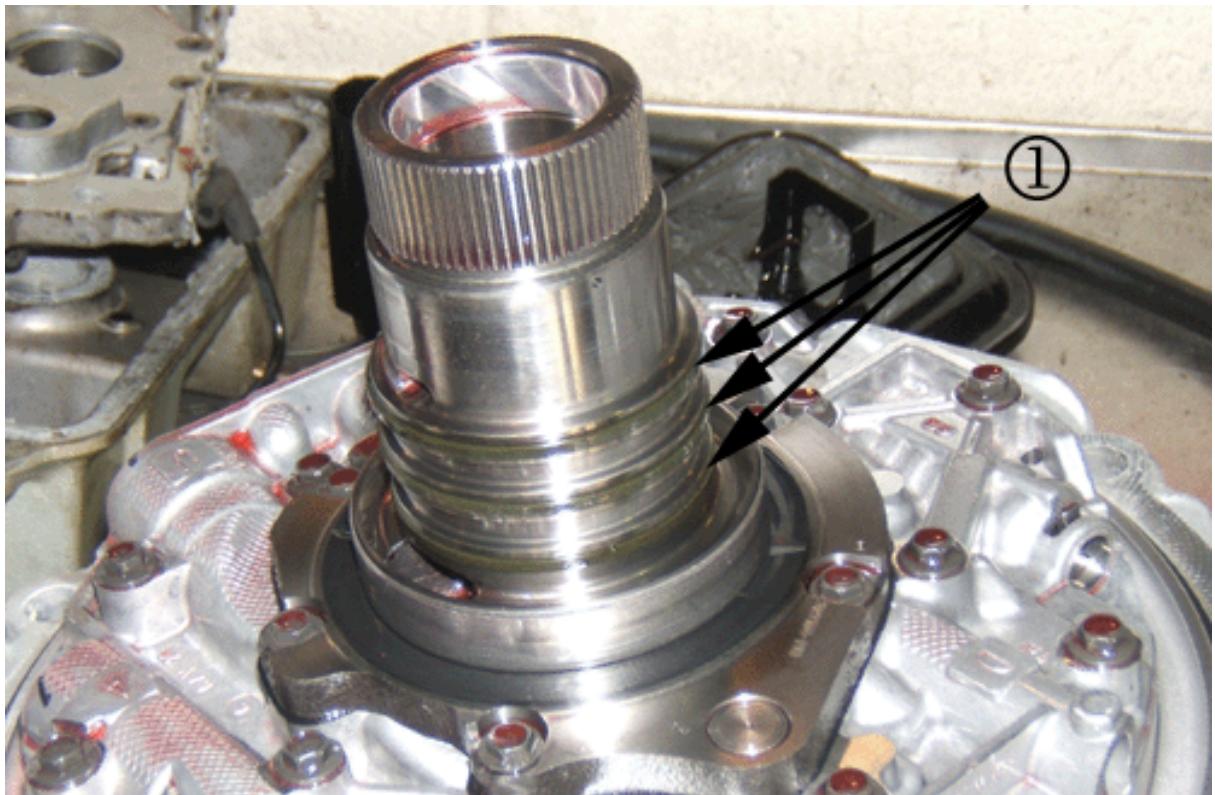
A harsh 2-3 shift condition may be caused by leaking 1-2-3-4 and 3-5-R clutch fluid seal rings (1) on the transmission fluid pump cover assembly.

Inspect the fluid seal rings. Transmissions in 2006, 2007, 2008 and early build 2009 models used a 1- piece design seal ring in production. Starting December 2008, a 2-piece seal ring design was implemented. The 1-piece seal ring design may cause a harsh 2-3 shift due to leakage. This is typically a low mileage issue. If the seal rings are a 1-piece design they should be replaced with new 1-piece design seal rings. It is not necessary to replace the pump cover.

Notice: The clutch fluid seal rings must be installed in a specific way. Failure to install new clutch fluid seal rings in the proper orientation may cause a repeat harsh 2-3 shift. Refer to 1-2-3-4 and 3-5 Reverse Clutch Fluid Seal Ring Installation (6L80/90) in SI for correct installation.

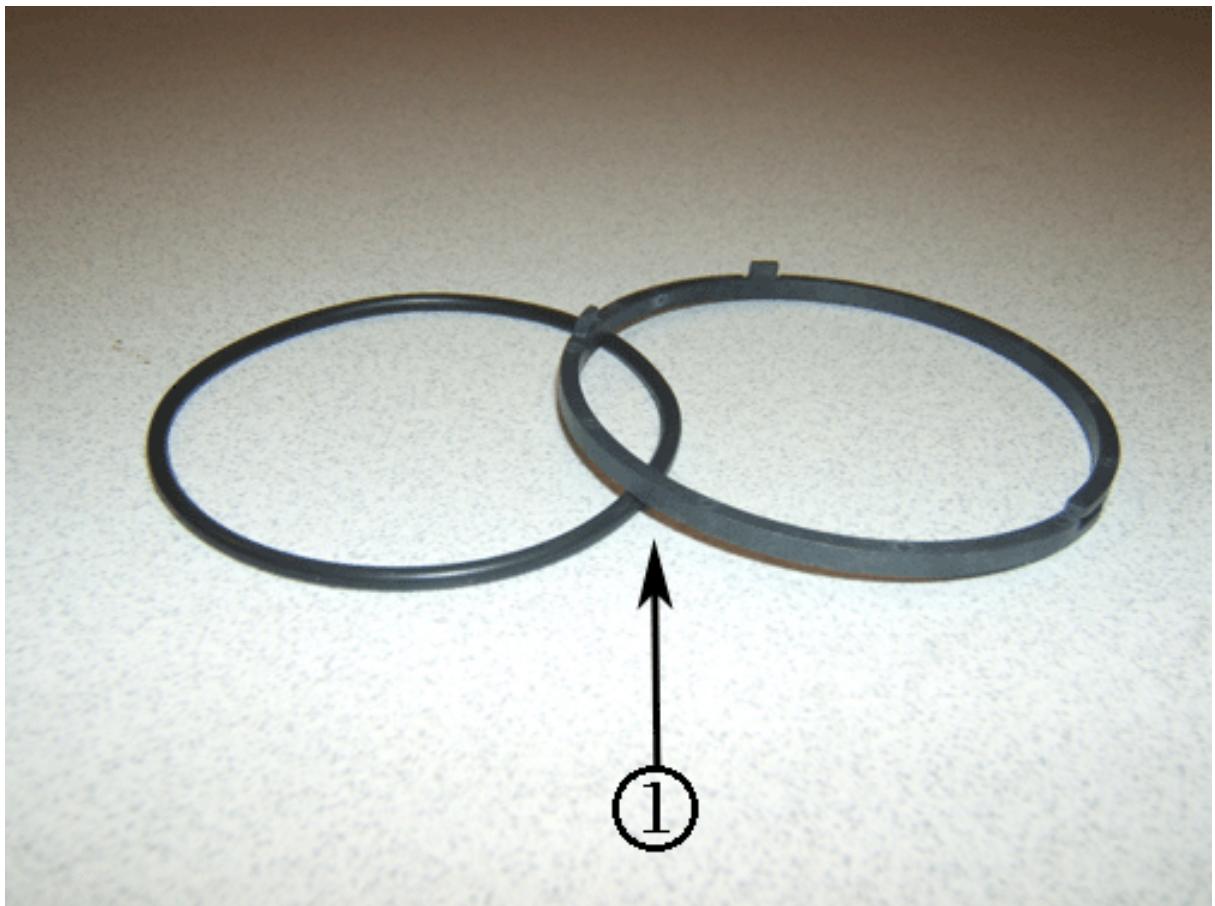
If the seals are the 2-piece design shown below, they do not need to be replaced unless they are worn or damaged.

ring design pump cover. The 2-piece seal ring design pump cover can be identified by the notch in the seal ring grooves that accepts the tab on the 2-piece design seal rings.

Important: Do not install 1-piece design seal rings on a 2-piece seal
