2006 - 2009 Cadillac XLR XLR-V: Service Bulletin: Slips in Reverse or Third, Delayed Reverse or Drive Engagement

#09-07-30-004J: Slips in Reverse or Third, Delayed Reverse or Drive Engagement, DTC P0776, P2715, P2723, Harsh 2-3 Shifts (Inspect 1-2-3-4 / 3-5-R Housing and Pump Seal Rings) - (Feb 25, 2014)

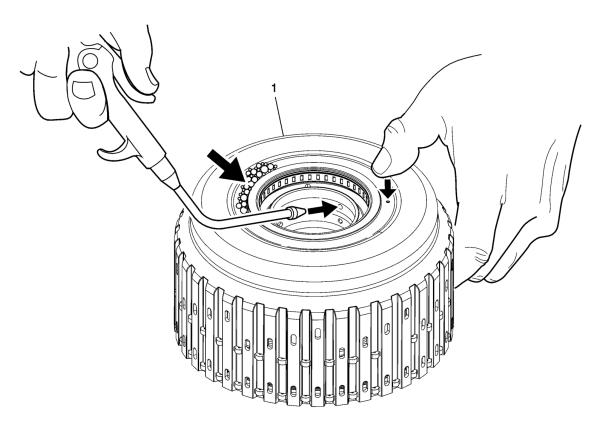
Housing Assembled

Inspect the 1-2-3-4 / 3-5-R clutch housing for a possible cracked weld. The housing can be inspected either assembled or disassembled.

- 1. Apply soap compound to the weld area of the housing.
- 2. Hold your thumb over the air bleed passage.
- 3. For a fully assembled 1-2-3-4 and 3-5 reverse clutch housing, spray compressed air into the 3-5R clutch feed hole and inspect the weld area for bubbles.
- 4. If bubbles are detected, a new housing is required.

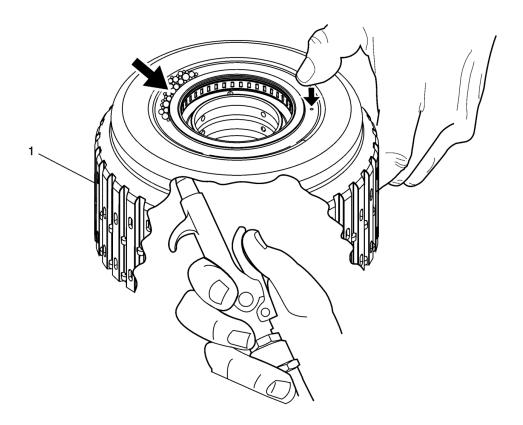
Housing Disassembled

Inspect the 1-2-3-4 / 3-5-R clutch housing for a possible cracked weld.

- 1. Apply soap compound to weld area of the housing.
- 2. Hold your thumb over the air bleed passage.
- 3. Spray compressed air into the housing and inspect the weld area for bubbles.
- 4. If bubbles are detected, a new housing is required.

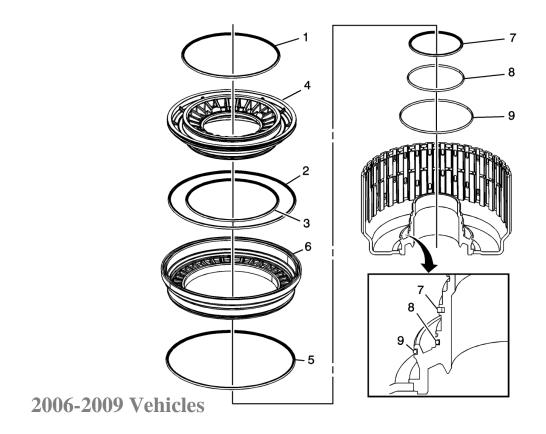
Important: The 6L80 transmission had a design change to the 1-2-3-4 piston, 1-2-3-4 piston housing and the 3-5-R piston for the 2008 model year. Installation of a 2008, 6L80 complete housing assembly into a 2007 or older 6L80 may result in a 2-3 shift flare or 3-5-R clutch distress.

Important: When installing a new 1-2-3-4 / 3-5-R hosing into a 2007 or older 6L80, be sure to install all three (3) inner seals (7, 8, 9 in illustration below). Failure to install these seals can result in no reverse, no forward or distressed clutches.

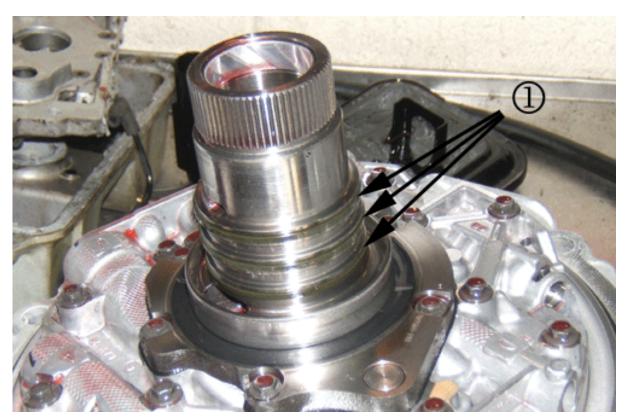
A harsh 2-3 shift condition may be caused by leaking 1-2-3-4 and 3-5-R clutch fluid seal rings (1) on the transmission fluid pump cover assembly.

Inspect the fluid seal rings. Transmissions in 2006, 2007, 2008 and early build 2009 models used a 1- piece design seal ring in production. Starting December 2008, a 2-piece seal ring design was implemented. The 1-piece seal ring design may cause a harsh 2-3 shift due to leakage. This is typically a low mileage issue. If the seal rings are a 1-piece design they should be replaced with new 1-piece design seal rings. It is not necessary to replace the pump cover.

Notice: The clutch fluid seal rings must be installed in a specific way. Failure to install new clutch fluid seal rings in the proper orientation may cause a repeat harsh 2-3 shift. Refer to 1-2-3-4 and 3-5 Reverse Clutch Fluid Seal Ring Installation (6L80/90) in SI for correct installation.

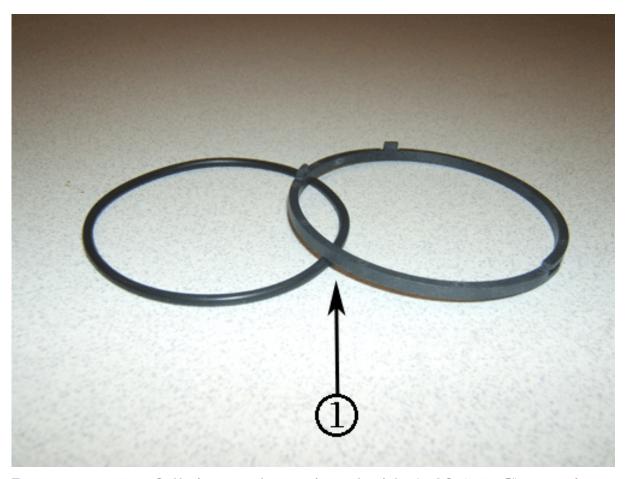
If the seals are the 2-piece design shown below, they do not need to be replaced unless they are worn or damaged.

Important: Do not install 1-piece design seal rings on a 2-piece seal

ring design pump cover. The 2-piece seal ring design pump cover can be identified by the notch in the seal ring grooves that accepts the tab on the 2-piece design seal rings.
