2006 - 2008 Cadillac XLR-V: Service Information: 6L80 or 6L90 Automatic Transmission Shift Conditions

Source: GM Techlink

Date: October 2011

Models: 2006 - 2008 Cadillac XLR-V

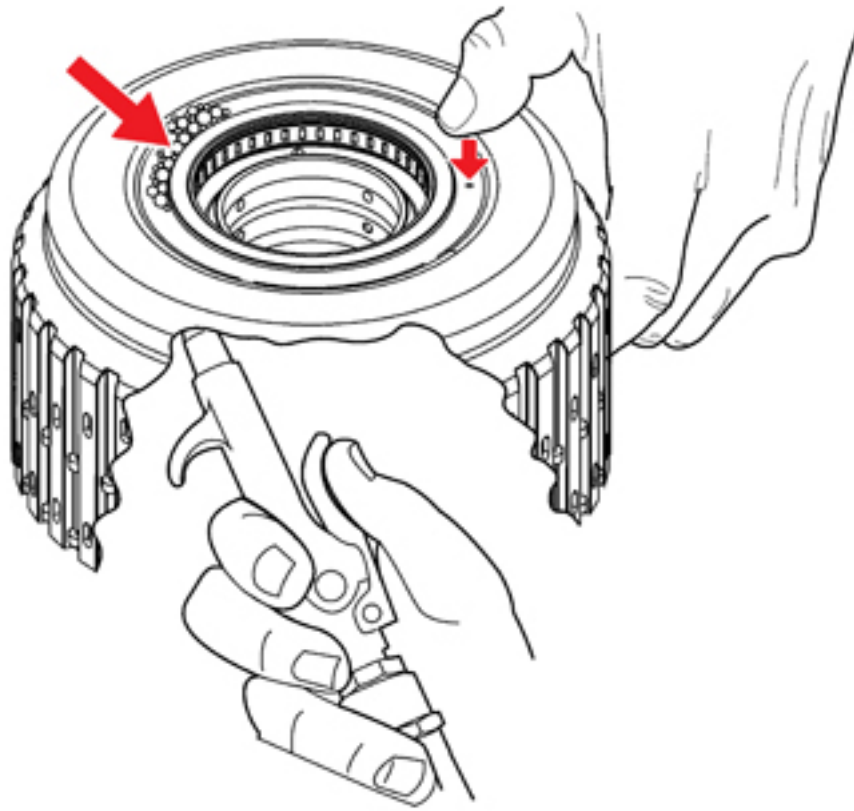
Fig. 14

A cracked 1-2-3-4/3-5-R clutch housing may cause any of the following conditions:

- Slip when Reverse is selected or no Reverse
- Delayed engagement into Reverse
- DTC P0776 set as an active or a history code in the Transmission Control Module, Malfunction Indicator Lamp (MIL) illuminated
- Harsh shifts from Second to Third

Inspect the 1-2-3-4 / 3-5-R clutch housing for a possible cracked weld by applying soap compound to the weld area of the housing. Hold your thumb over the air bleed passage and spray compressed air into the piston housing. Inspect the weld area for bubbles. If bubbles are detected, a new housing is

required. (Fig. 14)
