2006 - 2008 Cadillac XLR-V: Service Information: 6L80 or 6L90 Automatic Transmission Shift Conditions

Source: GM Techlink

Date: October 2011

Subject: 6L80 or 6L90 Automatic Transmission Shift Conditions

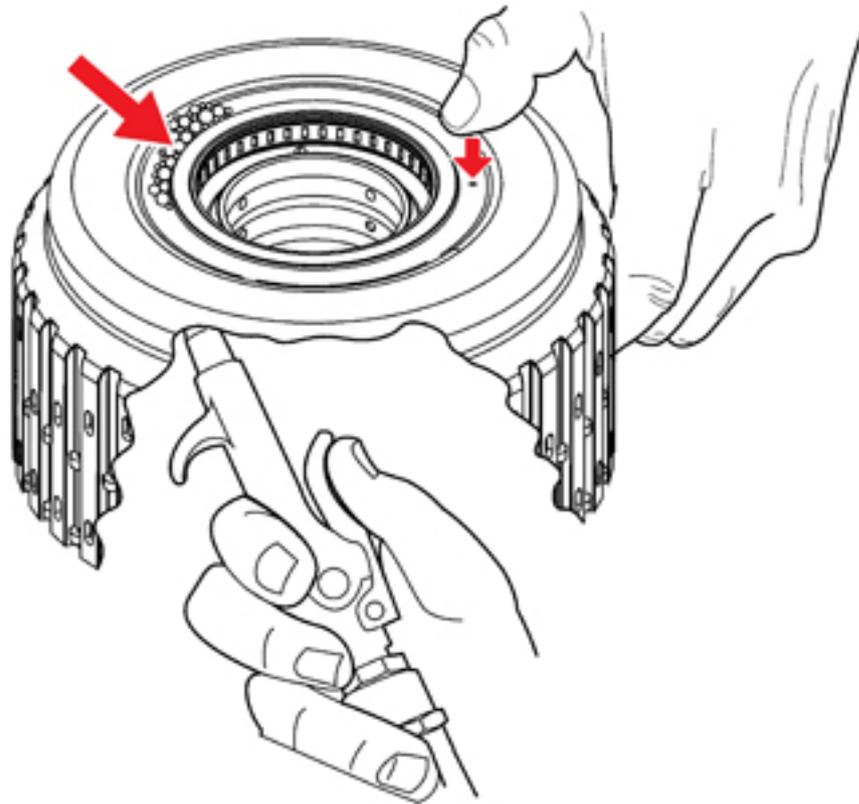
Fig. 14

A cracked 1-2-3-4/3-5-R clutch housing may cause any of the following conditions:

- Slip when Reverse is selected or no Reverse
- Delayed engagement into Reverse
- DTC P0776 set as an active or a history code in the Transmission Control Module, Malfunction Indicator Lamp (MIL) illuminated
- Harsh shifts from Second to Third

Inspect the 1-2-3-4 / 3-5-R clutch housing for a possible cracked weld by applying soap compound to the weld area of the housing. Hold your thumb over the air bleed passage and spray compressed air into the piston housing. Inspect the weld area for bubbles. If bubbles are detected, a new housing is

required. (Fig. 14)
