## 2006 - 2008 Cadillac XLR-V: Service Information: 6L80 or 6L90 Automatic Transmission Shift Conditions

**Source:** GM Techlink

Date: October 2011

Subject: 6L80 or 6L90 Automatic Transmission Shift Conditions

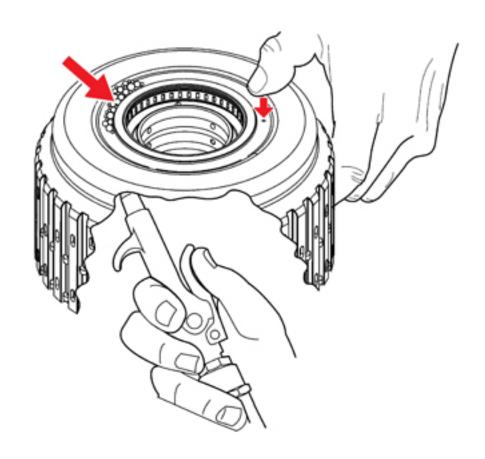
Fig. 14

A cracked 1-2-3-4/3-5-R clutch housing may cause any of the following conditions:

- Slip when Reverse is selected or no Reverse
- Delayed engagement into Reverse
- DTC P0776 set as an active or a history code in the Transmission Control Module, Malfunction Indicator Lamp (MIL) illuminated
- Harsh shifts from Second to Third

Inspect the 1-2-3-4 / 3-5-R clutch housing for a possible cracked weld by applying soap compound to the weld area of the housing. Hold your thumb over the air bleed passage and spray compressed air into the piston housing. Inspect the weld area for bubbles. If bubbles are detected, a new housing is
