# 2004 - 2009 Cadillac XLR: Service Bulletin: Red LED and B2455 After Performing Canada Upgrade Bulletin 15-08-44-001

## #PIC6140B: Red LED and B2455 After Performing Canada Upgrade Bulletin 15-08-44-001 - (Dec 21, 2015)

**Subject:** Red LED and B2455 After Performing Canada Upgrade Bulletin 15-08-44-001

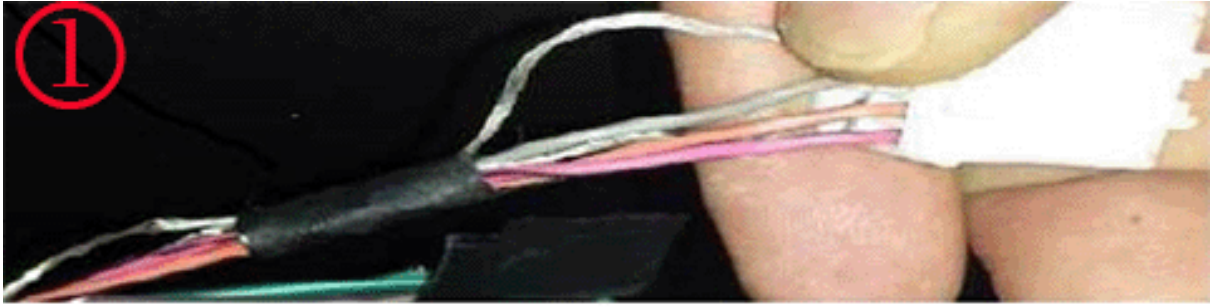
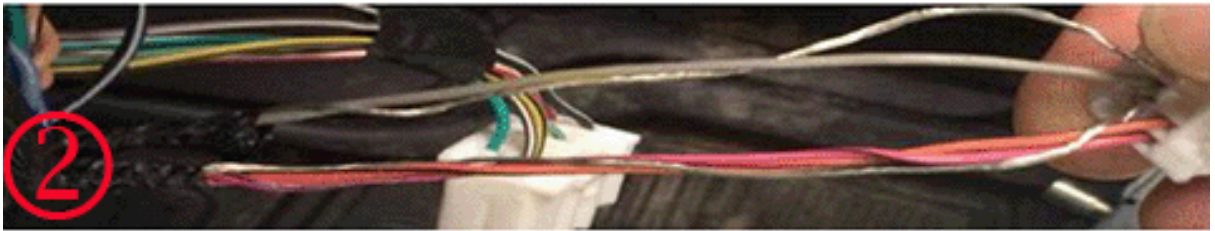
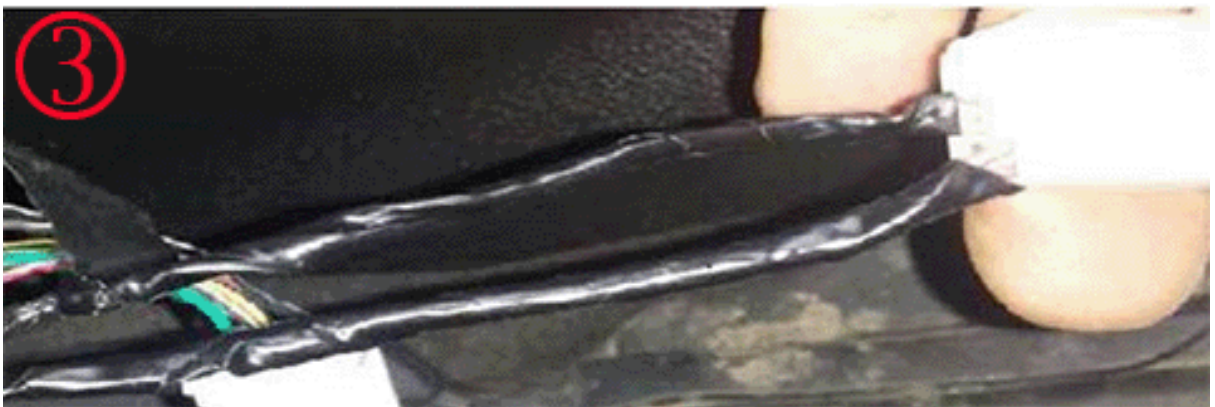
A dealer or customer may notice a red LED and DTC B2455 setting current in the VCIM after performing Canada upgrade bulletin 15-08-44-001.

1. It has been found that a short between the audio drain wire and microphone drain wire will cause this concern.
2. Pull back the tape at X2 of the VCIM far enough to see where the bare wires are covered.
3. Tape the bare wires individually to prevent them from shorting. Then tape the harness back up.
