Service Bulletin

Bulletin No.: 06-02-35-002

Subject: Diagnostic Trouble Code (DTC) C0710 Steering Wheel Position Sensor (SWPS) Signal, Service Stability System Message on Driver Information Center (DIC) (Inspect and Secure Wires in SWPS Connector)

**Models: 2004-2006 Cadillac XLR
2005-2006 Chevrolet Corvette
with Steering Wheel – Tilt, Telescoping (RPO N37)**

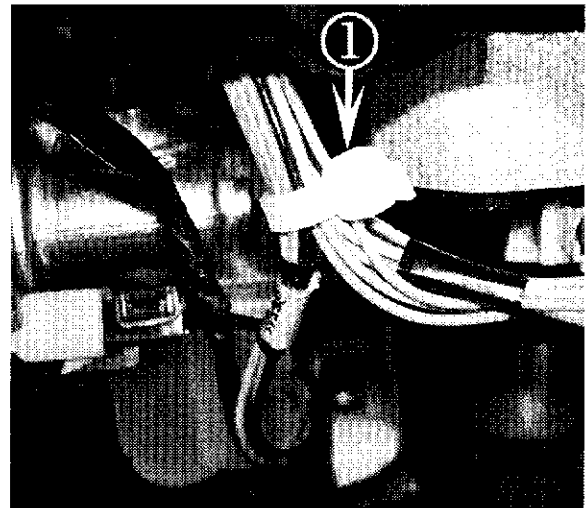
1714896

The most likely cause of a DTC C0710 on a vehicle equipped with telescoping/tilt steering wheel is high resistance in SWPS connector C202. Fretting terminal corrosion maybe present in the SWPS connector due to the telescoping motion of the steering column. When the steering column is telescoped in and out, the female terminals within the SWPS connector may move on the male terminals of the SWPS. This movement between the terminals may cause a high resistance condition in the SWPS connector.

1. Remove the driver's side close out panel.
 - Cadillac XLR — Refer to Closeout/Insulator Panel Replacement - Left (SI Document ID 1207847)
 - Chevrolet Corvette — Refer to Closeout/Insulator Panel Replacement - Instrument Panel (I/P) Lower (SI Document ID 1495116)
2. On XLR models only, locate and remove the plastic strap (1) on the steering column harness that retains the three wiring harnesses. Discard this strap.
3. Disconnect the SWPS connector C202 located on the lower center of the steering column.

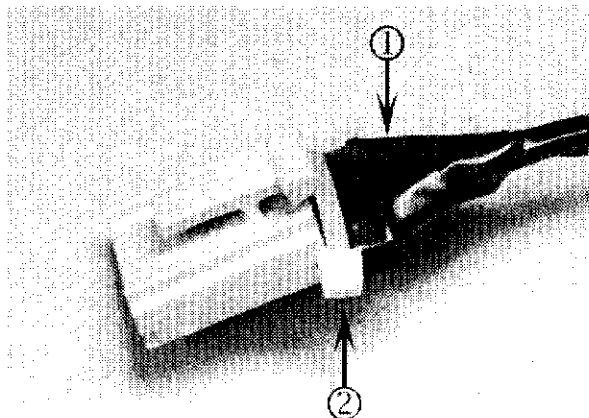
1743934

- Failure to properly tape the wires in the connector may result in additional concerns.
- Failure to use a small plastic strap 2.5-3.5 mm (0.10-0.14 in) in width may prevent the SWPS connector from properly seating, resulting in additional SWPS DTCs.
- Failure to position the plastic strap in the connector notch shown below may result in the strap becoming loose and allowing the terminal to move within the connector.

4. Using electrical tape (1), tape from the plastic strap up the wires a minimum of 2.5 cm (1 in).
5. Install a small plastic strap (2) 2.5-3.5 mm (0.10-0.14 in) wide around the SWPS sensor connector so that it retains the wires to the connector as shown.

Important: Install and remove the SWPS connector a minimum of three times to remove any possible terminal corrosion.
