2006 - 2009 Cadillac XLR and XLR-V: Service Bulletin: #PIC4965: Creak Or Ticking Noise From Roof Behind Seats

Subject: Creak or Ticking Noise From
Roof Behind Seats

Models: 2006 - 2009 Cadillac XLR V and
Platinum Series

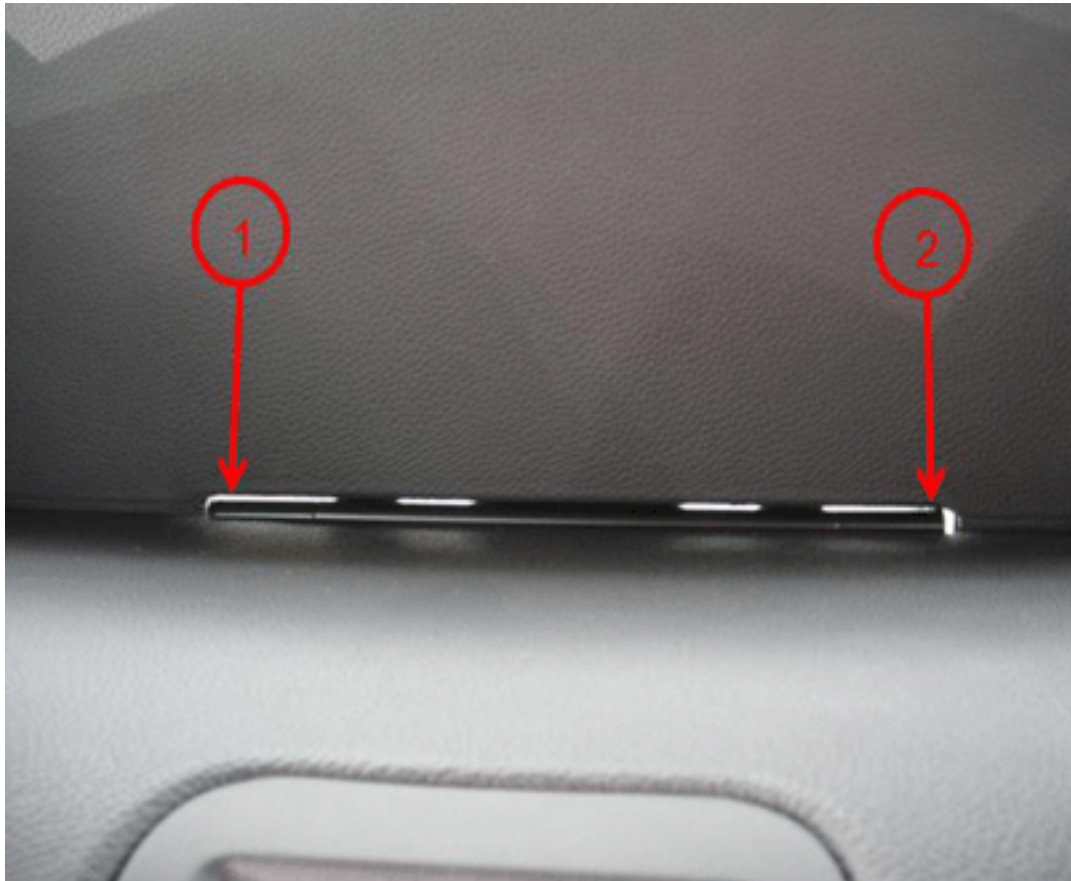
Some customers may comment on a creak or ticking noise heard behind driver while driving with slight road inputs like concrete expansion joints, or loud squawk noise when the front tonneau moves during a power folding roof cycle. This is due to a slip stick condition between the front tonneau cover center panel and the outer portions of the attached hinge. Refer to number 2 in the illustration above.

Note: When the tonneau is not adjusted correctly, the contact could occur in call out number 1 or 2 below. However only call out number 2 below demonstrates contact.

To correct this concern, first loosen the middle fastener of the center front tonneau panel hinge. Then loosen the right fastener and move the panel enough to gain 1mm of clearance between the panel and the right outer hinge barrel and re-tighten it to hold that position. Loosen the left fastener and move the panel to gain 1mm clearance between the panel and the left outer hinge barrel and re-tighten the fastener. Tighten the center fastener. When adjusted correctly, the gap for both call outs in the illustration above should look like the gap called out as number 1. Once adjusted, road test or cycle the roof system to verify the repair.
