2004 - 2009 Cadillac XLR: Service Bulletin: #01-07-30-032E: Transmission Oil Leaking From Transmission Vent

#01-07-30-032E: Transmission Oil Leaking From Transmission Vent (Replace Transmission Case Cover (Channel Plate) Gasket) - (Sep 29, 2008)

Subject:	Transmission Oil Leaking From Transmission Vent (Replace Transmission Case Cover (Channel Plate) Gasket)
Models:	1997-2009 GM Passenger Cars and Light Duty Trucks (including Saturn) with Hydra-Matic 4T65-E Automatic Transmission (RPOs MN3, MN7, M15, M76)

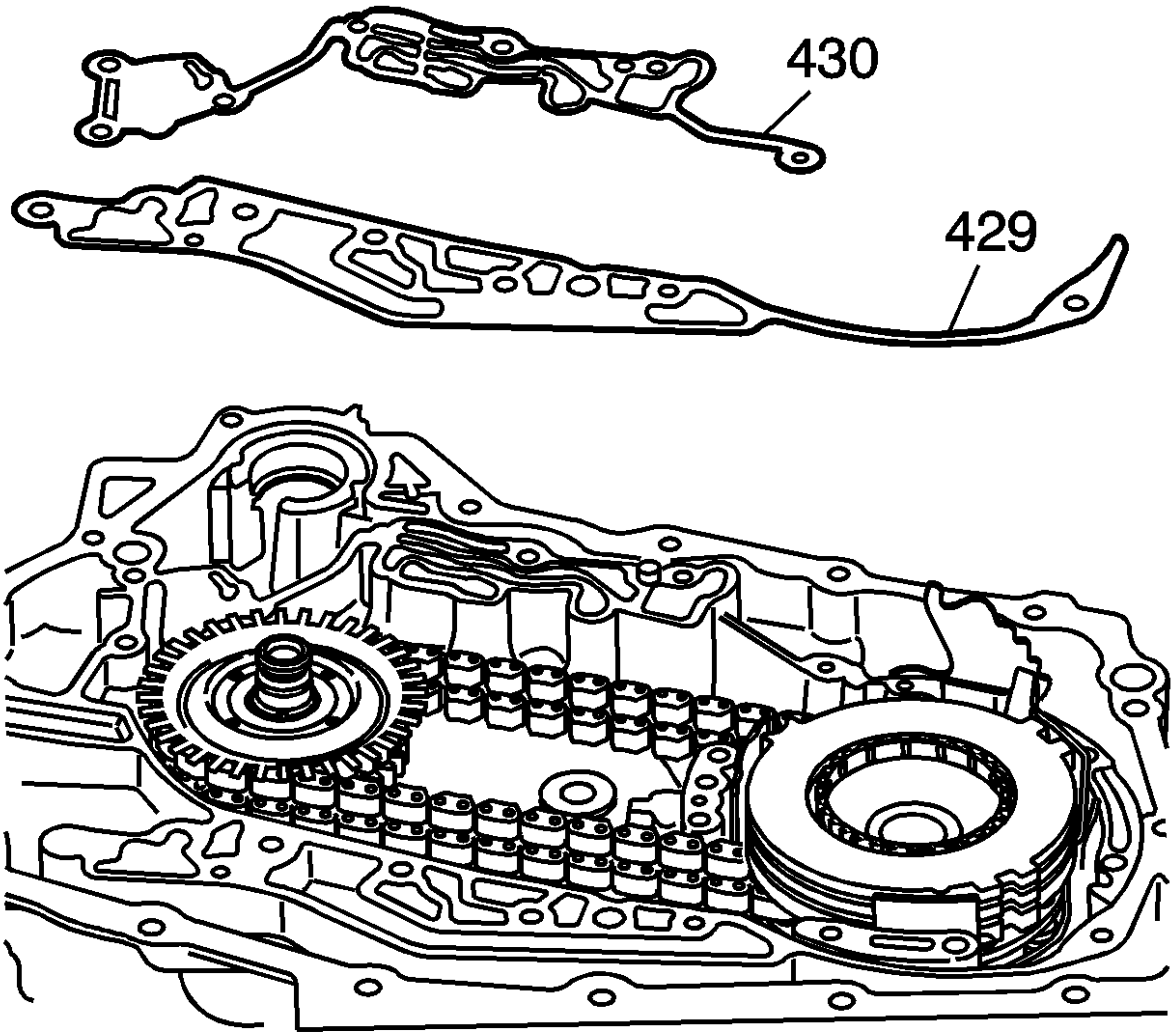
This condition may be caused by an improperly torqued channel plate gasket.

To correct this condition, replace the case cover (channel plate) gaskets (429 and 430). Refer to Unit Repair publication in SI of the appropriate vehicle being serviced.

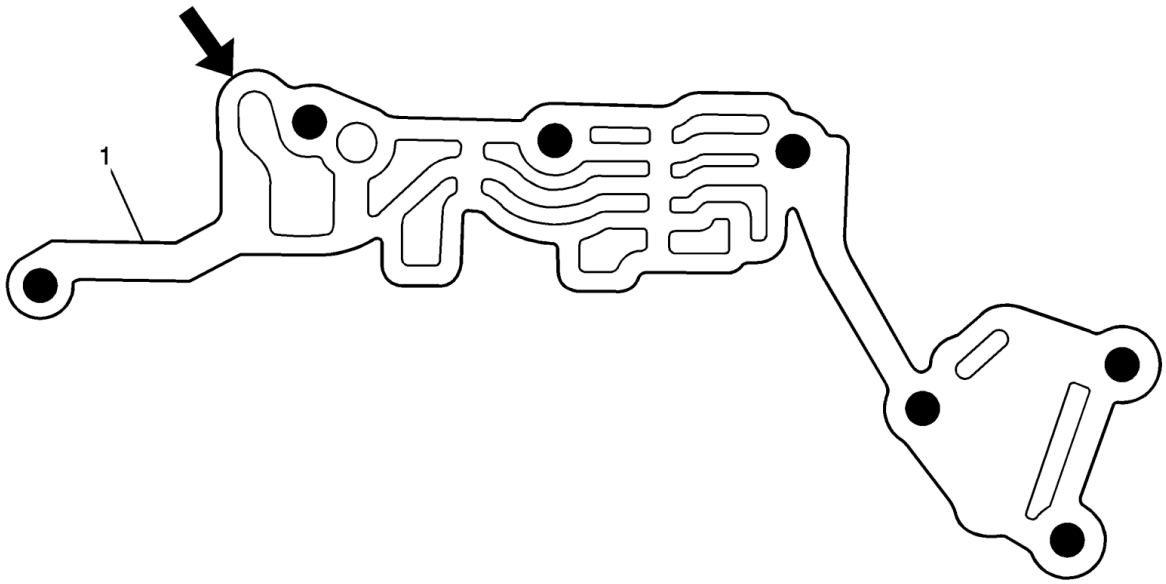
Visual inspection of the upper gasket (1) will reveal damage at the referenced area.
