## **2004 - 2009 Cadillac XLR: Service Bulletin: #PIC4858A: Navigation Radio CD Error - CD Player Will Not Accept Discs - (Feb 11, 2013)**

<b>Subject:</b>	Navigation Radio CD Error - CD Player Will Not Accept Discs
<b>Models:</b>	2004-2009 Cadillac XLR

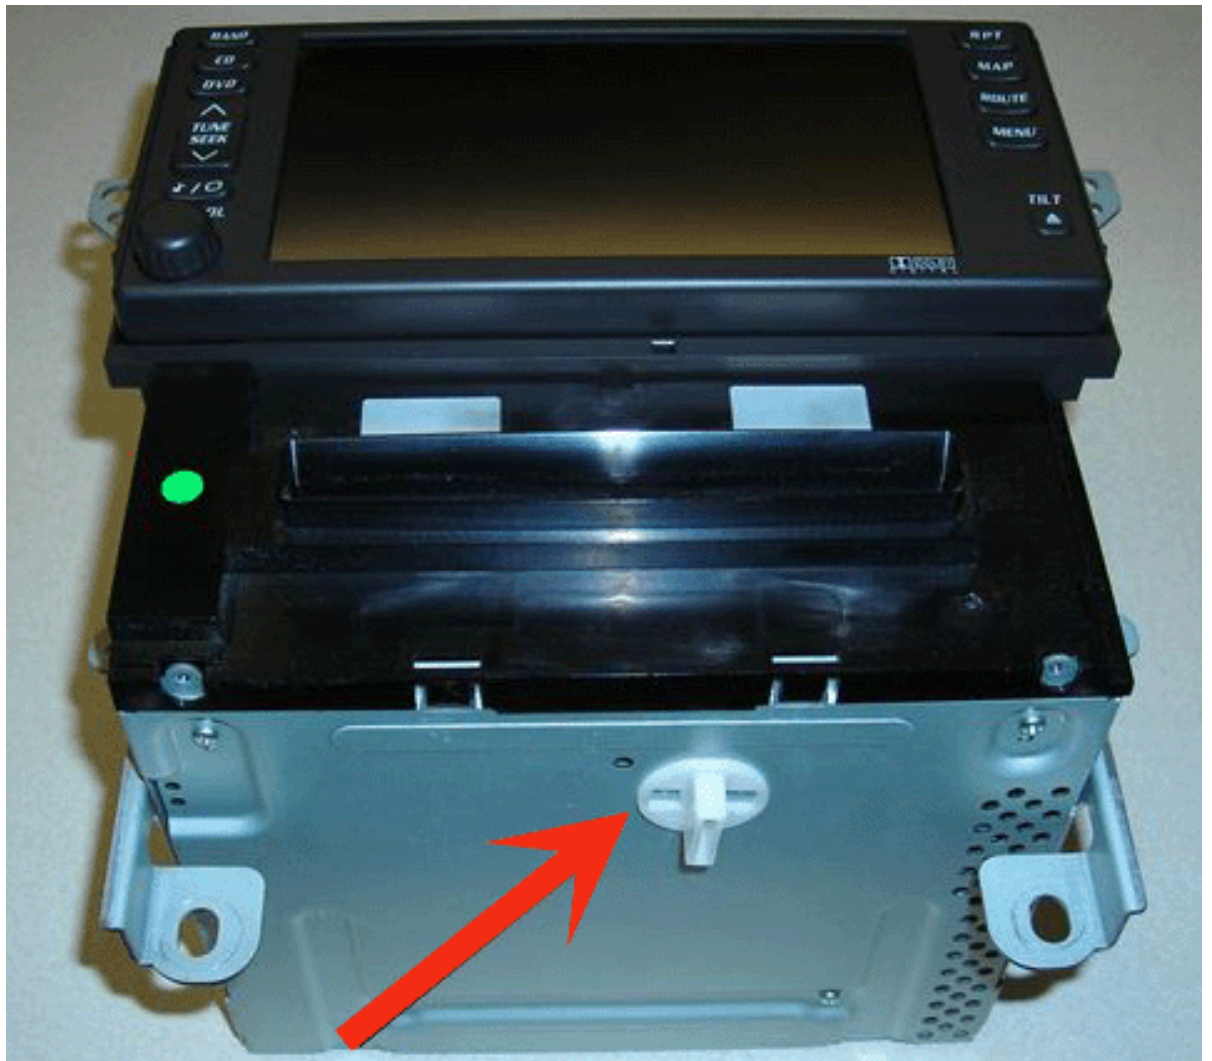
Some customers may comment that the CD changer (CDX) will not accept CD's or the display shows a "CD Error" message when attempting to play a disc. This will usually occur after the radio or CD changer was recently serviced for a different customer's concern. This may be caused because the "shipping pin" was not removed from the bottom of the CD changer prior to installing the service part into the vehicle.

Remove the shipping pin from the bottom of the CD changer prior to installing into the vehicle. This item is called out by an arrow in the first picture below. The second picture shows the shipping plug that has already been removed from the CD changer.

If returning the Navigation radio to the Electronic Service Center, be sure to reinstall the shipping pin to prevent damage to the unit while in transit.
