2004 - 2009 Cadillac XLR: Service Bulletin: #PIC4858A: Navigation Radio CD Error - CD Player Will Not Accept Discs - (Feb 11, 2013)

Subject:	Navigation Radio CD Error - CD Player Will Not Accept Discs
Models:	2004-2009 Cadillac XLR

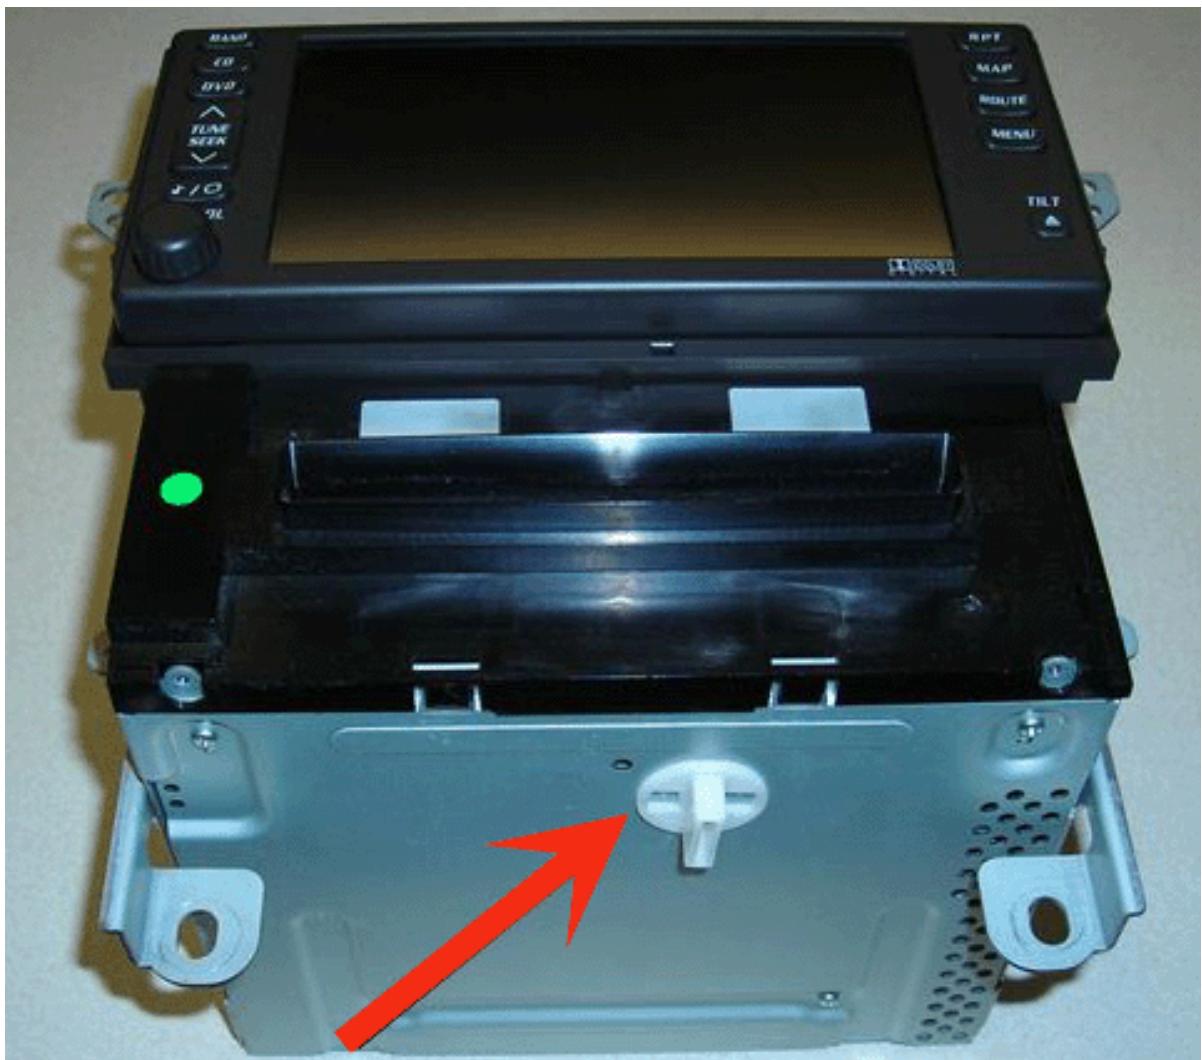
Some customers may comment that the CD changer (CDX) will not accept CD's or the display shows a "CD Error" message when attempting to play a disc. This will usually occur after the radio or CD changer was recently serviced for a different customer's concern. This may be caused because the "shipping pin" was not removed from the bottom of the CD changer prior to installing the service part into the vehicle.

Remove the shipping pin from the bottom of the CD changer prior to installing into the vehicle. This item is called out by an arrow in the first picture below. The second picture shows the shipping plug that has already been removed from the CD changer.

If returning the Navigation radio to the Electronic Service Center, be sure to reinstall the shipping pin to prevent damage to the unit while in transit.
