# 2004 - 2009 Cadillac XLR: Service Bulletin: #PIC4858A: Navigation Radio CD Error - CD Player Will Not Accept Discs - (Feb 11, 2013)

<b>Subject:</b>	Navigation Radio CD Error - CD Player Will Not Accept Discs
<b>Models:</b>	2004-2009 Cadillac XLR

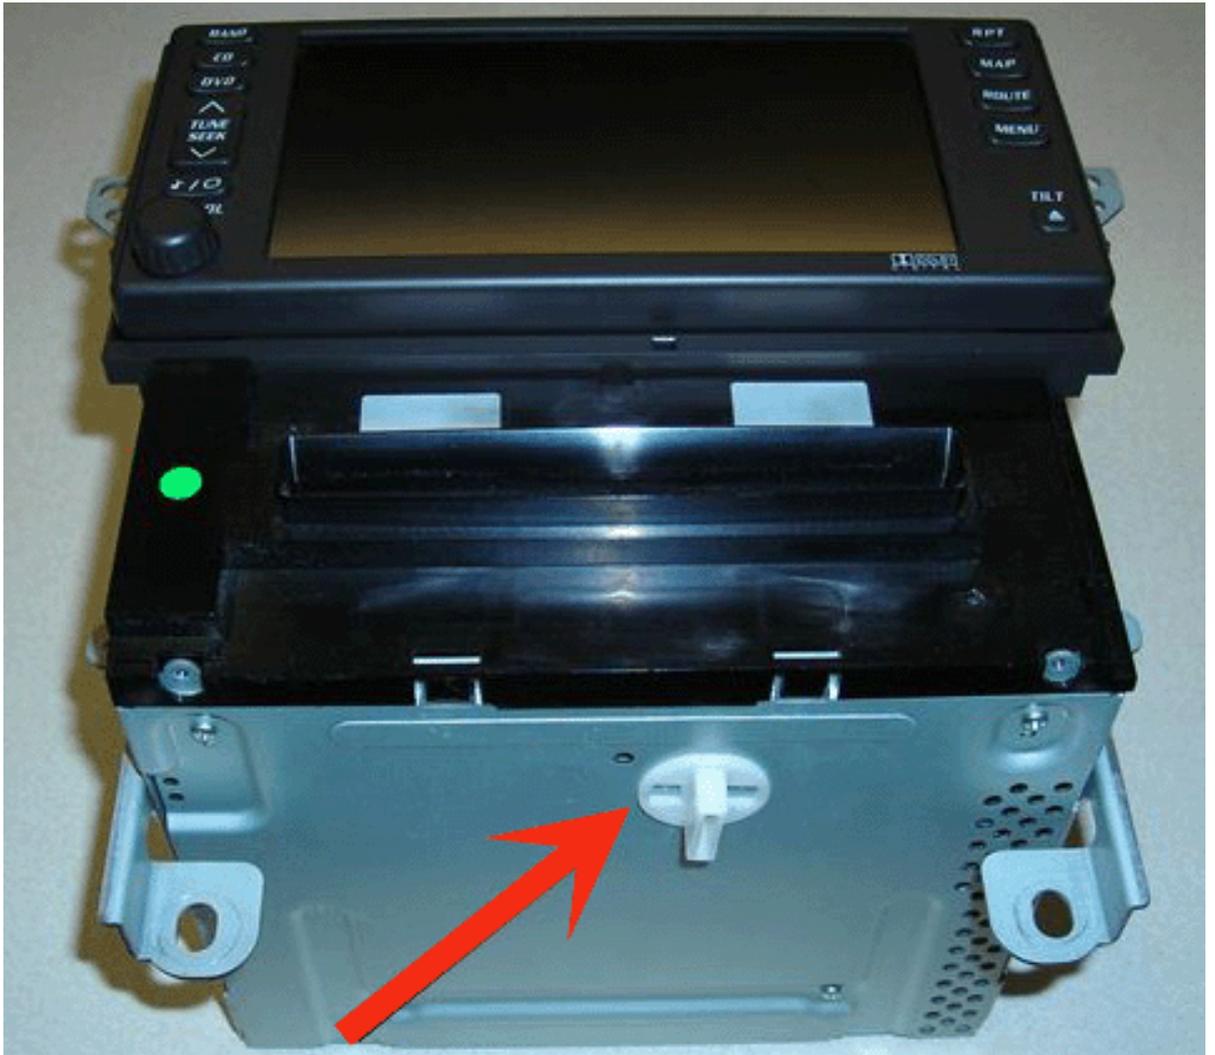
Some customers may comment that the CD changer (CDX) will not accept CD's or the display shows a "CD Error" message when attempting to play a disc. This will usually occur after the radio or CD changer was recently serviced for a different customer's concern. This may be caused because the "shipping pin" was not removed from the bottom of the CD changer prior to installing the service part into the vehicle.

Remove the shipping pin from the bottom of the CD changer prior to installing into the vehicle. This item is called out by an arrow in the first picture below. The second picture shows the shipping plug that has already been removed from the CD changer.

If returning the Navigation radio to the Electronic Service Center, be sure to reinstall the shipping pin to prevent damage to the unit while in transit.
