2004 Cadillac XLR: Service Information: HVAC Module Service

This information applies to the 2004 Cadillac XLR and the 2005 Chevrolet Corvette and newer.

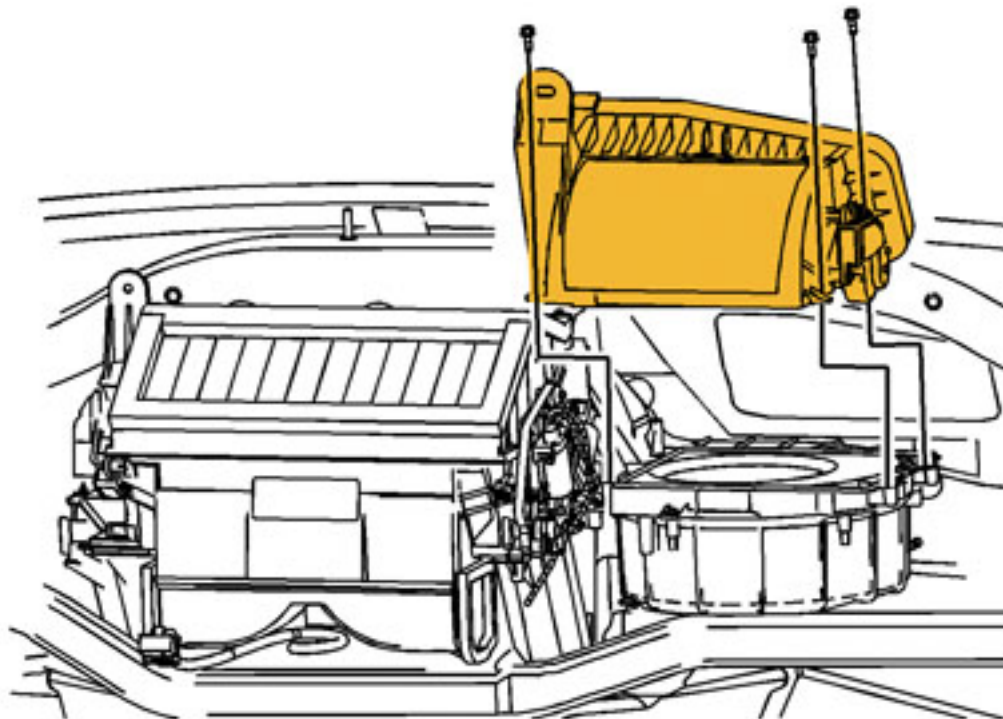
Use special care when removing or installing the HVAC module for service. The HVAC module is seated between a non-removable upper and lower tie bar

(fig. 11 - attached). The HVAC module must be partially disassembled before removal and installation (fig. 12 - attached).

Refer to SI 2000 to obtain the service procedure for correctly removing and installing the HVAC module. Failure to do could result in damage to the HVAC module.
